Site Studies Borssele Wind Farm Zone

Archaeological Assessment

Archaeological assessment Borssele Windfarm Zones

Periplus Archeomare Report 16A001-02

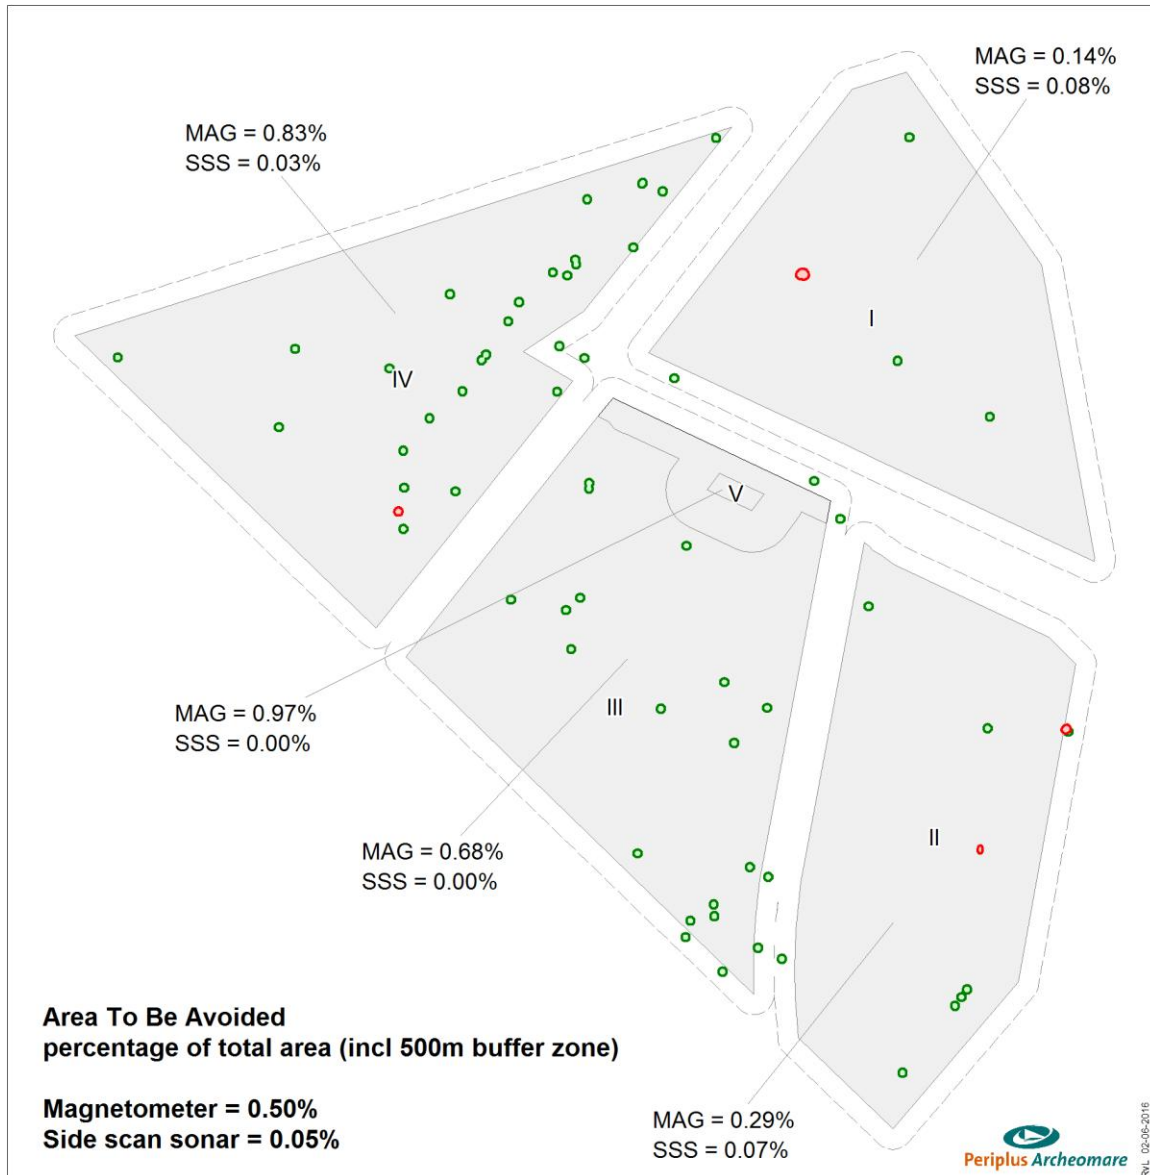
The cumulative surface areas occupied by side scan sonar and magnetometer buffer zones are shown in the figure below.

It is advised that the UXO research within 100 meter of the 65 magnetometer anomalies are carried out under onboard archaeological supervision. Depending on the outcome of the UXO research can be decided if additional research (for instance by means of ROV or dive investigations) is needed. If the UXO research indicates that the object has no archaeological value, the location can be omitted.

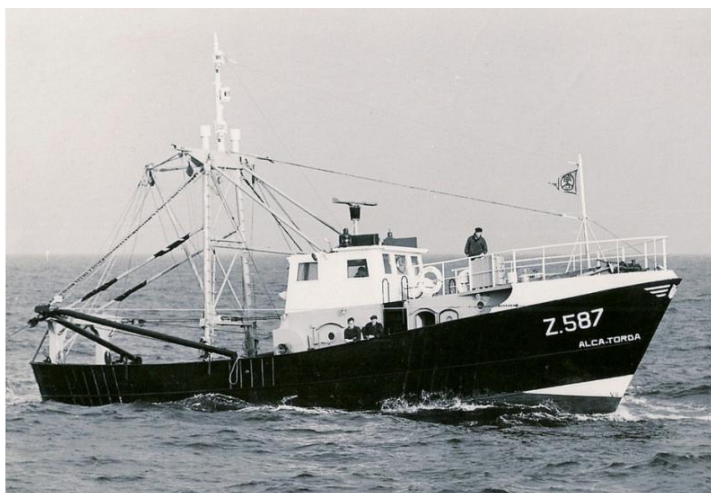
Figure 4. Photograph of the Alca Torda before sinking in 1973

Wreck NCN1684/SR12173 has been identified as the Belgian cutter 'Alca Torda' which sunk in 1973. The database of the Hydrographic service placed the wreck at the incorrect location (NLhono1703 instead of NLhono1723). The incorrect location was adopted by the desk study and Fugro.

The wreck is not considered to be of archaeological value. Therefore its presence will not - from an archaeological point of view - jeopardize the development of the wind farm.

Within BWFSI and BWFSII only one clear shipwreck is found (location NLhono 1723). Additional research of historical data prove this to be the wreck of the 'Alca Torda'. The initial location of the 'Alca Torda' was placed 6.8 km to the south (NLhono 1723), with a position accuracy of 1 km. At this location, no evidence was found of a ship wreck. From the data and additional research it may be concluded the unknown wreck at location 1723 is actually the wreck of the 'Alca Torda', and there is no wreck at location 1703.

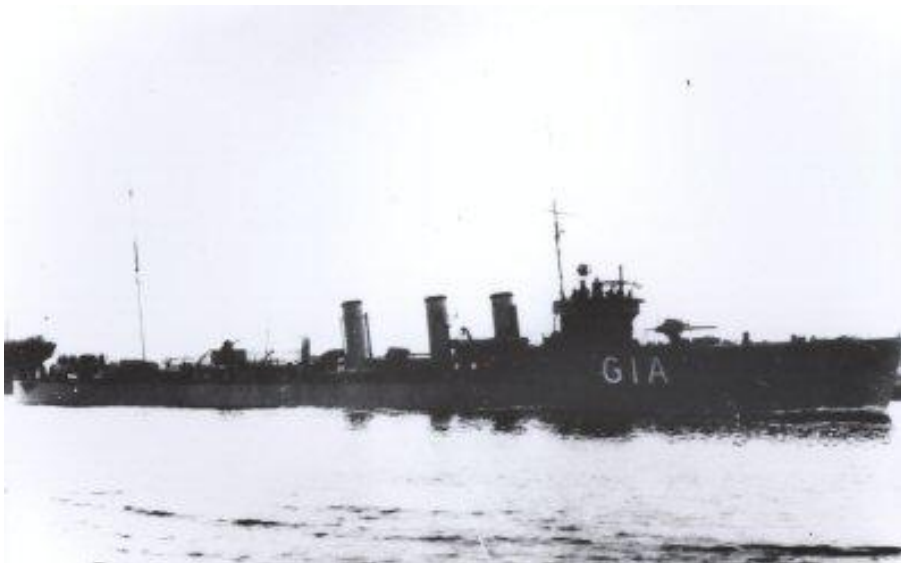
Figure 5. Photograph of the HMS Simoom (1916)

According to the database information NCN2494/SR8379 has been identified as the 'HMS Simoom'. The SR database dimensions are: L=28m; W=3m. The internet site www.wrecksite.eu contains two (2) wrecks named HMS Simoom.

One wreck concerns a British submarine built in 1941 and sunk by a mine 'in the Aegian Sea' in 1943; the other wreck is a British destroyer built in 1916 and scuttled by a torpedo the night of January 22nd, 1917. According to www.wrecksite.eu the 1916 steamer HMS Simoom is located 9 kilometer east of the NCN-database location: 518435E/5727220N. This ship however is larger than the wreck found: 84,1 x 8,2 x 2,8m. Possibly part of the wreck exposed at the seabed is smaller than the total length of the wreck. In other words part of the wreck can be buried. The certainty with which the wreck was identified as HMS Simoom is not known. So it cannot fully be excluded the actual wreck present is that of another ship than the HMS Simoom.

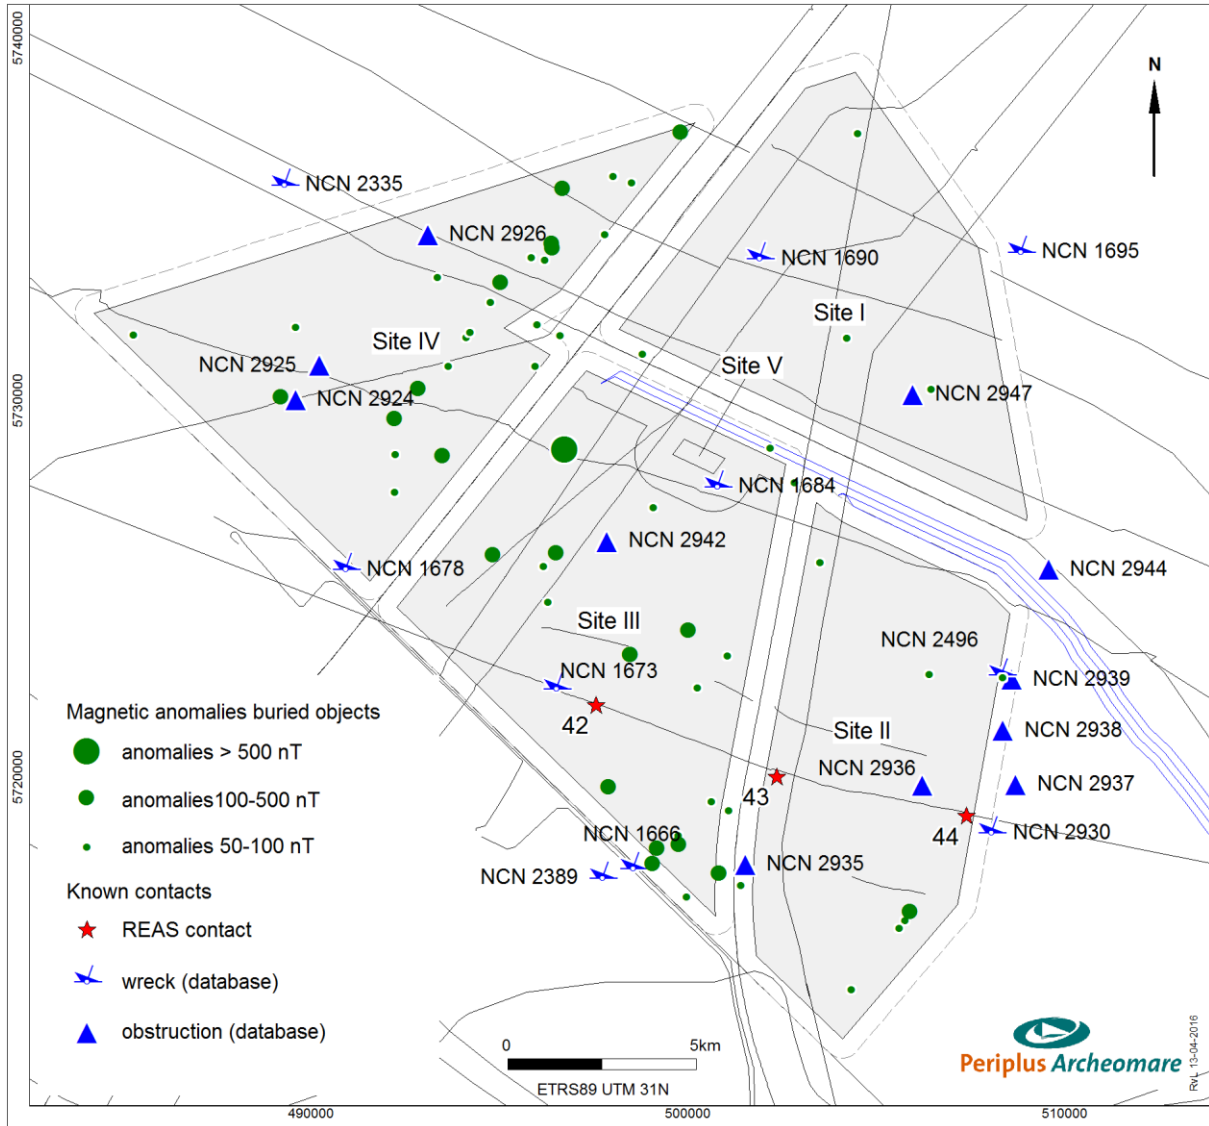
Figure 13. Magnetometer contacts of potential archaeological interest

The *magnetometer* contacts of potential archaeological interest are shown in figure 13 and summarised in table 8. A listing of all *magnetometer* anomalies can be found in Appendix 3.

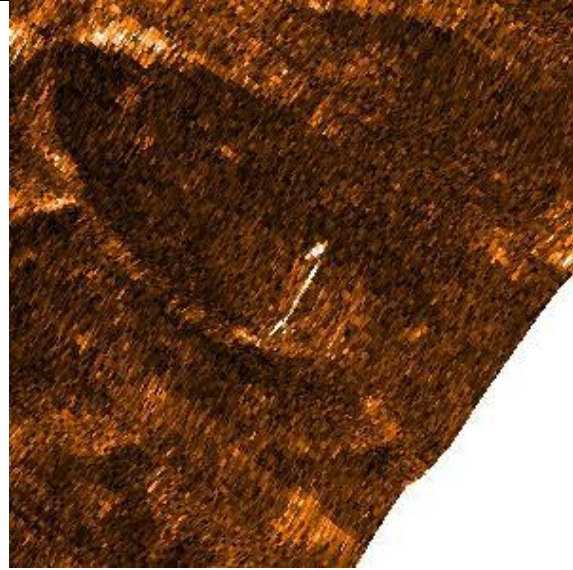
1	SSS-WFS1-209	85-8500	506498	5729838	12.0	0.0	HNM	Object	Possible cable

MBES: no signs of morphological disturbances or scouring; PP: probably cable
1	SSS-WFS1-206	71-7100	504039	5729040	11.2	9.6	HNM	Contact	Unknown contact

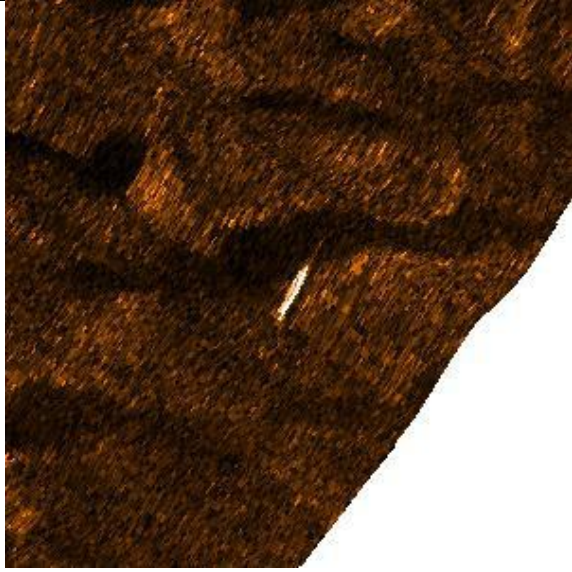
1	SSS-WFS1-211	95-9500	507520	5729519	5.0	0.8	0.1	Object	Unknown object

SSS: clear straight elongated contact; MBES: no morphological anomalies; MAG: no anomaly tagged; PP: unknown object
1	SSS-WFS1-158	41-4100	505827	5736186	4.5	0.9	HNM	Contact	Linear contact

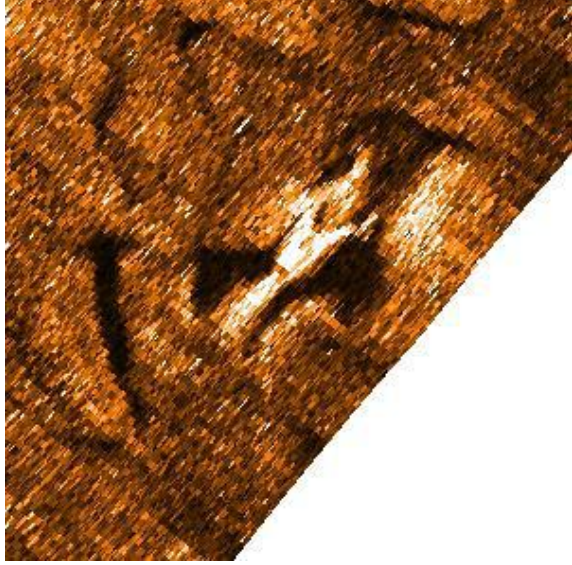
<p>MBES: elongated contact with scouring at northeast and southwest side; L=5.8m; W=3.2m; H=1.1m;</p> <p>MAG: no anomalies tagged;</p> <p>PP: unknown object</p>
2	SSS-WFS2-642	124-12400	503678	5719878	18.1	4.9	0.5	Object	Unknown object

<p>SSS: fork shaped contact with clear hard reflection; scouring on two sides;</p> <p>MBES: slightly elevated contact; L=3.2m; W=3.2m; H=0.6m; pronounced scouring at northwest side;</p> <p>MAG: no anomaly tagged</p> <p>PP: unknown object;</p>

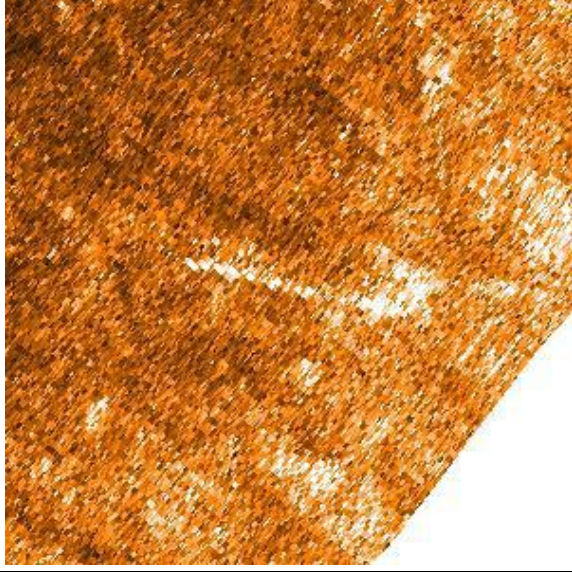
<p>SSS: hard granular reflections only; no shadows;</p> <p>MAG: no anomalies tagged;</p> <p>PP: natural phenomenon; possible exposed shell bed;</p>
2	SSS-WFS2-701	139-13900	505391	5719631	17.5	0.7	HNM	Contact	Linear contact

<p>SSS: hard reflections only; no shadows;</p> <p>MAG: no anomalies tagged;</p> <p>PP: natural phenomenon; possible exposed shells parallel to sediment ripple;</p>
2	SSS-WFS2-593	110-11000	505246	5724461	17.2	4.1	0.4	Object	Unknown object

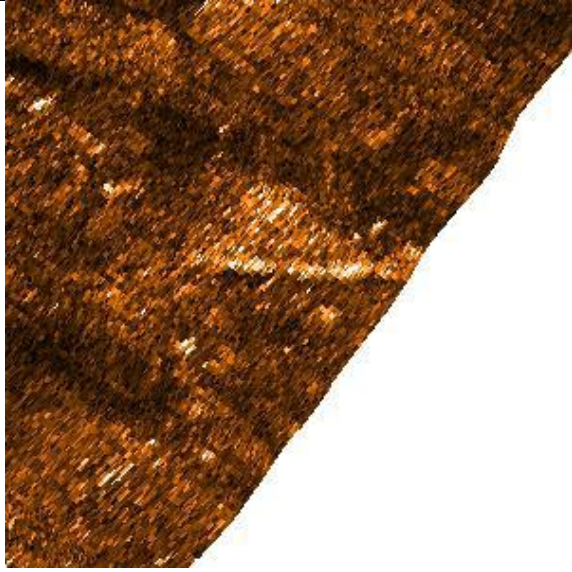
2	SSS-WFS2-576	104-10400	505944	5726013	7.0	2.3	0.2	Object	Unknown object

<p>SSS: elongated contact; granular reflection; faint shadow;</p> <p>MAG: no anomalies tagged;</p> <p>MBES: no signs of morphological disturbances or scouring;</p> <p>PP: natural phenomenon; possible shell ridge;</p>
2	SSS-WFS2-666	168-16800	504656	5714197	6.9	2.9	0.4	Contact	Unknown contact	 	<p>SSS: isolated contact; reflection very alike surrounding seabed;</p> <p>MAG: no anomaly tagged;</p> <p>MBES: no signs of morphological disturbances or scouring;</p> <p>PP: natural phenomenon; possible outcrop of clay/peat;</p>
2	SSS-WFS2-568	102-10200	501703	5720952	6.7	0.7	0.1	Object	Unknown object	 	<p>SSS: clear reflection; no clear shadow;</p> <p>MAG: no anomaly tagged;</p> <p>MBES: no signs of morphological disturbances or scouring; top of sand wave crest;</p> <p>PP: natural phenomenon;</p>

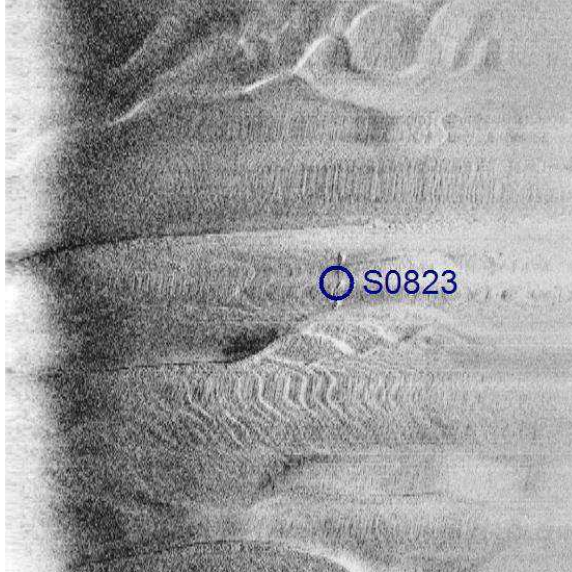
SSS: irregular shaped contact; clear reflection and shadow; MBES: slight disturbance of natural morphology; MAG: no anomalies tagged; PP: unknown object;
3	S0823	A31074_SH_Nav Merged	493047	5724239	9.7	0.2	0.1	linear debris	Cable?

SSS: linear contact; MAG: M0729 PP: cable or pipe
3	S0832	A3SB016_SH_Na vMerged	498854	5723863	9.4	0.6	0.2	debris

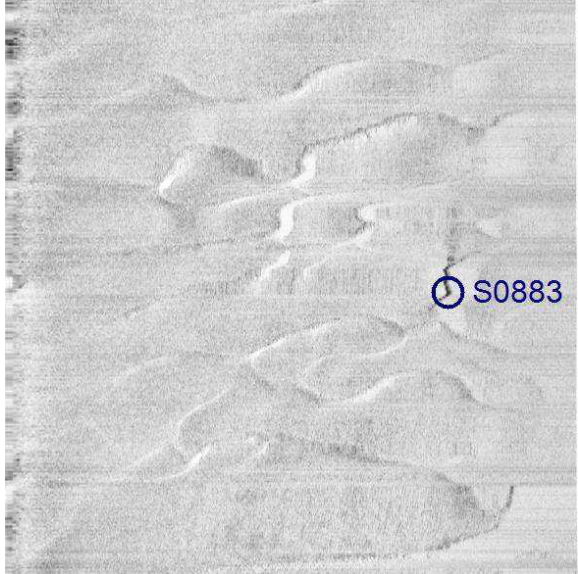
SSS: linear contact; disturbance of SSS-image; striping; MBES: no signs of morphological disturbances or scouring; MAG: no anomalies tagged; PP: rope or cable;
3	S0883	A31004_SH_701_ NavMerged	501158	5716728	7.8	1.4	0.7	debris

SSS: linear contact; hard reflection; MBES: amidst scouring; MG: no anomalies tagged; PP: Zeepipe exposure

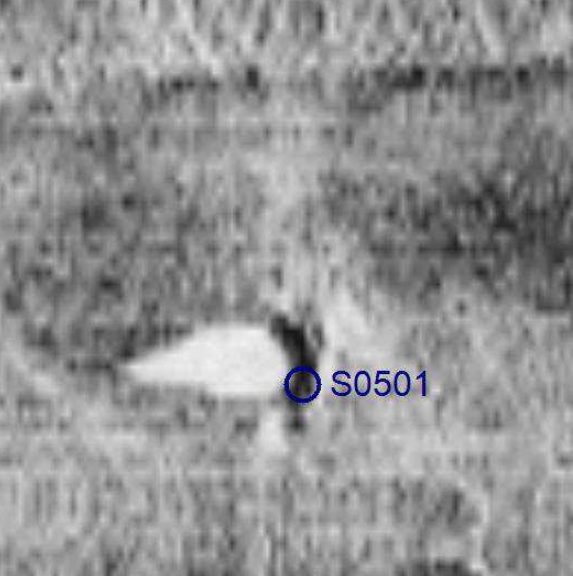
SSS: elongated contact; hard reflection; clear large shadow; MBES: elevated elongated contact; parallel to sand wave crest; 9m southwest on tagged SSS-contact; correct coord. = 491519E/5729786; L=4.3m; W=1.0m; H=0.4m; MAG: no anomalies tagged; PP: natural phenomenon; intersection outcropping clay?

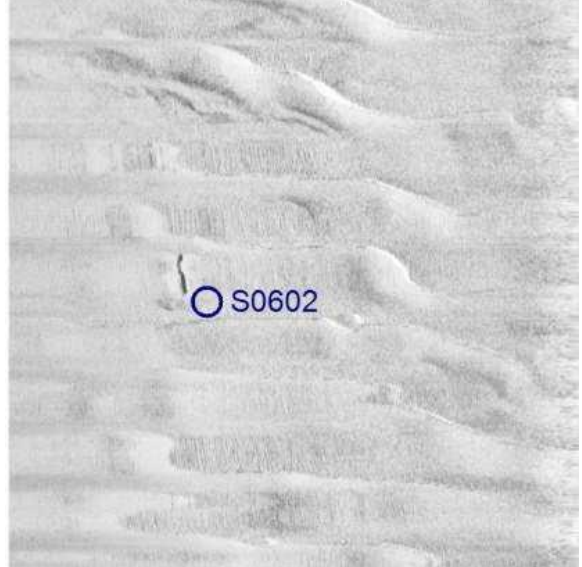
<p>SSS: elongated contact; hard reflection; shadow visible; MBES: connection between two sand ripples; MAG: no anomalies tagged; PP: natural phenomenon; sand ripple;</p>

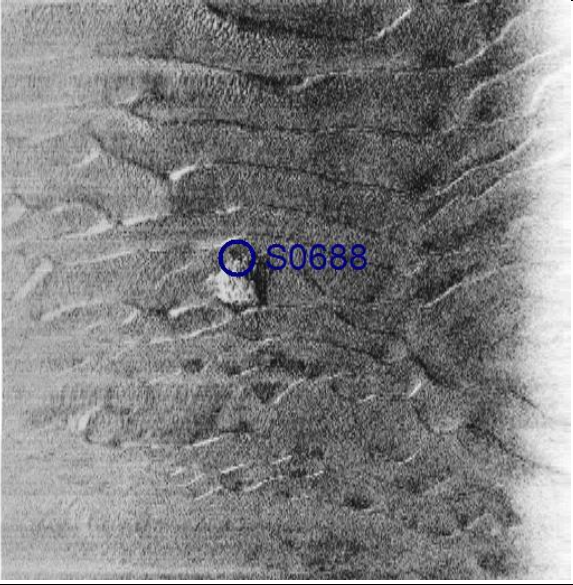
4	S0688	A41107_SH_Nav Merged	489958	5727405	9.0	4.3	1.3	debris

SSS: spherical contact; moderate granular reflection; no shadow; MBES: no signs of morphological disturbances or scouring; MAG: no anomalies tagged; PP: natural phenomenon; possible outcrop of clay;
4	S0693	A41105_SH_Nav Merged	490358	5727289	4.3	1.2	0.5	debris
