Pilot archaeological analysis of geophysical and geotechnical data BWFZ

Document Control	
Document 16A001_Pilot_Arch_analysis_WOZ1600005_final_2.1.pdf	
Revision	2.1 (final)
Date	18-03-2016
Periplus Archeomare Reference	16A001-01
RVO.nl reference	WOZ1600005

Periplus Archeomare Report 16A001-01

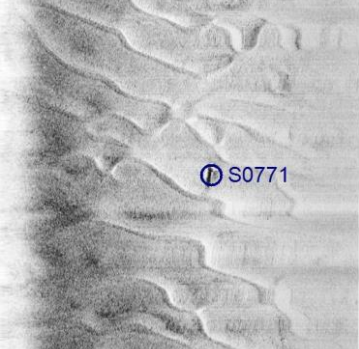
Figure 2. Original description and interpretation from Fugro report of contact S0771

S0771 <ul style="list-style-type: none"> • Sonar Time at Target: 09-Jun-15 22:59:38 • Click Position 51.6815462401 2.8859150569 (WGS84) 0.0000000000 0.0000000000 (NAD27LL) 51.6815462401 2.8859150569 (LocalLL) (X) 492112.56 (Y) 5725626.00 (Projected Coordinates) • Fish Height: 12.23 Meters • Line Name: A41086_SH_NavMerged 	Dimensions and attributes <ul style="list-style-type: none"> • Target Width: 1.12 Meters • Target Height: 0.37 Meters • Target Length: 6.67 Meters • Target Shadow: 1.84 Meters • Classification1: debris • Description: visible on the MBES
---	---	---

The figure above shows the original description, interpretation and sonar image of contact nr. S0771, located in WFS IV. The supposed object has a length of more than 6 meters and a width of a meter. It was interpreted as debris, a more detailed interpretation was not possible on the basis of only the sonar image.

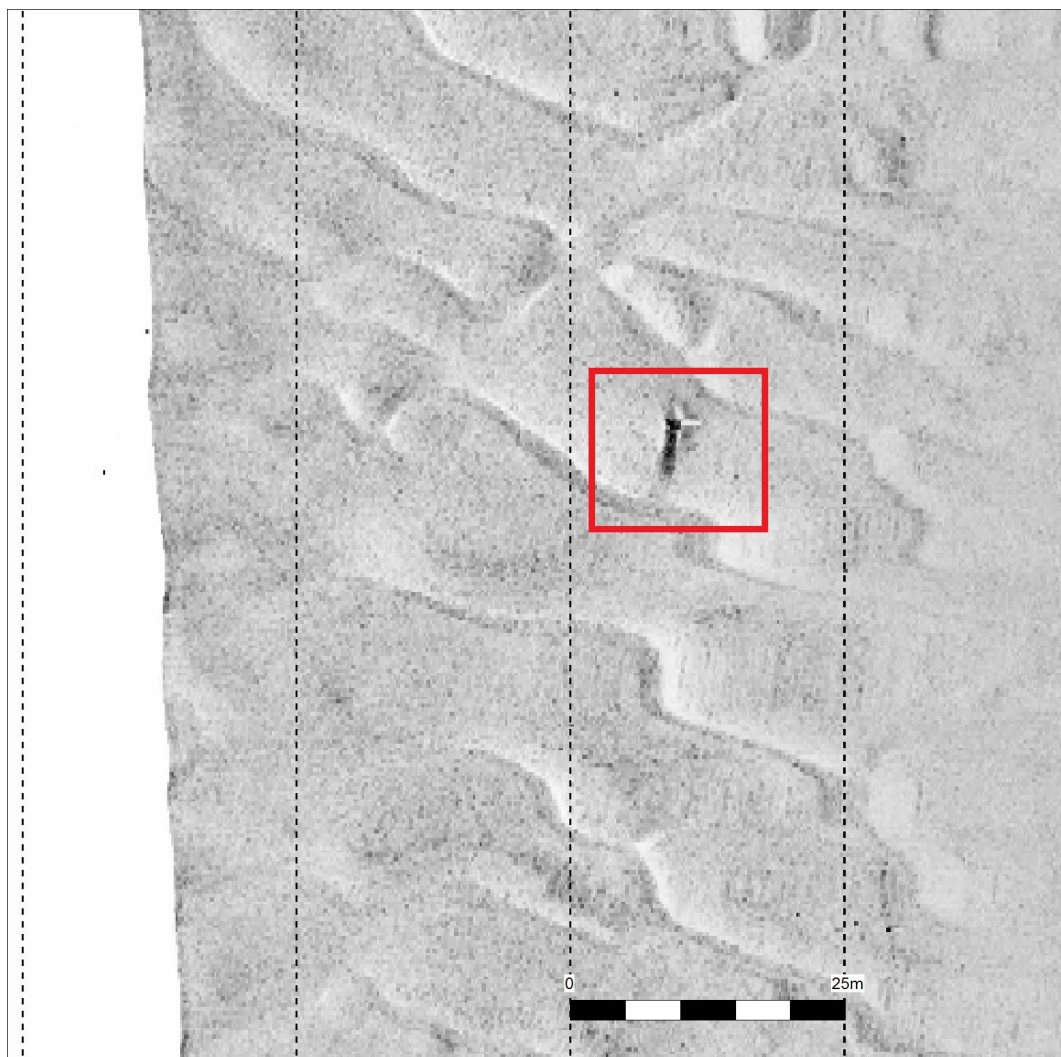
Figure 3. Raw waterfall sonar image of contact S0771

The original raw sonar image (figure below) shows slightly more details.

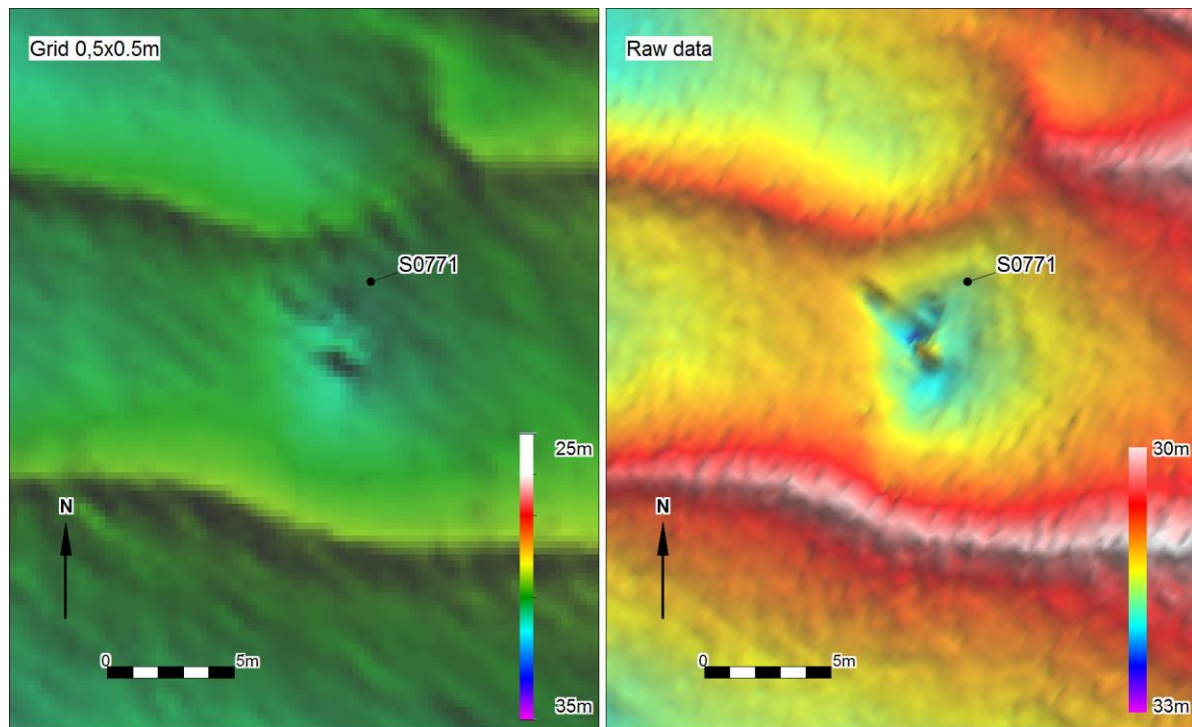
Figure 4. Gridded and raw multibeam data of contact S0771

From the raw multibeam data more details can be revealed. The figure below shows the gridded data (binsize 0.5x0.5m) and an image of the raw data (density approximately 11 points per square meter).

Within the image of the raw data, two structures can be observed: one point object protruding from the seabed surrounded by a depression caused by scouring, and one elongated object with a length of 4 meters.

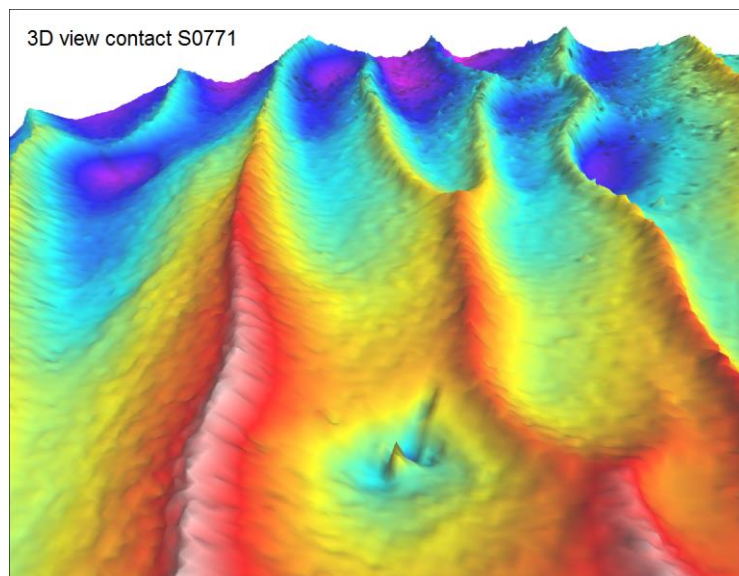
Figure 5. 3D view of raw multibeam data of contact S0771

Based on these images, the object can be interpreted as a man-made structure which is partly buried in the seabed. No magnetic anomalies have been observed at the site, but it should be noted that no acquisition lines of the magnetometer cross the site.

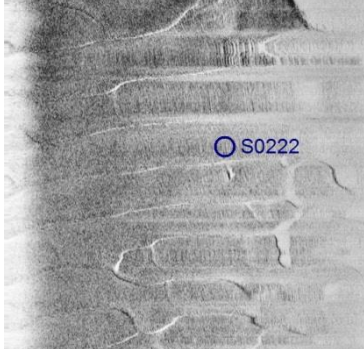
Figure 6. Original sonar image and description from Fugro report of contact S0222*

S0222 <ul style="list-style-type: none"> • Sonar Time at Target: 06-Jun-15 05:37:02 • Click Position 51.7407362864 2.8890832572 (WGS84) 0.0000000000 0.0000000000 (NAD27LL) 51.7407362864 2.8890832572 (LocalLL) (X) 492341.60 (Y) 5732208.62 (Projected Coordinates) • Fish Height: 10.35 Meters • Line Name: A41117_SH_NavMerged 	Dimensions and attributes <ul style="list-style-type: none"> • Target Width: 0.56 Meters • Target Height: 0.17 Meters • Target Length: 2.84 Meters • Target Shadow: 1.06 Meters • Classification1: debris • Description: visible on the MBES
---	---	---

*Note: based on the side scan sonar-image presented the target appears not to be 'tagged' at the right spot.

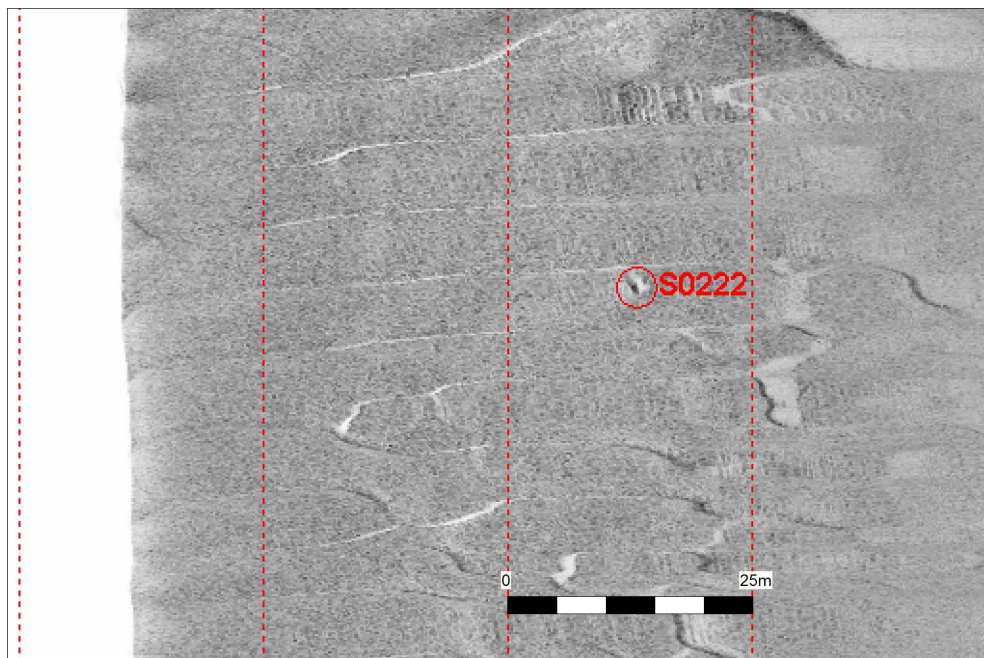
Figure 7. Raw waterfall sonar image of contact S0222

The original raw sonar image (figure below) does not reveal more details.

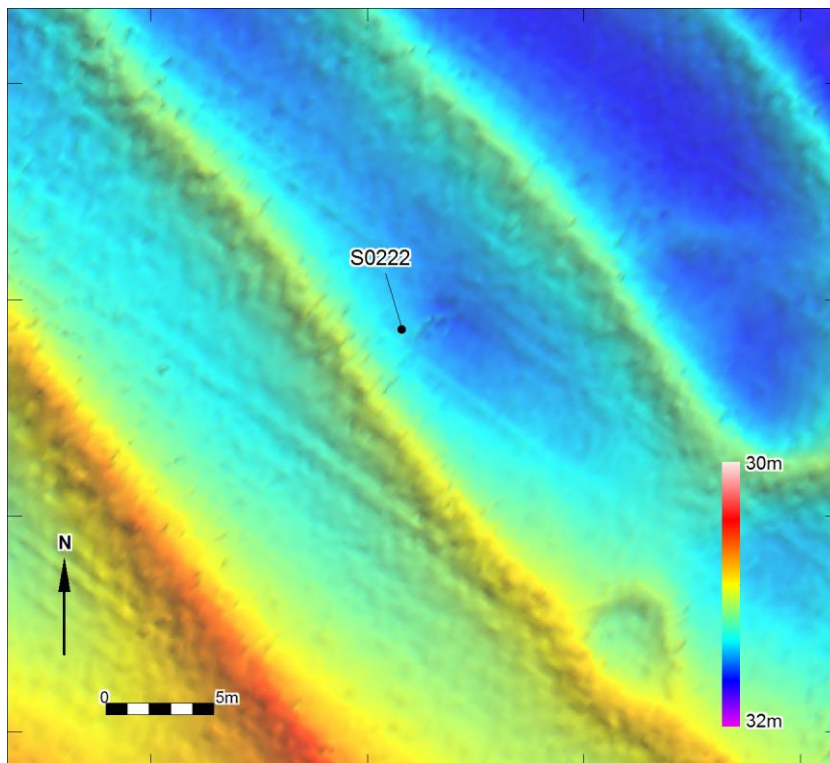
Figure 8. Raw multibeam data of contact S0222

In the raw multibeam data, the object is hardly visible (figure below) due to limited height of the object (less than 0.2 m) and the fact that almost no scouring has taken place.

Based on these images, the object seems to be an isolated object lying on the seabed and might be of natural origin. No magnetic anomalies have been observed at the site, but it should be noted that no acquisition lines of the magnetometer cross the site.

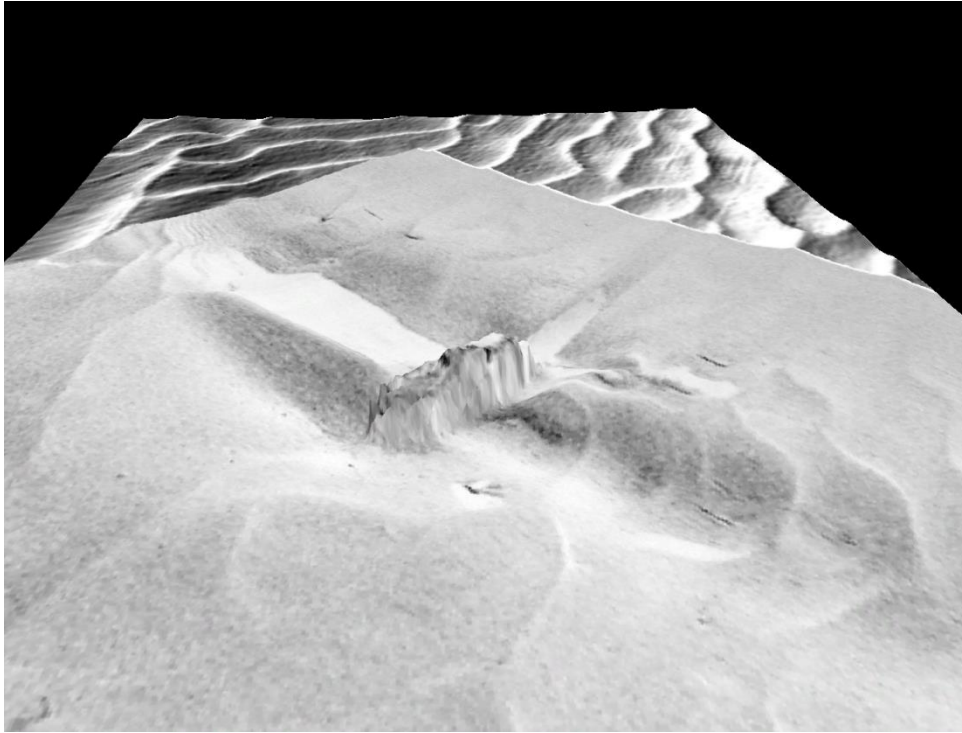
Figure 10. Side scan sonar image of the wreck draped over the multibeam model

Within the two research areas only one clear shipwreck was found by Fugro (location NLhono 1723). Additional research of historical data proved this to be the wreck of the 'Alca Torda'. The initial location of the 'Alca Torda' was placed 6.8 km to the south (NLhono 1723), with a position accuracy of 1 km. At this location, no evidence was found of a ship wreck. From the data and additional research it may be concluded the unknown wreck at location 1723 is actually the wreck of the 'Alca Torda', and there is no wreck at location 1703. It is recommended to pass this information to Rijkswaterstaat and the Hydrographic office.

The quality of the data set suffices for the identification of the ship wreck as such. The identification is supported by the integration of the different types of geophysical data available: SSS, MBES, MAGGY and SBP. The wreck is embedded in sandy sediments. The seabed is characterized by the presence of mega-ripples. Considerable scouring caused by tidal currents is observed both northeast as southwest of the wreck. In the surroundings side scan sonar contacts are observed which possibly are linked to the wreck site.

The unknown wreck at NLhono location 1723 is actually the wreck of the 'Alca Torda', and we found no wreck at NLhono location 1703 to which the 'Alca Torda' wreck currently is assigned. It is recommended to pass this information to Rijkswaterstaat and the Hydrographic office.

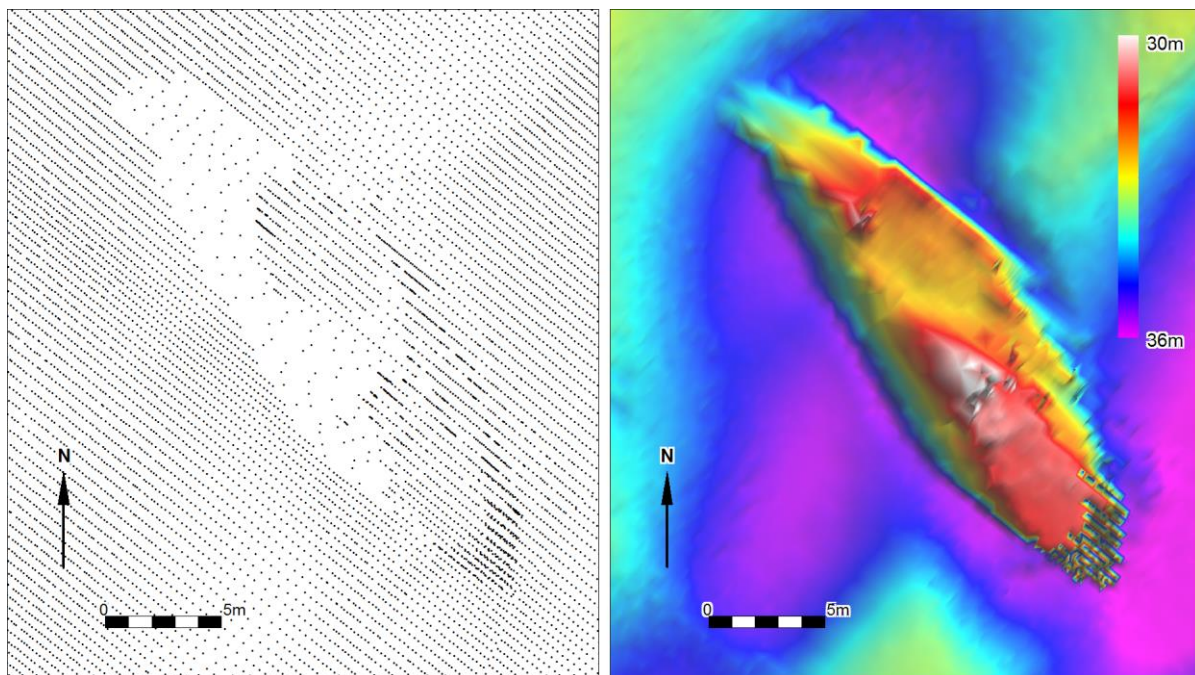
Figure 11. Raw multibeam soundings (left) and colour image of the multibeam data of the wreck Alca Torda

The raw multibeam data (with a data density of 11 points per square meter) supply slightly more details than the original gridded data (4 points per square meter) and is therefore useful for an archaeological assessment.

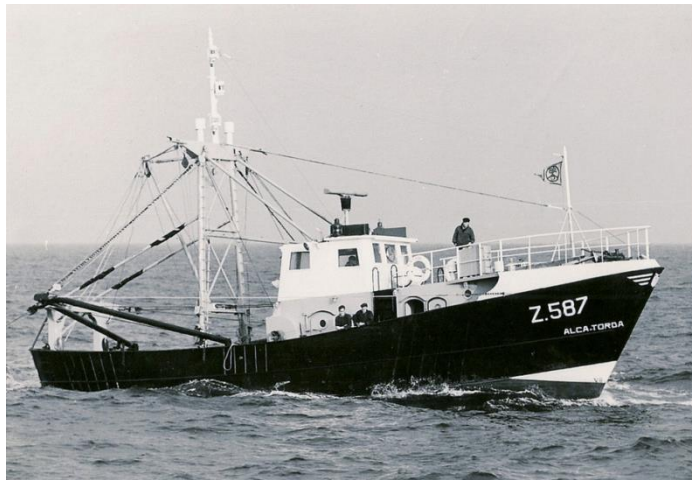
Figure 12. Photograph of the Alca Torda before sinking in 1973

Additional research within various databases provided additional and valuable information of the wreck. The wreck is identified as the Belgian kutter 'Alca Torda' which sunk in 1973. The database of the Hydrographic service placed the wreck at the incorrect location (1703 instead of 1723), which was adopted by the Desk study and Fugro.
