Metocean measurement campaigns

Borssele and
Hollandse Kust zuid

Arve Berg
Fugro OCEANOR

Webinar
Amsterdam Jan 2017

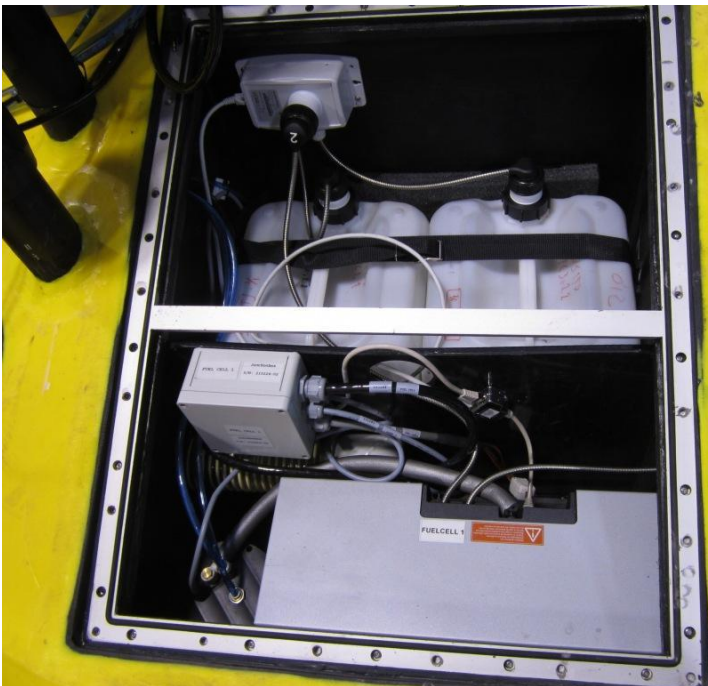
Power – Fuel cells

- Average power consumption 70 W (1680 Watt hours per day)
- 4 independent compartment (redundancy)
- 2x2 cans: contribution 37 days each chamber
- 2x3 cans: contribution 55 days each chamber

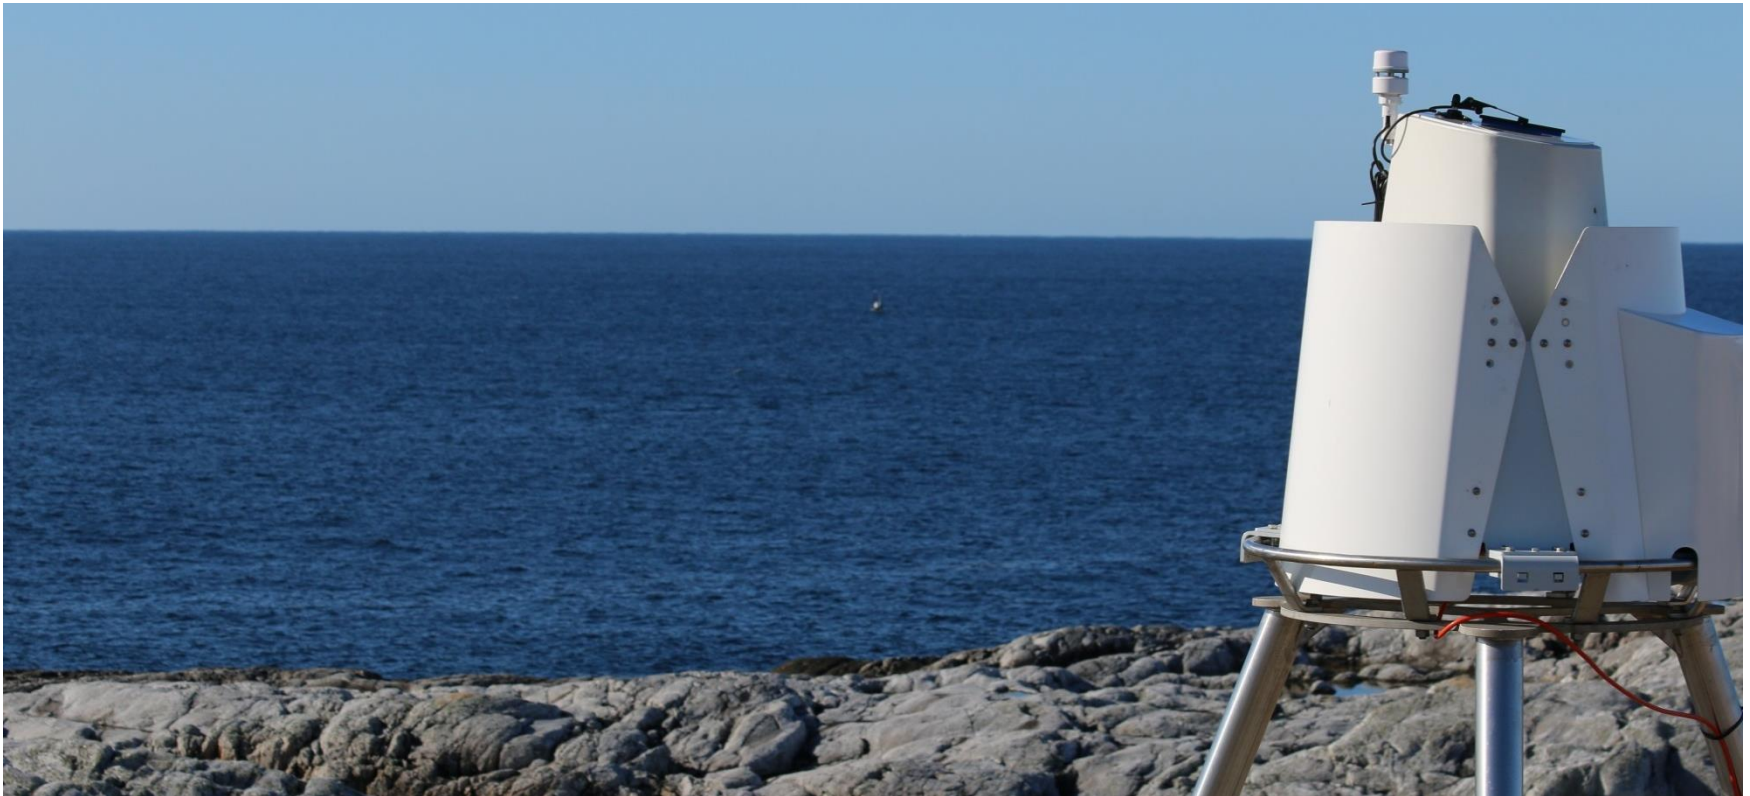
Fugro Lidar Buoy validation site – Titran, Frøya

- Pre- and post validation site approved by DNVGL
- On-shore Lidar reference at Stabben Fort is established, and standard anemometry reference masts (NTNU/ University) are available
- So far: Five SWLB successfully validated at site since March 2015

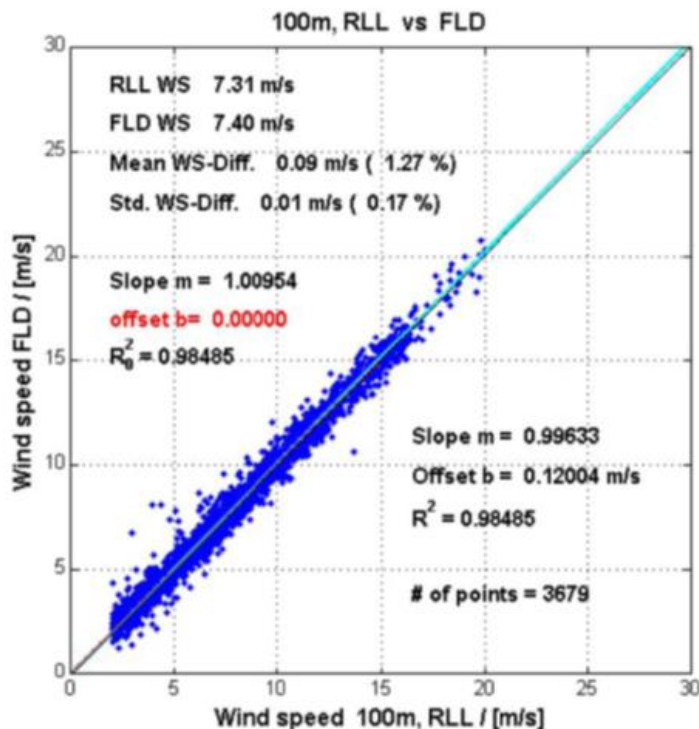
For Mean Offset (OFF_{mwd}) accuracy for wind direction (WD) has been a significantly improved from buoy WS156 till buoy WS158. This has been achieved by using a compass of better quality.

Correlation of Lidar buoy and Land Lidar for 100 m height for buoy WS158

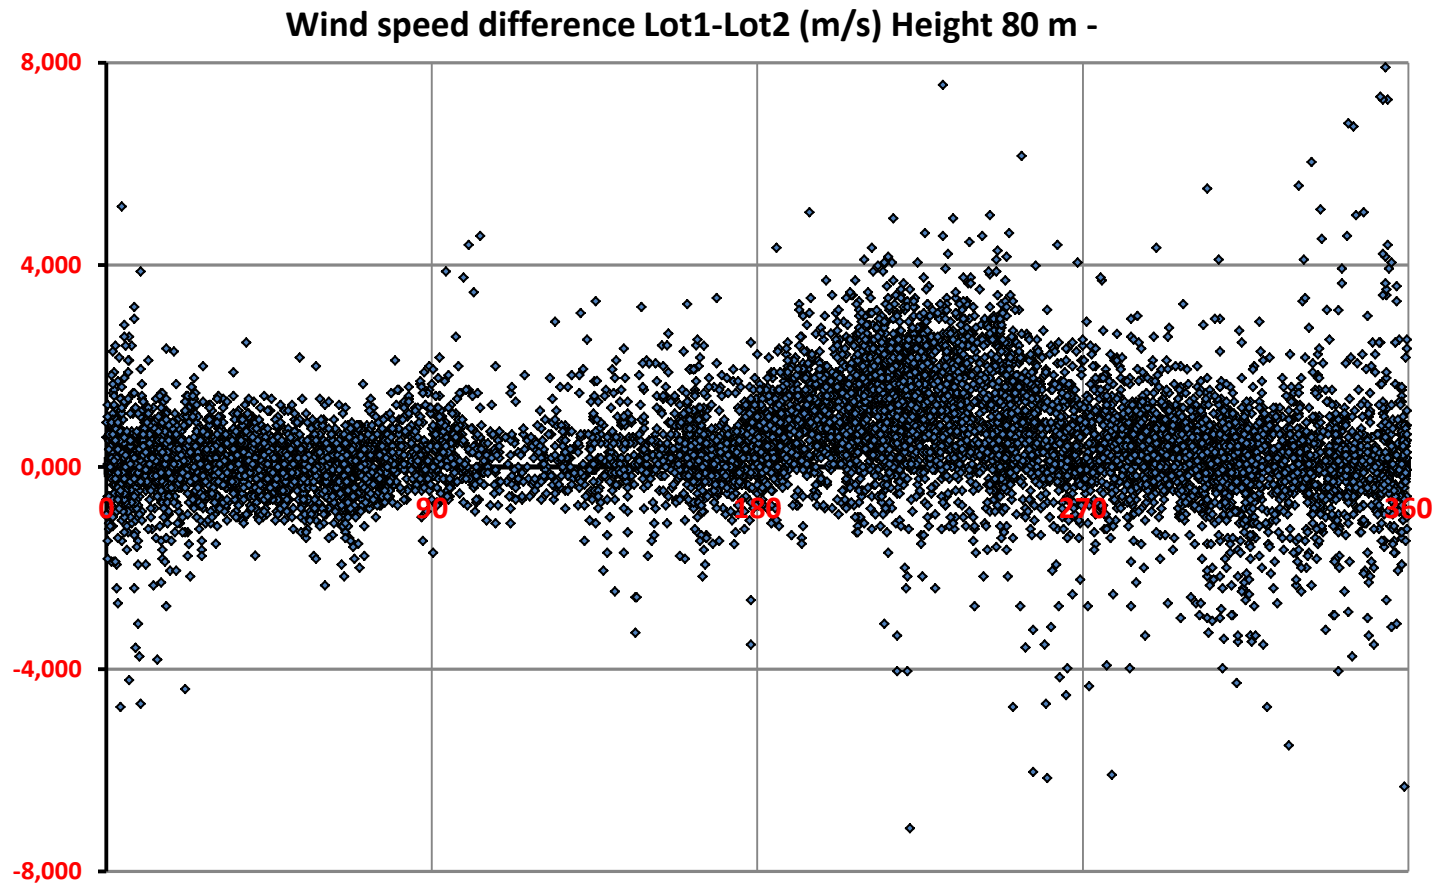
Preliminary Results wake effects study

Wind speed at Lot 2 lower and turbulence higher than at Lot 1 for direction between 180° (south) and 300° (west-northwest) - wind speed at Lot 1 is 1-2 m/s, or 5-10 % higher than at Lot 2

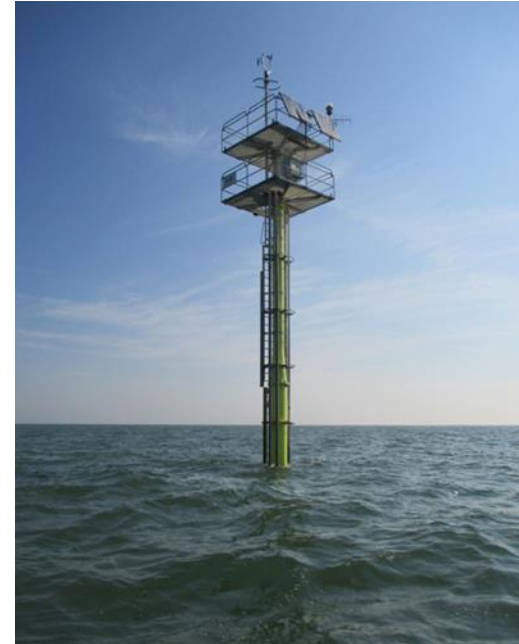
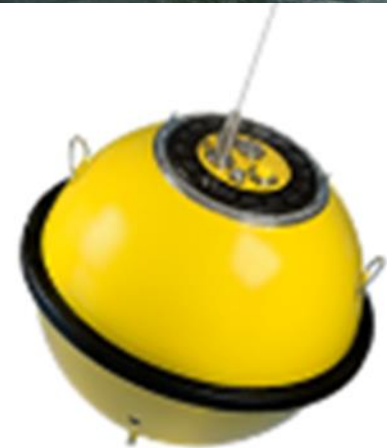
- wind measurements validated against the platform at Vlakte van de Raan
- Wind speed - KNMI cup-anemometer
- Wind direction - KNMI wind vane.
- 27.6 km from Wind Lidar buoy
- 12 km from the nearest shore

- wave measurements validated against buoy at Schouwenbank
- directional (“2D”) Datawell Waverider buoy
- 19.3 km from Wind Lidar buoy
- 22.0 km from nearest shore

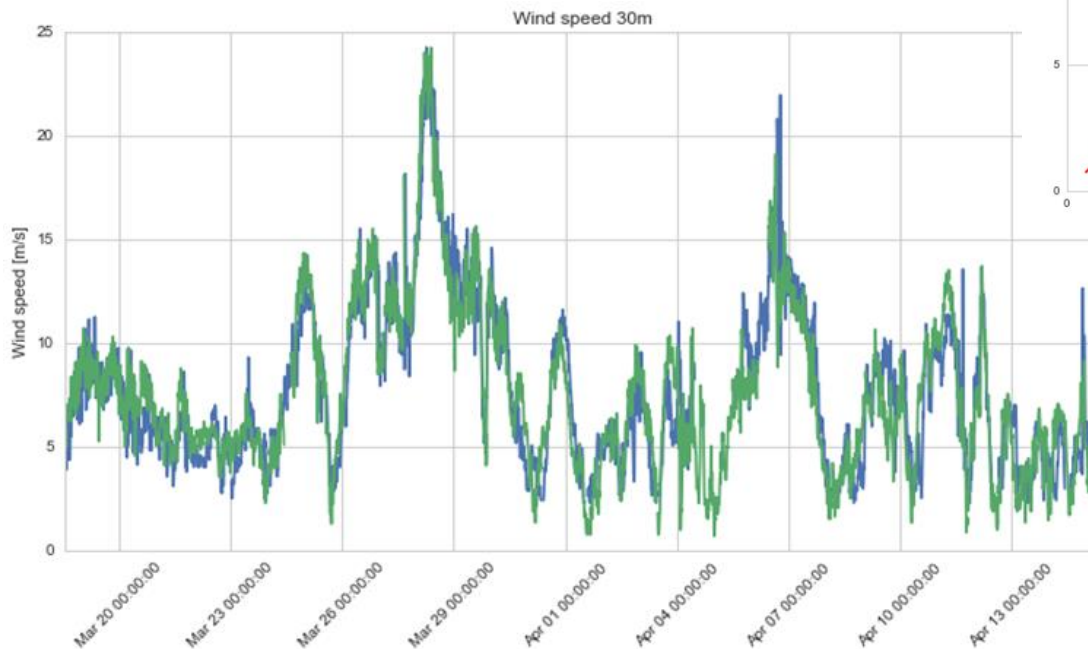
Wind speed time serie and scatter at 30 m above sea level measured by the Lidar buoy (green curve) compared to wind speed at Vlakte van de Raan adjusted to 30 m (blue)

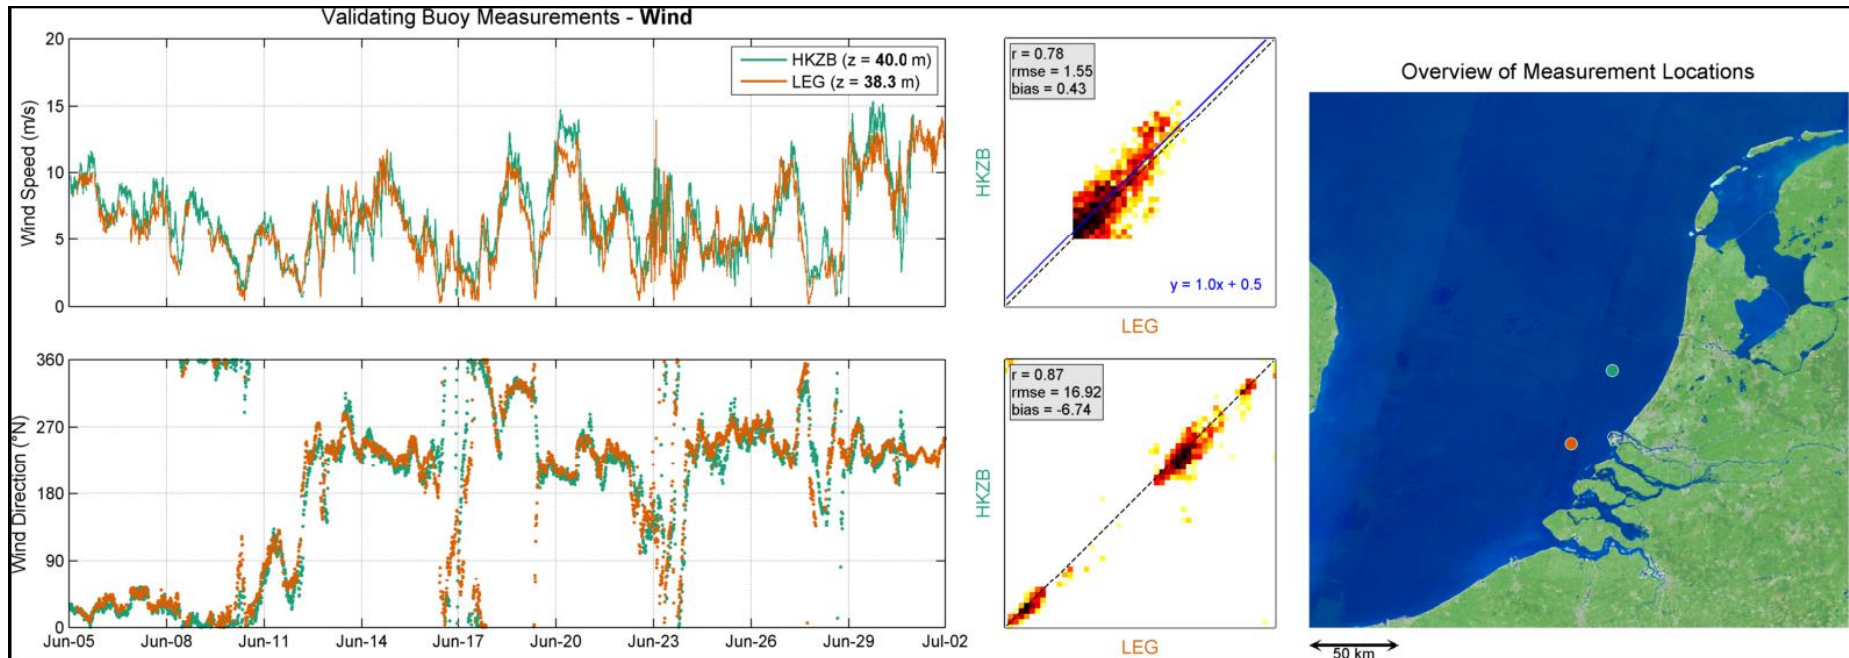
Validation of HKZB wind with LEG (June 2016 period)

Left panel: timeseries.

Middle panel: Density scatter, with the darker colours indicating more data density.

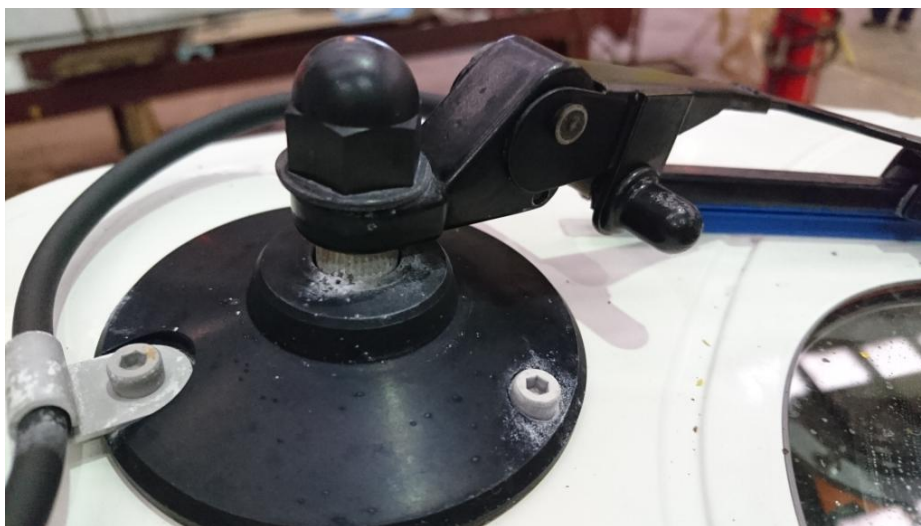
Salt Water Ingress through Wiper Seal

- Apply grease to sealing ring,
- proper tightening

Z300 On/off button corrosion	Lidar permanently switches to on or off position. If locked in off, Lidar stops.	E	5	On/off button removed/bypassed, hole sealed	A	1
Z300 Salt water ingress through wiper seal	Salt water droplets ingress. Can damage the Lidar electronics	C	3	Apply grease to sealing ring, check for no damage, proper tightening.	B	2
Z300 Old type connector corrosion	Old type connectors stuck to chassis	E	1	Monitor corrosion progress, replace with marine grade alloy when possible. In future only use marine grade connectors.	A	1
Z300 Old type(150-series) Met station failure	Water ingress in met station. Lidar met. station failure. (Additional met. sensors on buoy used as backup)	D	2	Upgrade to new type met station(200-series)	B	2

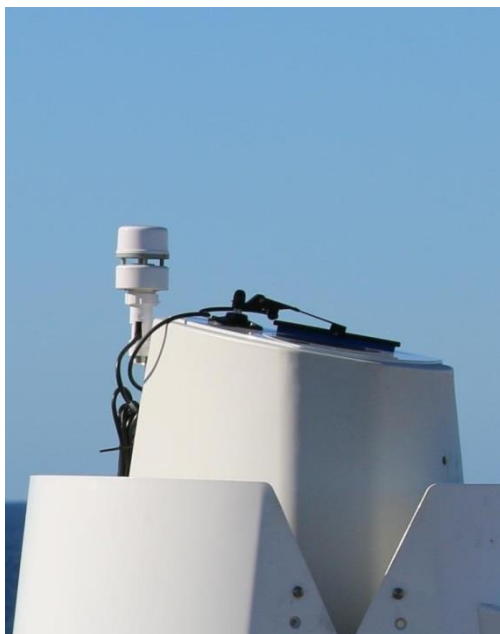
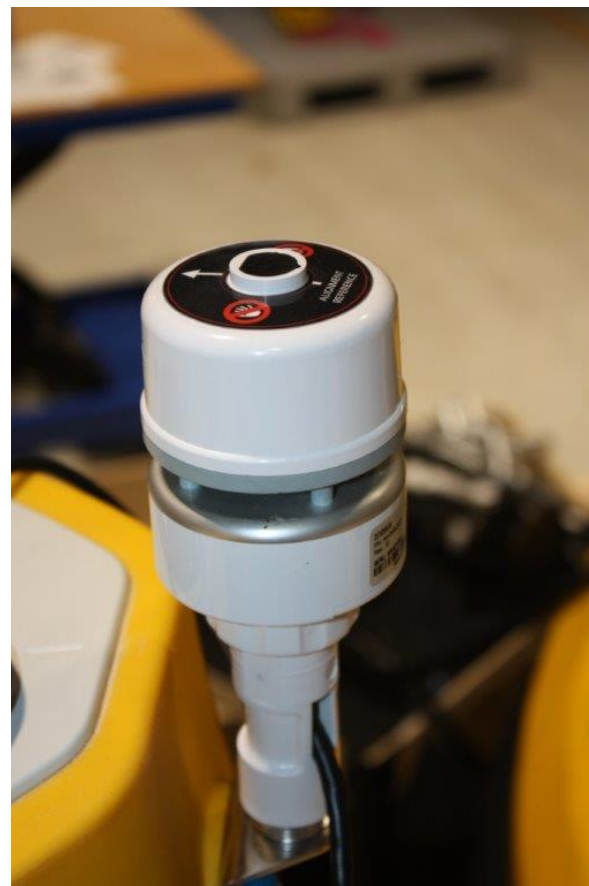
Met station failure (old 150-series type)

- Upgrade to new 200-series type (without humidity sensor water ingress weakness)

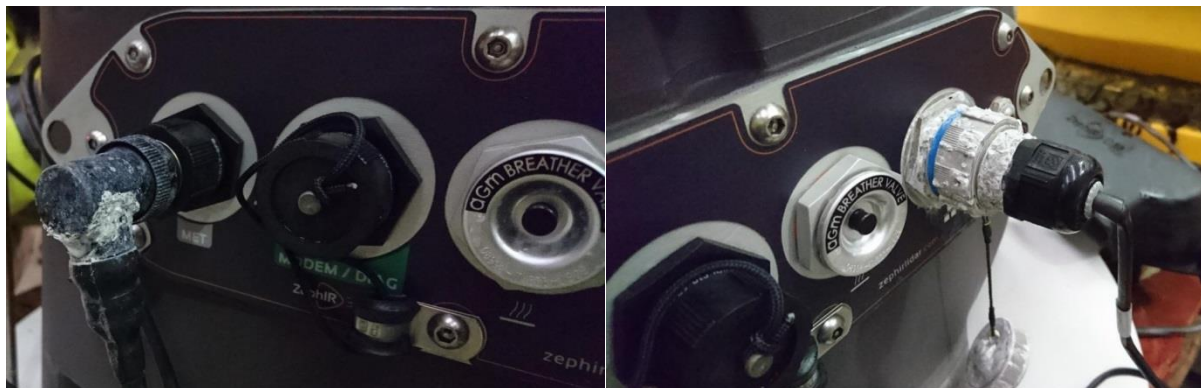
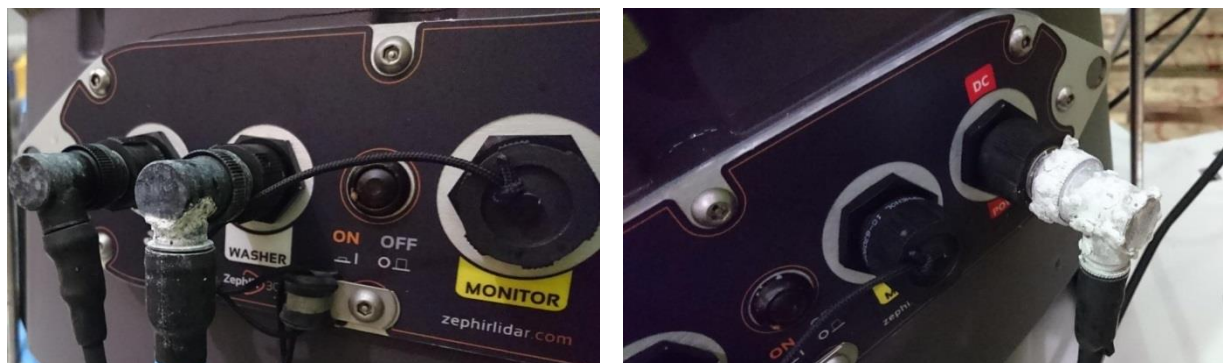
Connector corrosion

- Replace with marine grade alloy
- In future only use marine grade connectors
- Marine version launched by Zephir Nov 2015 (after start of Borssele)

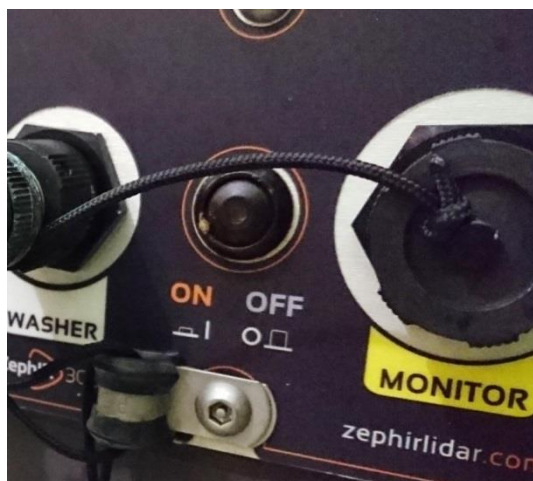
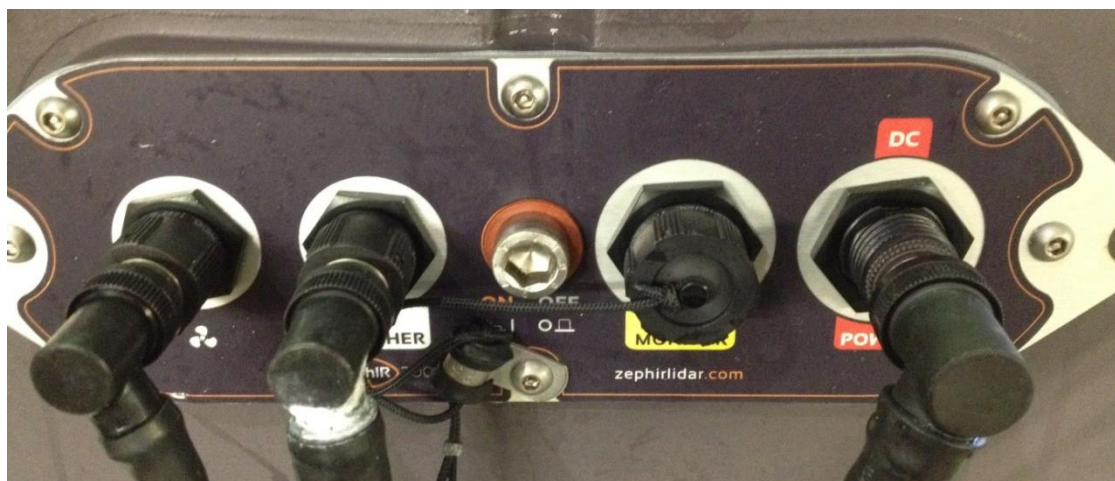
On/off button corrosion (caused Lidar power failure)

- On/off button removed/bypassed
- Hole sealed

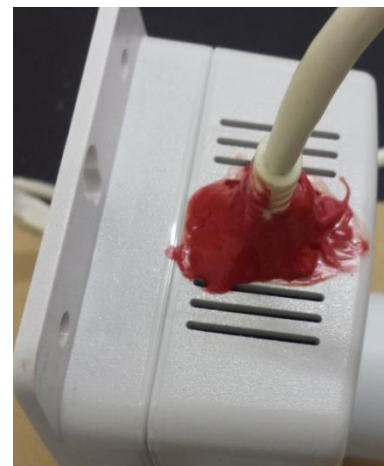
Corrosion on fuel cell cables and connectors

- Replacing corroded connectors at service
- Seal non-IP connectors with rubber seal

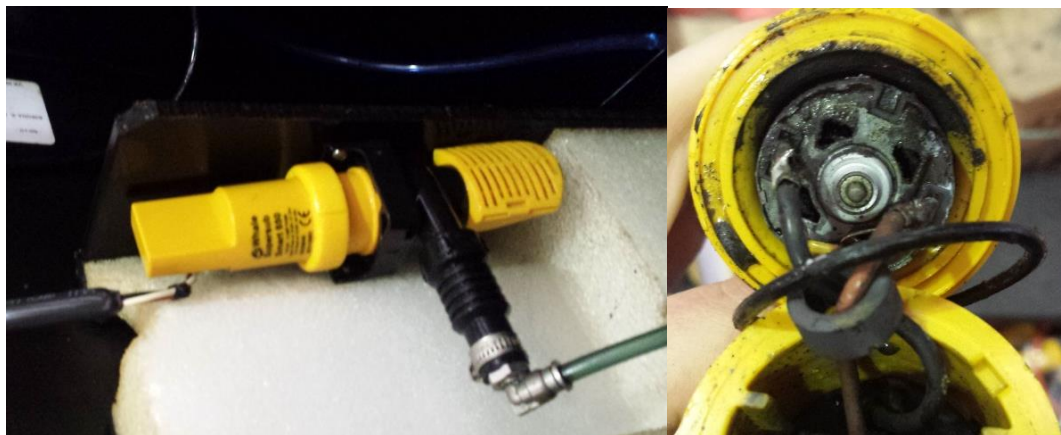
Dry-running bilge pumps

- Installation improved
- Timer added
- Change to better pump

Event	Description/Consequence	Likelihood of occurrence	Severity for total system	Mitigating measures	Likelihood of occurrence	Severity for total system
Dry-running bilge pumps	Pump wears out, fuel cell exposure to salt water. (4 independent systems.) Time for service and refuelling will come sooner.	C	2	Installation improved, timer added. In future change to better pump	A	2
Seized/corroded exhaust pump	Higher exhaust pressure. Damage on fuel cell. (4 independent systems.) Time for service and refuelling will come sooner.	C	2	Housing redesigned without pump	A	1
Corrosion on fuel cell cables and connectors (RJ45)	Corrosion on RJ45 connectors. In worst case fuel cells can stop working. (4 independent systems.) Time for service and refuelling will come sooner.	B	2	Seal non-IP connectors with liquid rubber. Corroded connectors replaced when buoy is serviced.	A	2
Fuel cell error messages/failure	Error messages appears indicating that over time fuel cells can stop working. (4 independent systems.) Time for service and refuelling will come sooner.	C	2	Fuel cells having error messages are replaced when buoy is serviced. Work time is logged and fuel cells are sent for service before service intervals expires	B	2
