UXO Desk Study

Hollandse Kust (noord)
Wind Farm Zone

Site Data Hollandse Kust (noord) Wind Farm Zone

20170705_SDHKNWFZ_REASeuro_UXO Desk Study_EvdBerg_V2_F
July 5, 2017

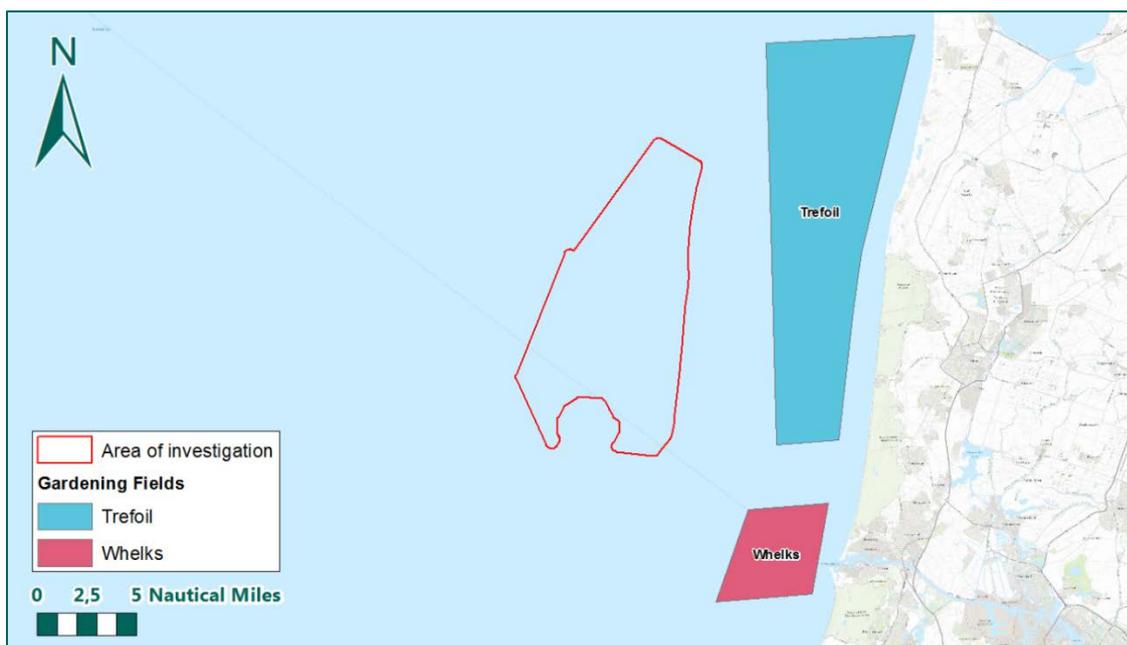
Figure 8: Gardening fields near the HKNWFZ.

As indicated in Figure 8, two garden fields lay in the vicinity of the area of investigation. These garden fields were mined earlier in the year 1944 by the British coastal forces. Later during the year, with the lengthening of the days, the nights became too short for the Coastal Forces operations. The garden fields passed to Bomber Command for aerial mining. Both garden zones lay at least 3.2 NM (6 km) from the wind farm zone.

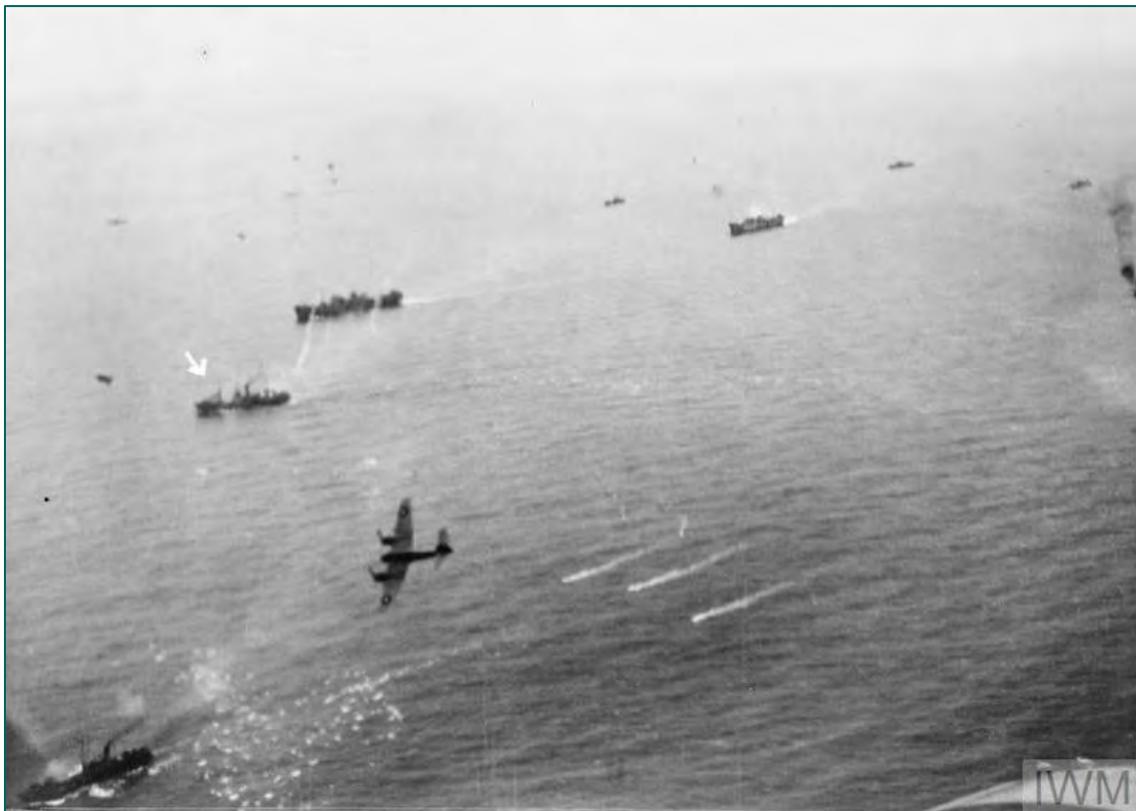
Figure 13: Oblique aerial photograph taken during an anti-shipping strike by Bristol Beaufighter on a heavily-armed northbound convoy off IJmuiden, Holland. The arrowed vessel is a 'Sperrbrecher' (magnetic-mine detonating vessel). (Source: <http://www.iwm.org.uk/collections/item/object/205023235>).

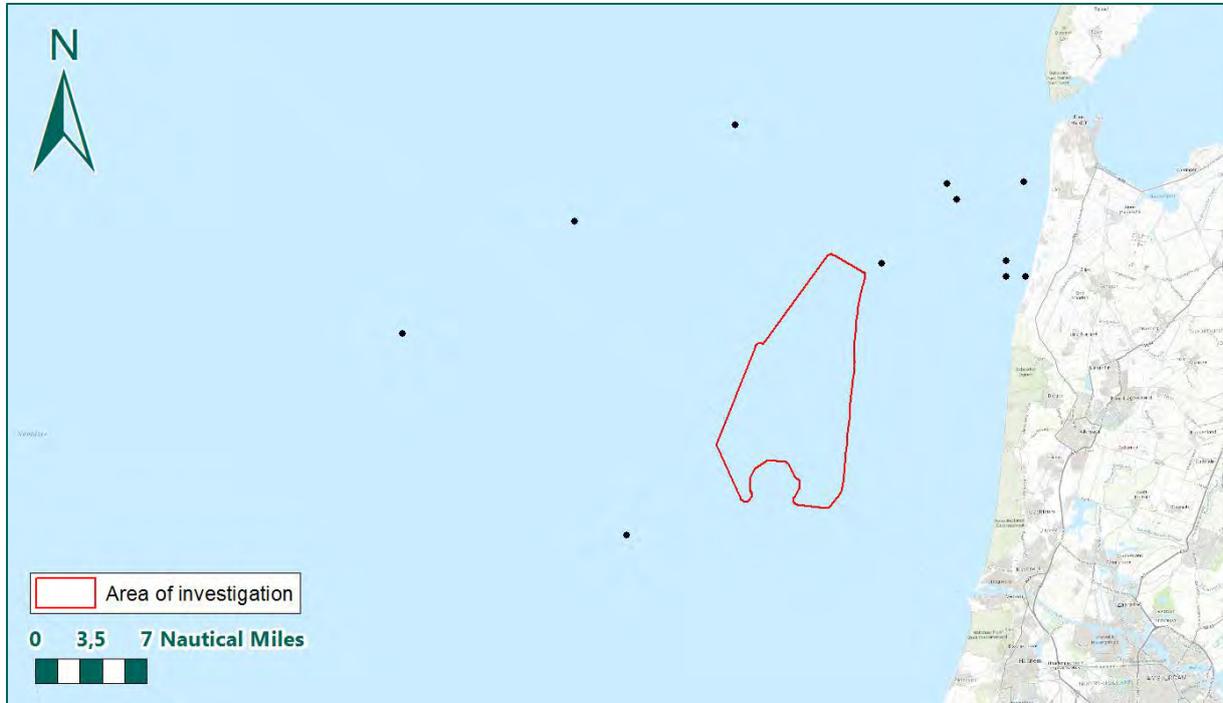
Figure 15: Area of investigation HKNWFZ and Bomber Command attacks (black dots) on ships and convoys.

Allied attacks on ships and convoys are also documented in the Operations Record Books of Bomber Command and Coastal Command, see annex 7. The records refer to coordinates and the locations where attacks took place. Some examples are presented in Figure 15.⁴

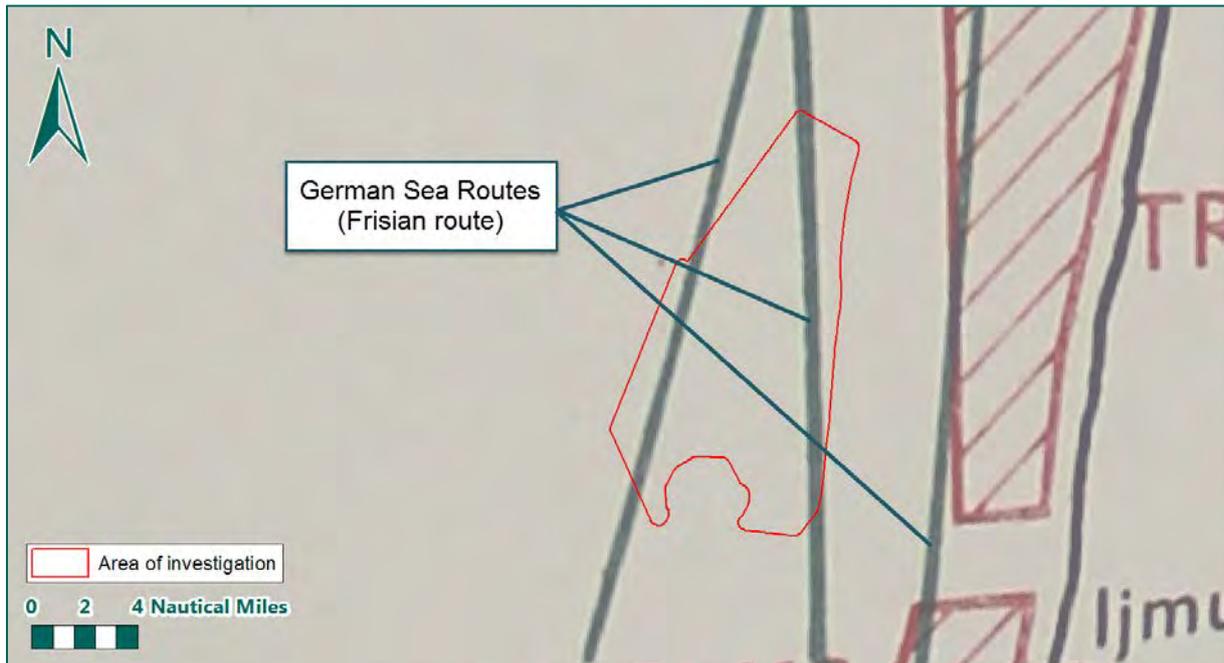
Figure 17: German sea routes. (Source: annex 7, TNA, ADM 234/561).

By August 1944, the German Command had been forced to cease sending convoys by day along the Dutch coast. The toll taken by the allied air forces had become too heavy. The only possible tactic was to sail the convoy by night in short hops from port to port, sheltering in strong defended harbours during daylight hours. In response, the allied air forces tried to attack convoys at night using new tactics. Because of the minelaying activities, German convoys were stuck to certain sea routes. Figure 17 shows that German sea routes crossed the area of investigation. Convoys along these routes are likely to have been attacked by allied planes.

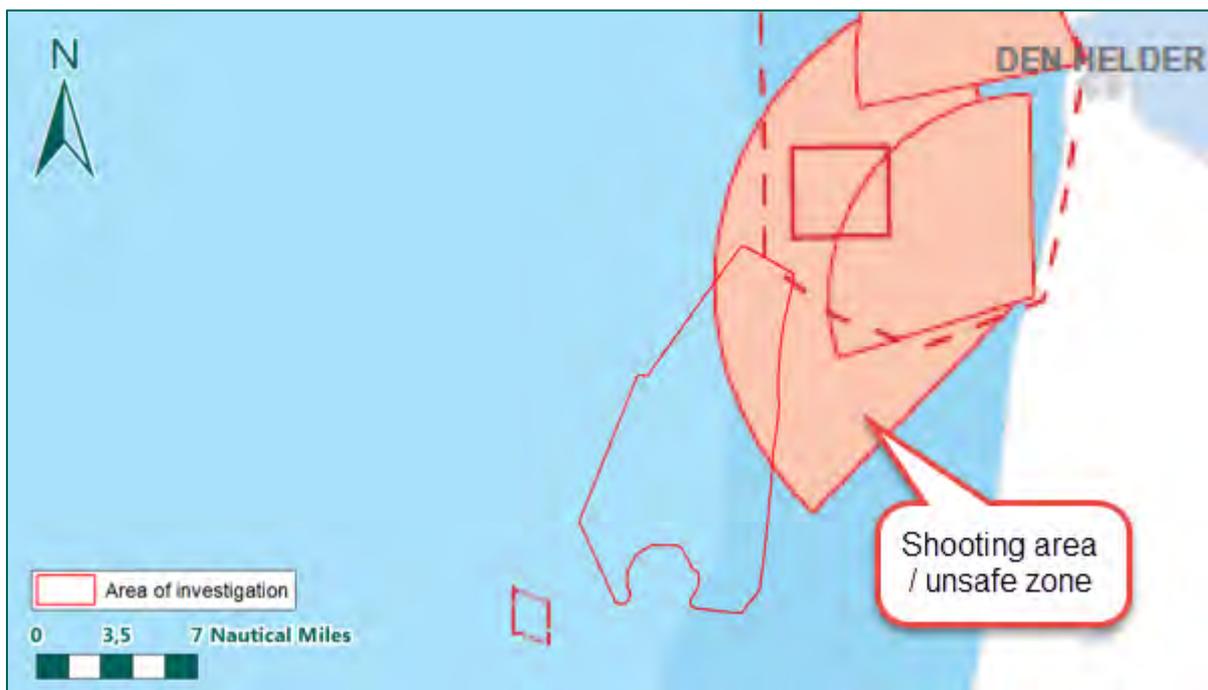
Figure 19: Extract of the map 'Military Use'. (Source: annex 5, Noordzeeloket).

Different shooting areas are visible on the map 'Military Use' of the Noordzeeloket (see annex 5). Figure 19 shows that a large artillery firing range / unsafe zone has overlap with the Wind Farm Zone. This shooting area near Petten is bounded with a 14 NM (25.9 km) radius, and is further restricted to the sector between 225° to 345°. Based on experiences of former Dutch Navy personnel the used calibres vary from 20 mm to 40 mm anti-aircraft shells.

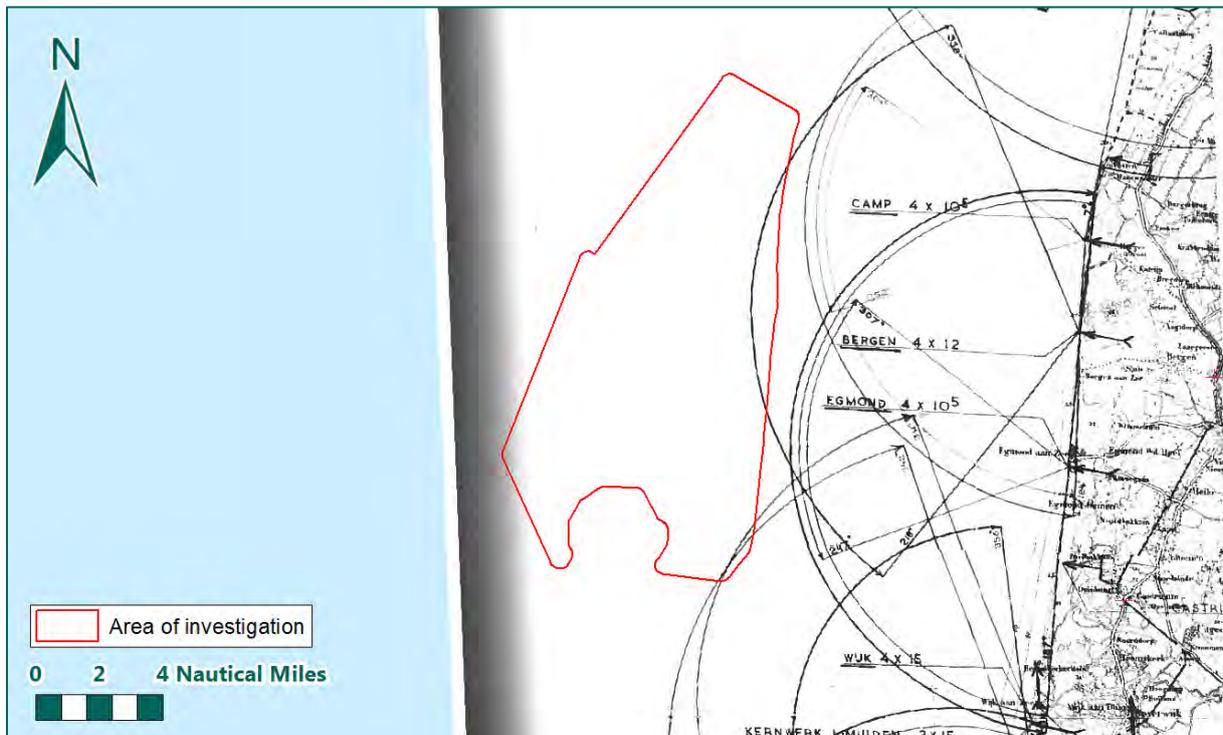
Figure 22: German coastal guns and shooting ranges, Den Helder to IJmuiden, mid 1944. (Source: annex 4, HAR, page 328).

During World War I the coastal defences near Den Helder and IJmuiden were reinforced with 21 cm and 12 cm guns, with a range of 12 km and 12.5 km. The mentioned calibres were also present in 1940, on the eve of World War II. The area of investigation lies at least 20 km off IJmuiden and 25 km off Den Helder, which means only the calibre of 28 cm munitions would have been capable of reaching the area of investigation.

During World War II, after the capitulation of the Netherlands on 14 May 1940, the German occupier started to reinforce the Dutch coast. Since 1942, the defences were firmly reinforced and became known as the *Atlantikwall*. This was a German coastal defence line from Norway to France. Figure 22 shows the German coastal guns and their shooting range. According to this figure, the calibres of 12 cm, 15 cm and 17 cm were able to reach the area of investigation. The book *Bergen (NH) 1940-1945* (see annex 4) mentions that those coastal guns rarely fired. The anti-aircraft artillery however was frequently used.

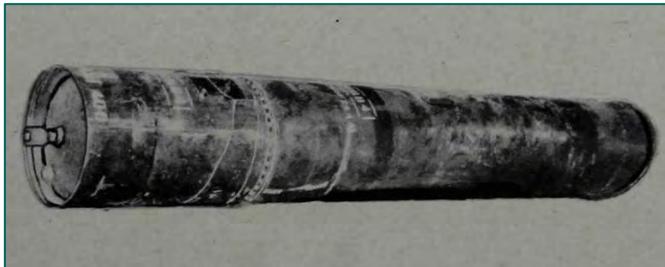
A Mark I-IV

Type: magnetic, induction of acoustic ground mine.

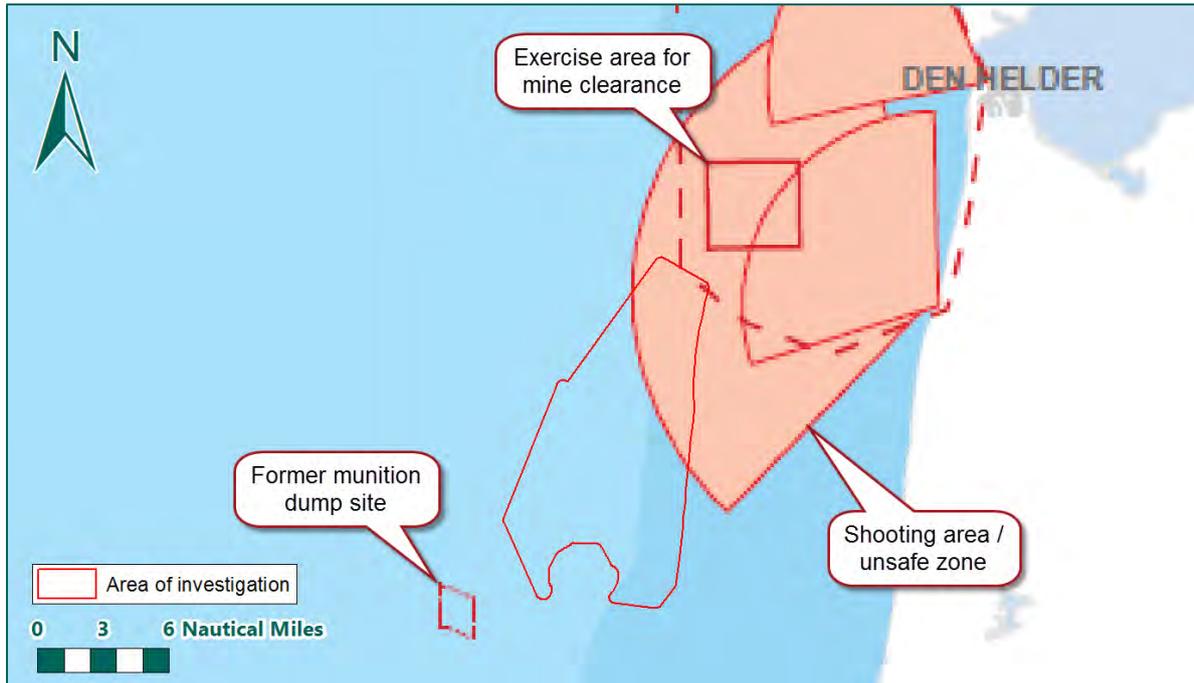
Figure 32: Extract of the map Military Use.

The North Sea Desk ('Noordzeeloket') is a cooperation between different departments of the Dutch Government that deal with the North Sea. This desk can be consulted at: <https://www.noordzeeloket.nl>. The website contains the map 'Military Use'. Figure 32 shows this map.

- A former munition dump site. This site is also shown on the NEMEDRI 227 mine map from the Marinemuseum (Navy Museum).
- An exercise area for mine clearance. This area has overlap with the area for naval exercises as shown on the the NEMEDRI 227 mine map from the Marinemuseum (Navy Museum).
- Different shooting areas. The large zone has overlap with the area of investigation.

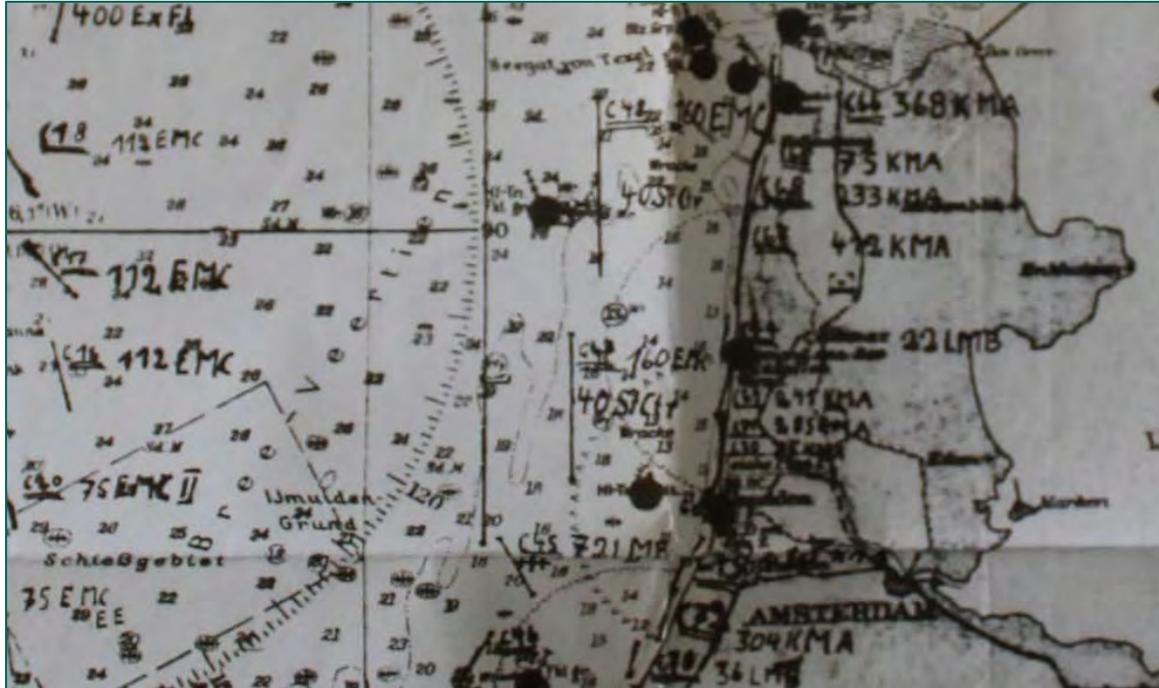
Relevant. Map indicating the locations of German naval minefields. The mine fields C.35, C.47 and C.48 have overlap with HKNWFZ. Mine field C.45 lies south of HKNWFZ.

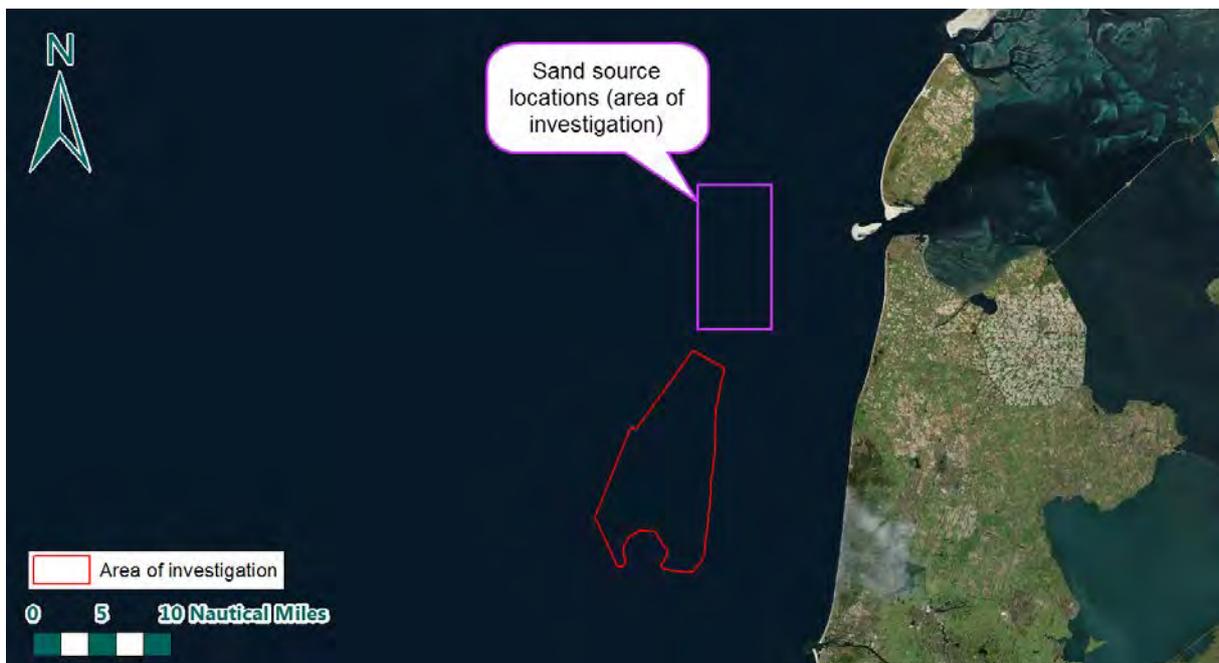
Figure 37: Areas of investigation WFZHKZ and Sand source locations.

In 2016 Saricon Safety & Risk Consultancy conducted a historical UXO research for potential sand source locations in the North Sea, in front of the Dutch coast. The locations lie approximately 10 kilometres (= 4,5 NM) out of the coast, in front of Den Helder, Callantssoog and the isle of Texel, just north of the HKNWFZ, see Figure 37.

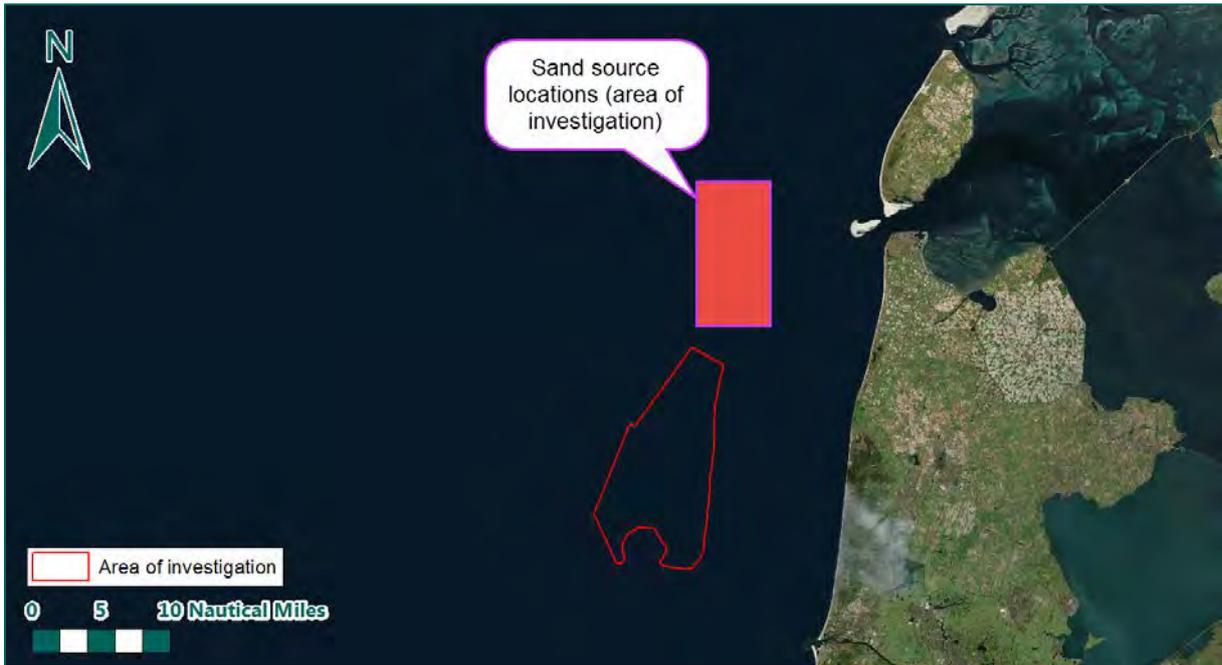
The report's conclusion is that these UXO can be encountered within the whole area of investigation of the sand source locations. The UXO suspected area is indicated with red in Figure 38.

Figure 38: Areas of investigation HKNWFZ and Sand source locations. The red area within the latter area of investigation indicates the UXO suspected area.
