UXO Desk Study -Unexploded Ordnance-

Ten noorden van de Waddeneilanden Wind Farm Zone

73458 / RO-190129

Client	:	Rijksdienst voor Ondernemend Nederland
Reference	:	73458 / RO-190129 version 1.0 Final version
Place, date	:	Riel, July 12 th , 2019
Author	:	Mr. L.J.J. Arlar, MA, Historian / UXO Advisor
Checked by	:	Mr. J. Owens, UXO Expert
Approved by	:	Mr. M. Taks, Head of Advice Department

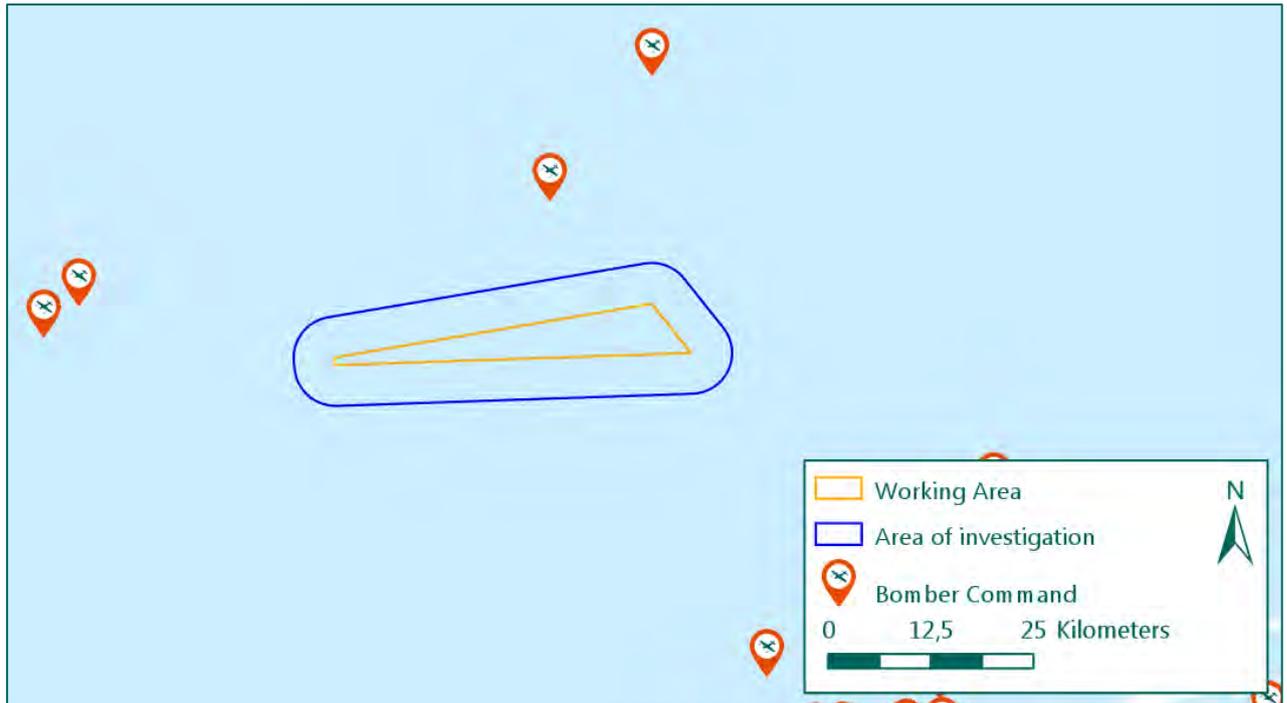
Figure 21: Bomber Command operations against convoys and jettisons.
