# Geophysical Survey - Operations and Processing Report - 3D UHRS Block in Site VI

IJmuiden Ver Wind Farm Zone – Site Gamma (Sites V-VI)

# Operations and Processing Report – Fugro Pioneer 3D Seismic

Phase 4 3D UHRS Survey at the IJmuiden Ver Wind Farm Sites V and VI (IJ56) |  
Dutch Sector, The Netherlands

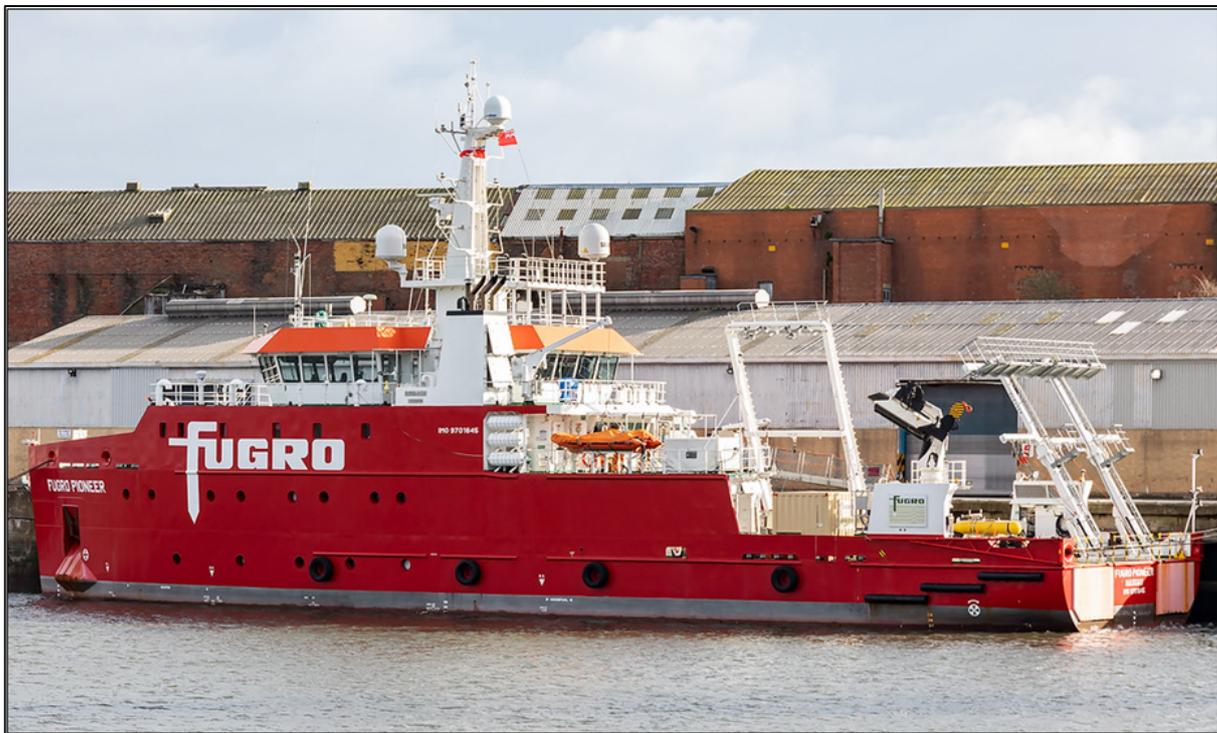
Figure 2.2: Fugro Pioneer

The Fugro Pioneer (Figure 2.2) is a 53 m vessel built at Damen Shipyards in 2014. Being purpose designed for the demanding environments in which Fugro’s coastal fleet operate, the Fugro Pioneer has excellent weather capabilities and is an ideal platform for geophysical surveys.

The Fugro Pioneer has space for a maximum of 31 persons and is equipped for 24-hour operations. The Fugro Pioneer has a top speed of 10 knots allowing for fast and comfortable transits. Weather limitations for the Fugro Pioneer are detailed in Table 2.5. Further details of the vessel can be found in Appendix D.

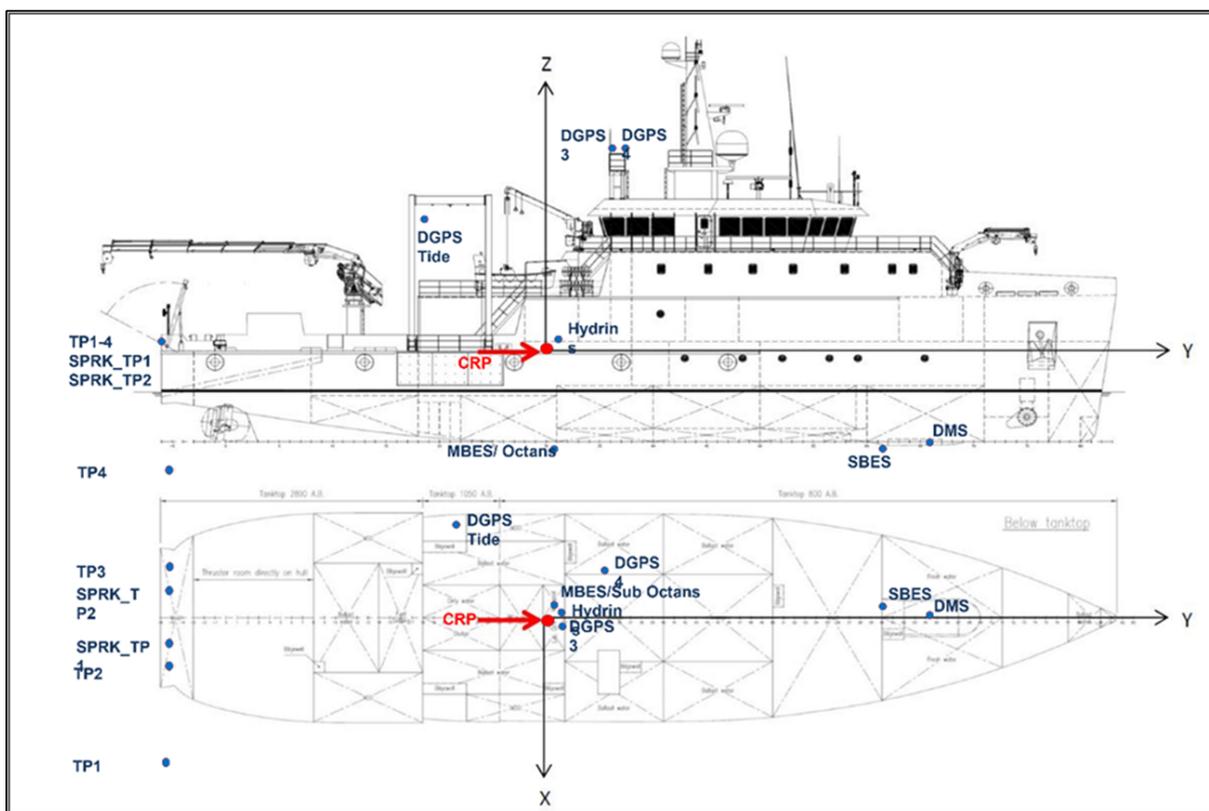
Figure 3.1: Fugro Pioneer Offsets.

All instrument offsets have been presented below in Figure 3.1 and a corresponding vessel offsets table has been provided in Table 3.1.

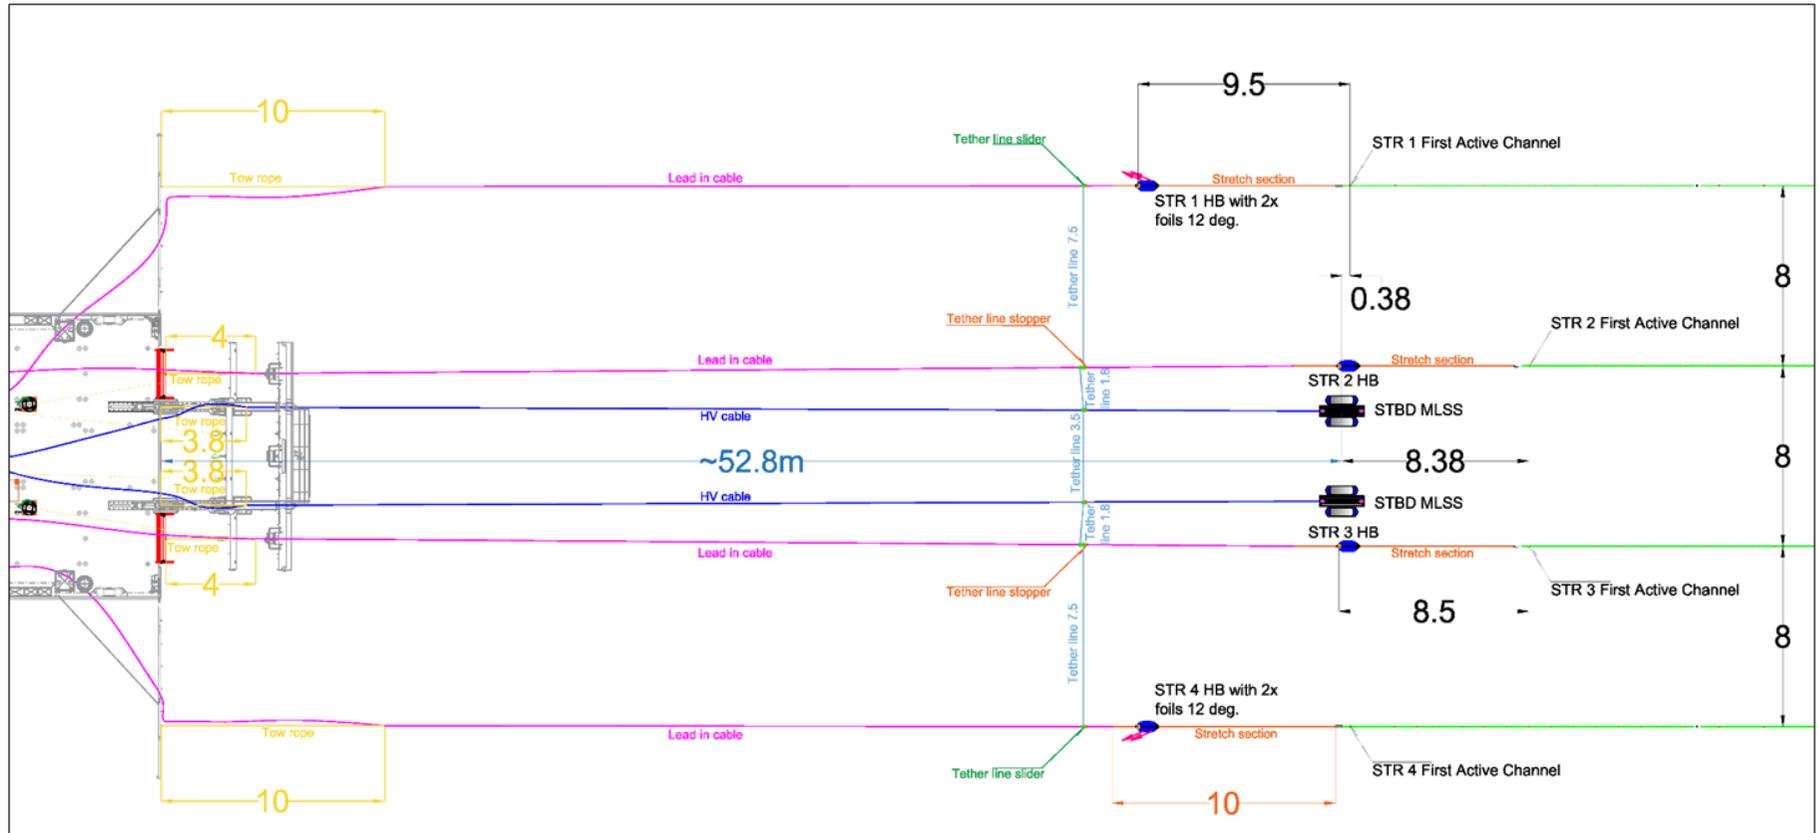
Figure 3.2: 3D UHRS Streamer offsets

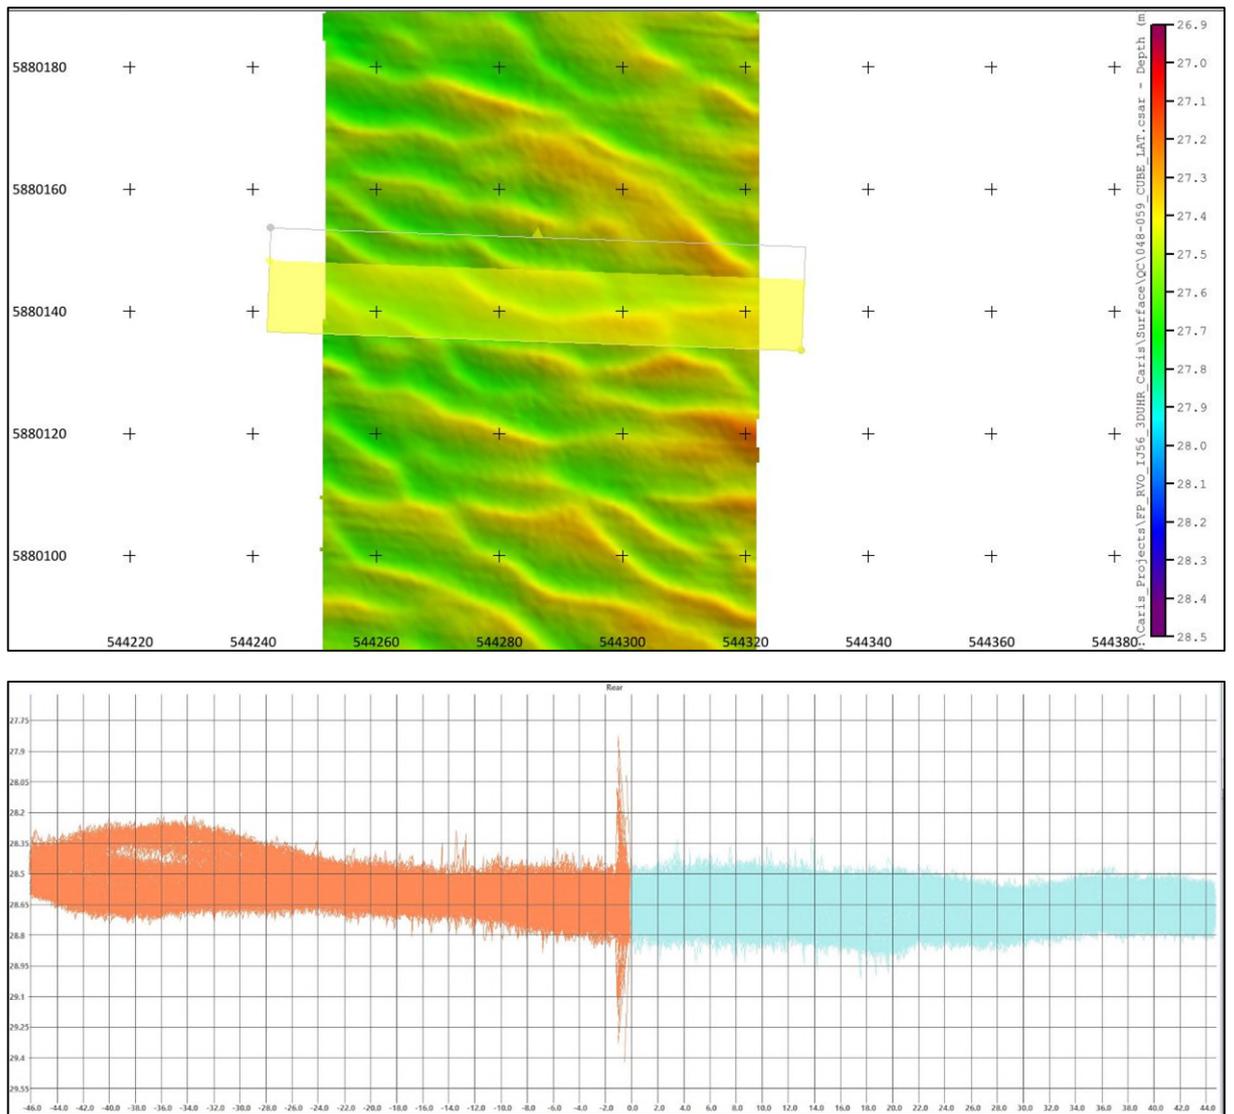
Multibeam echosounder data quality was within specification for the entire survey. Figures presenting good MBES data examples are shown below in Figure 4.1 (pre-swath editing) and in Figure 4.2 (post-swath editing) with corresponding cross profiles.

Figure 4.1: Data example presenting MBES data pre-swath editing.

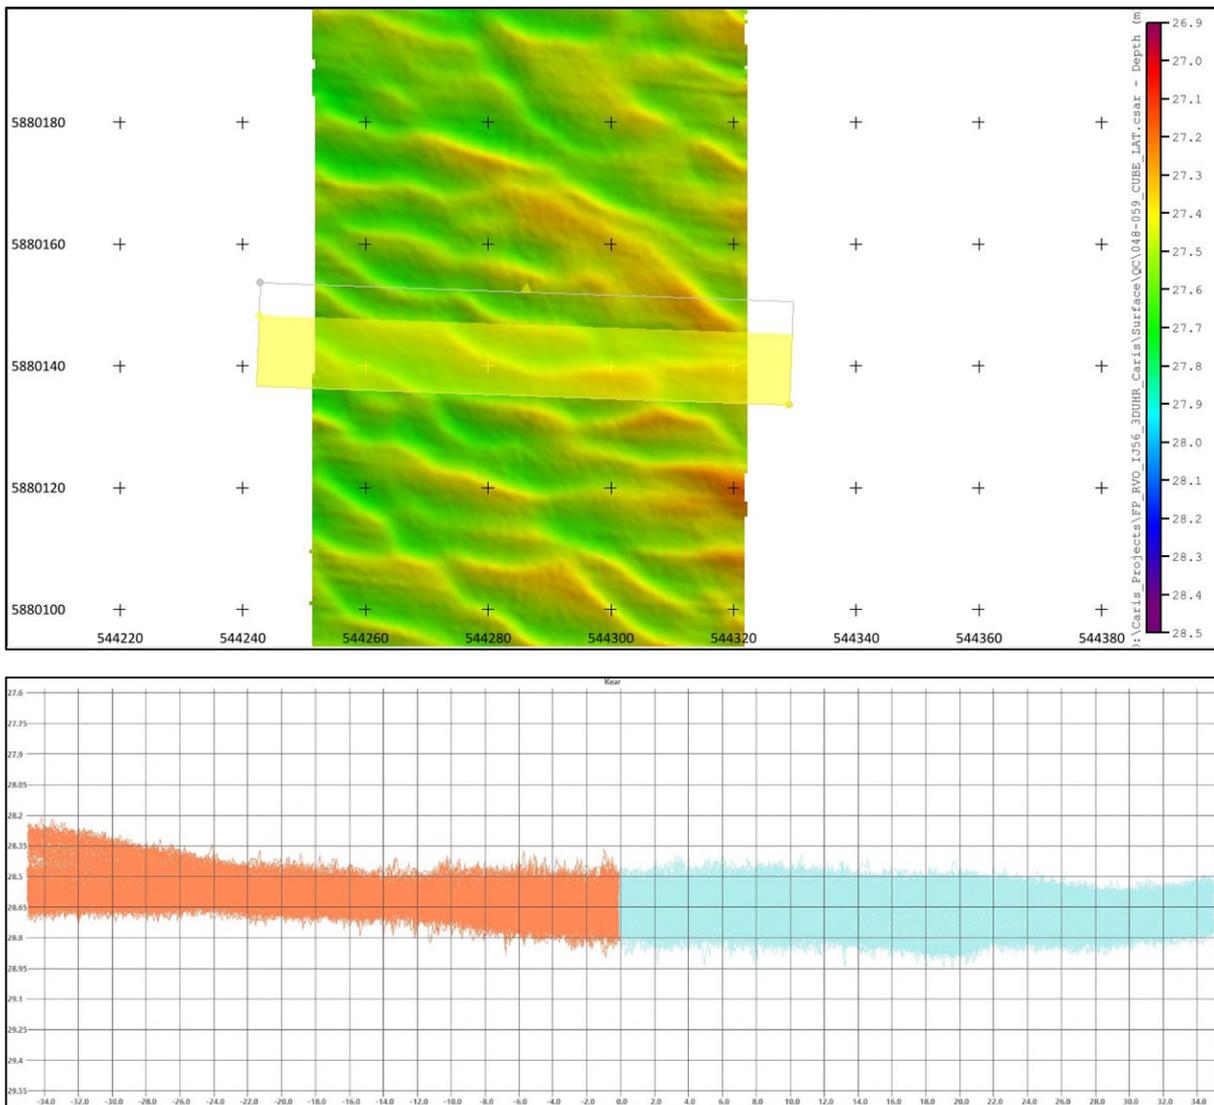
Figure 4.2: Data example presenting MBES data post-swath editing.

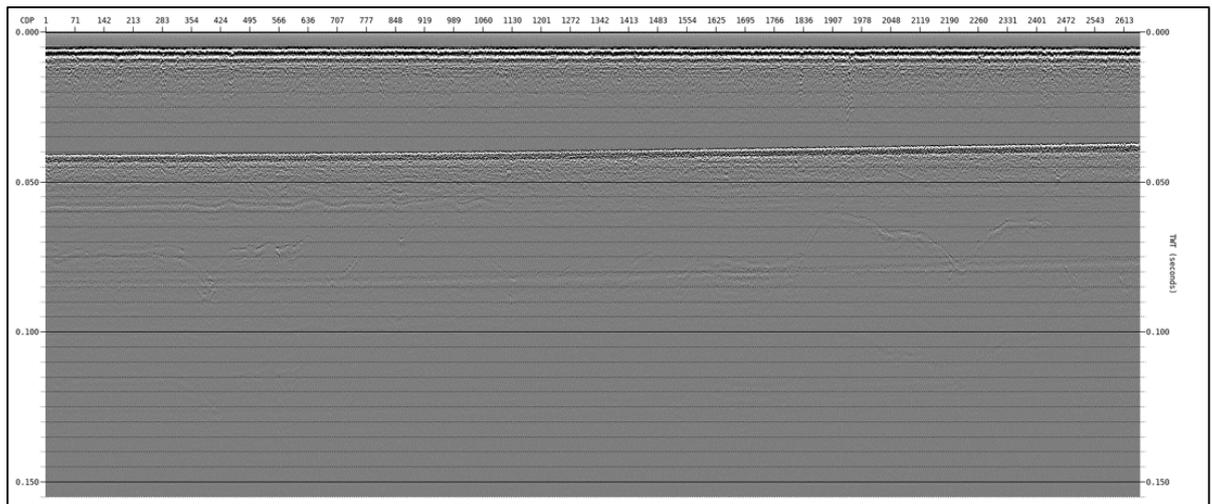
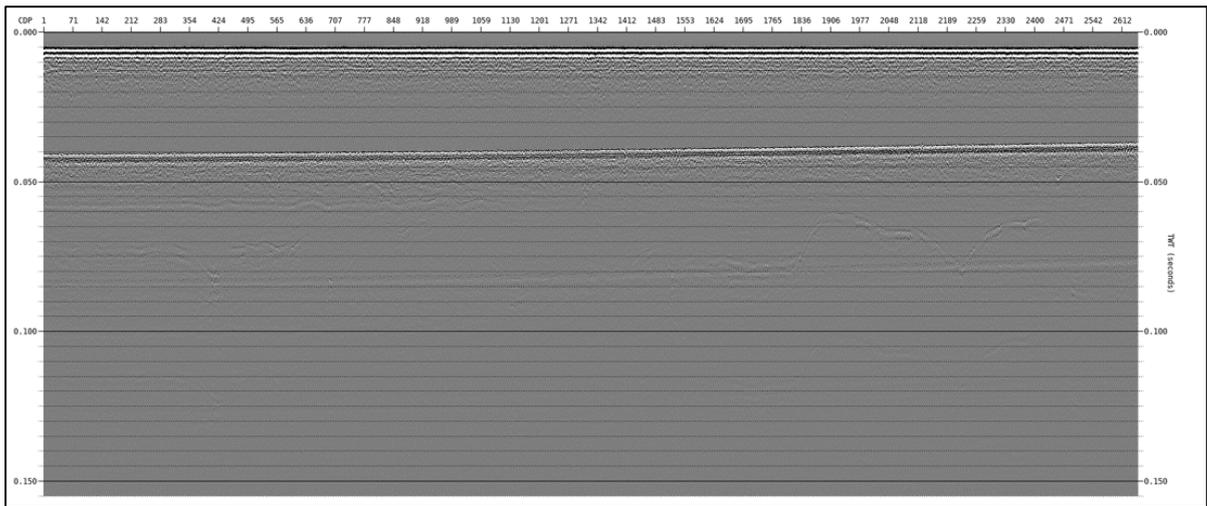
Near trace gathers were generated to analyse the source-receiver offset throughout the line, to assess the presence of bad shots due to recording system problems. Near trace gathers were also used to assess the presence of washouts due to marginal sea conditions and streamer movement.

Data examples of near trace gathers, one from each source, are presented below in Figure 4.4 and Figure 4.5.

Figure 4.4: Near trace gather data example of IJ3IA117P1 Source 1 Streamer 2.

Figure 4.5: Near trace gather data example of IJ3IA117P1 Source 2 Cable 3.

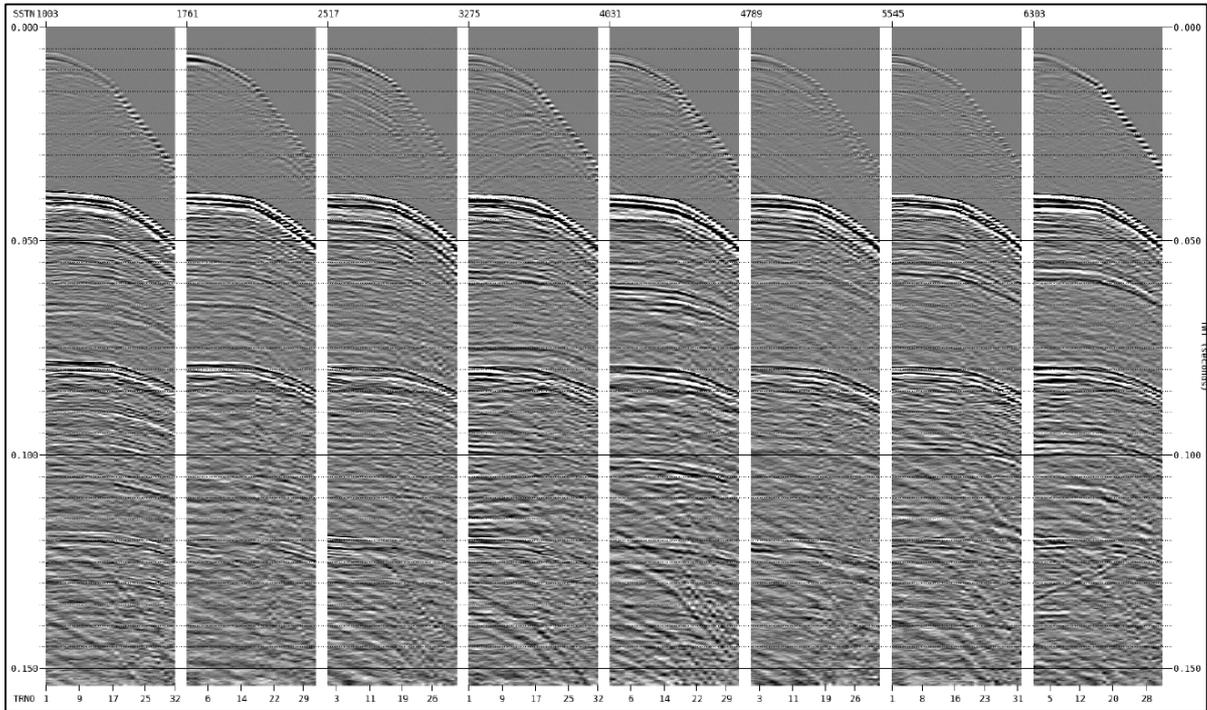
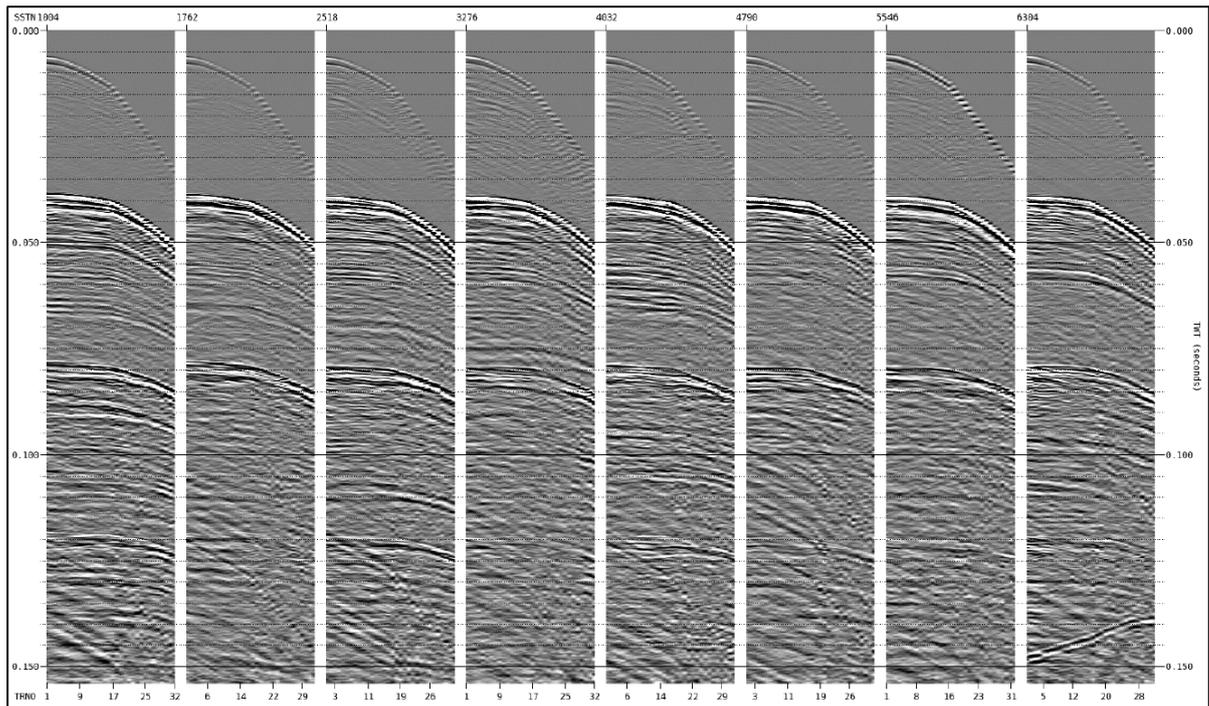
Data examples of shot records, one from each source, are presented below in Figure 4.6 and Figure 4.7

Figure 4.6: Shot record data example from IJ3IA182P1 Source 1 Streamer 1.

Figure 4.7: Shot record data example from IJ3IA182P1 Source 2 Streamer 4.

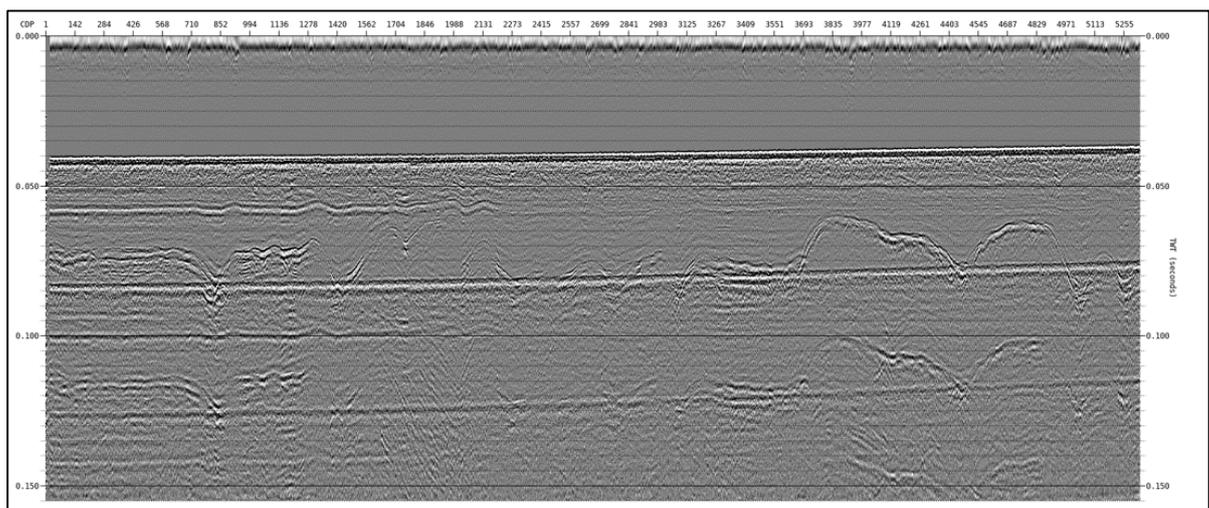
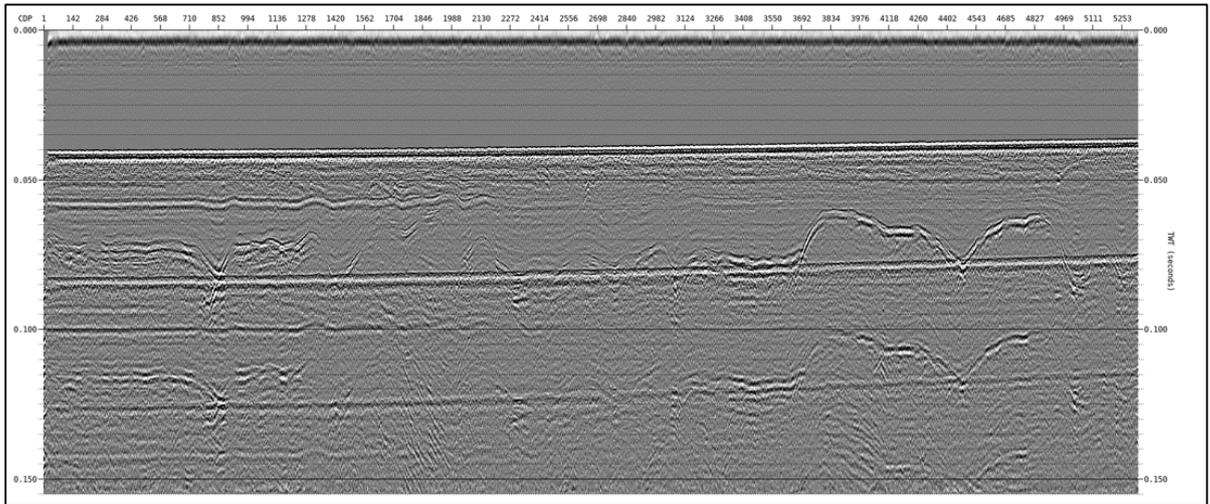
Data examples of brute stack, one for each source, are presented below in Figure 4.8 and Figure 4.9.

Figure 4.8: Brute stack data example from IJ3IA117P1 Source 1 Streamer 2.

Figure 4.9: Brute stack data example from IJ3IA117P1 Source 2 Streamer 3.

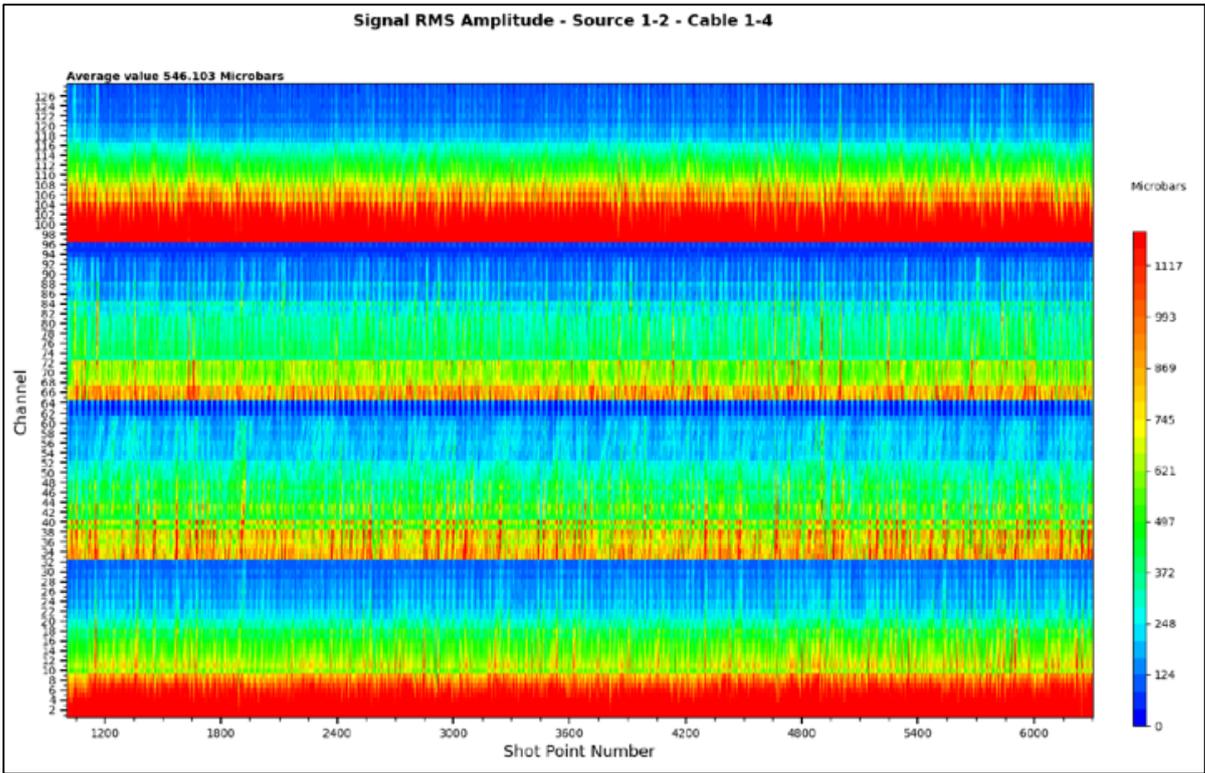
Figure 4.10 presents an example of the RMS signal amplitude plot, and Figure 4.11 presents an example of the RMS noise amplitude plot.

Figure 4.10: RMS Signal Plot from IJ3IA117P1 Source 1-2 Streamer 1-4 (32 Channels).

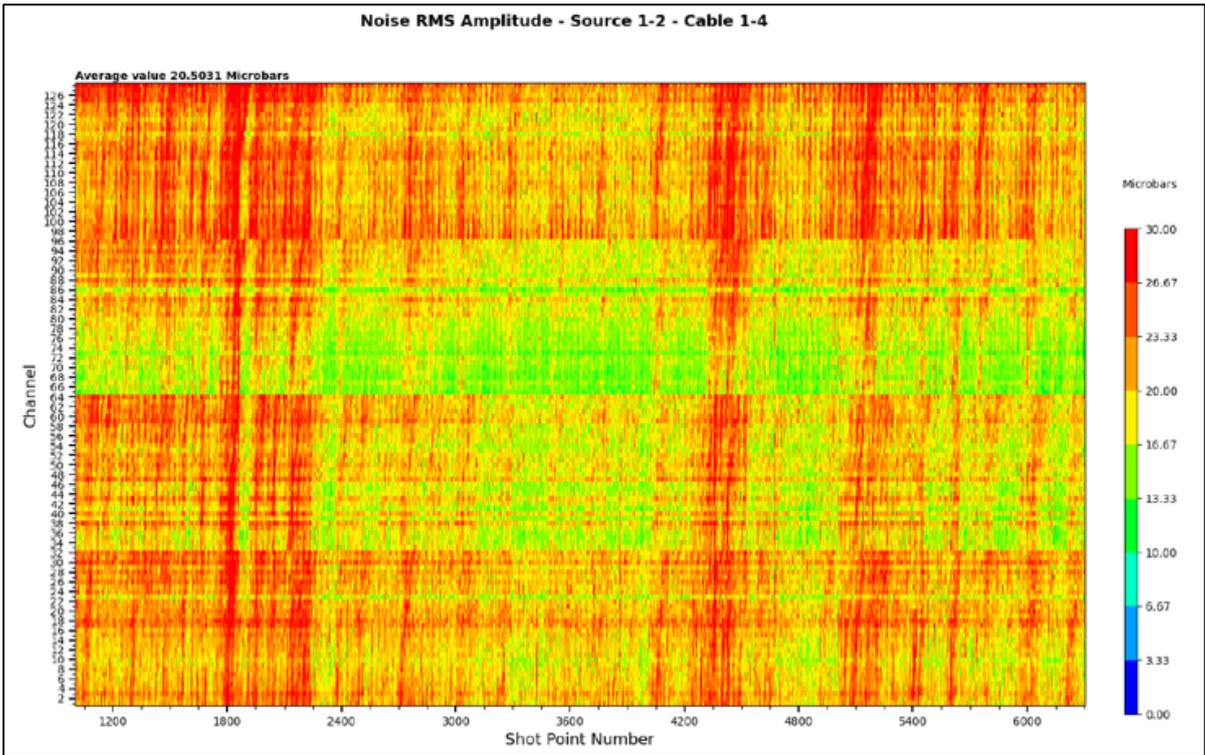
Figure 4.11: RMS Noise Plot from IJ3IA117P1 Source 1-2 Streamer 1-4 (32 Channels).

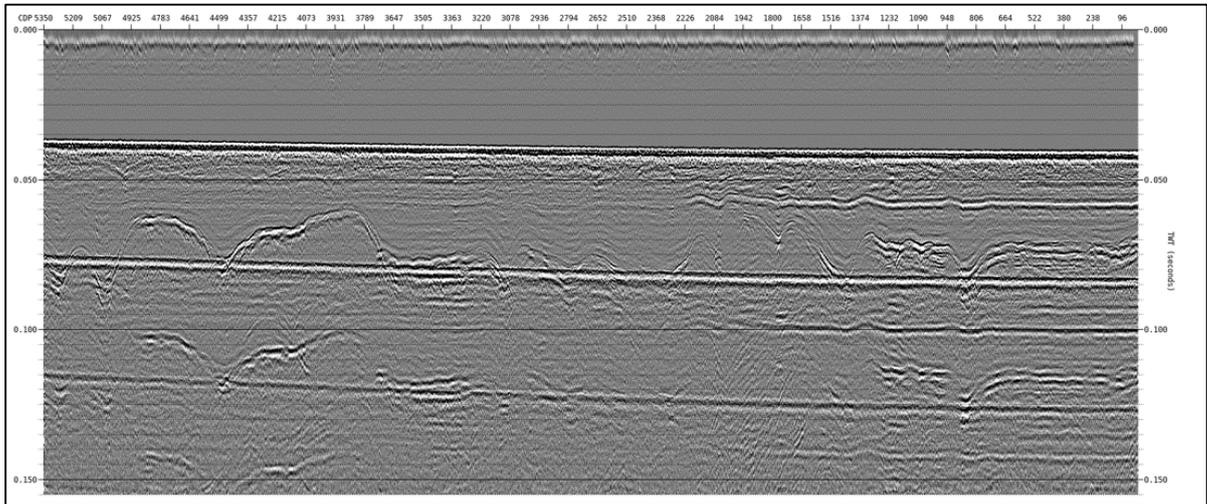
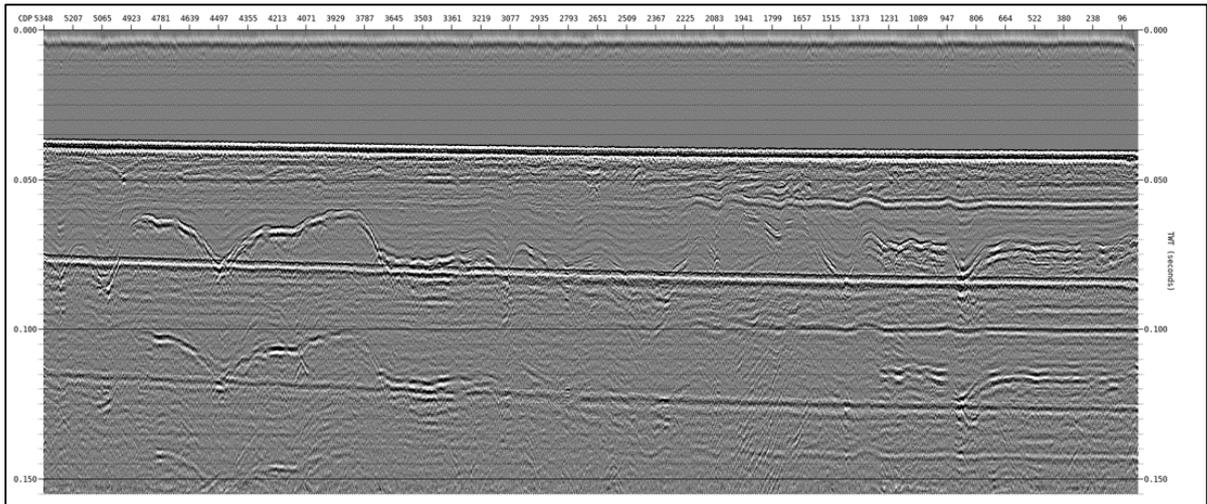
CMP positions and navigation stacks were assessed for each source-streamer combination. Data examples of navigation merged stacks, one from each source, are presented below in Figure 4.12 and Figure 4.13.

Figure 4.12: Navigation updated stack data example of IJ3IA117P1 Source 1 Streamer 2.

Figure 4.13: Navigation updated stack data example of IJ3IA117P1 Source 2 Streamer 3.

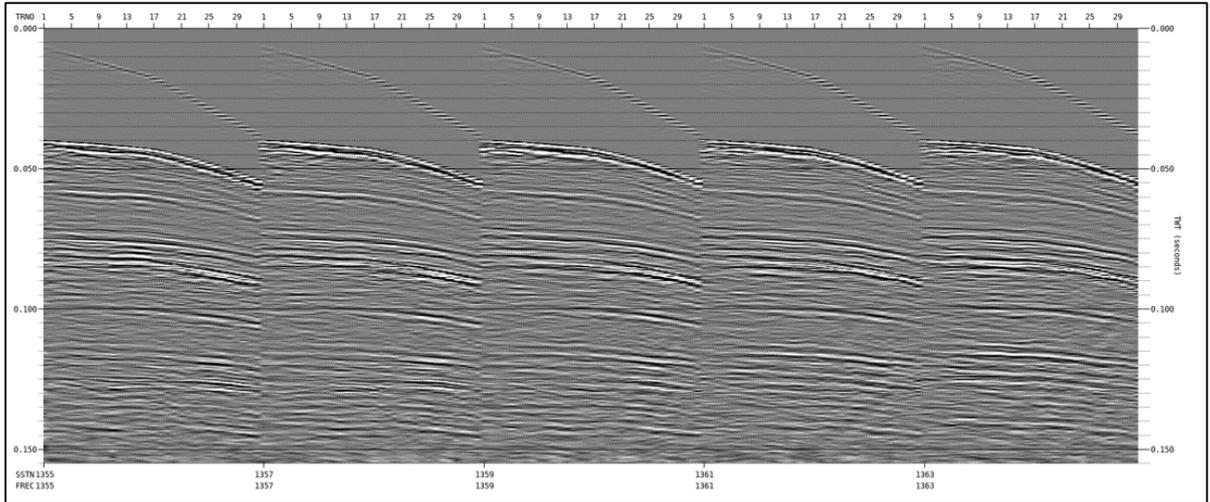
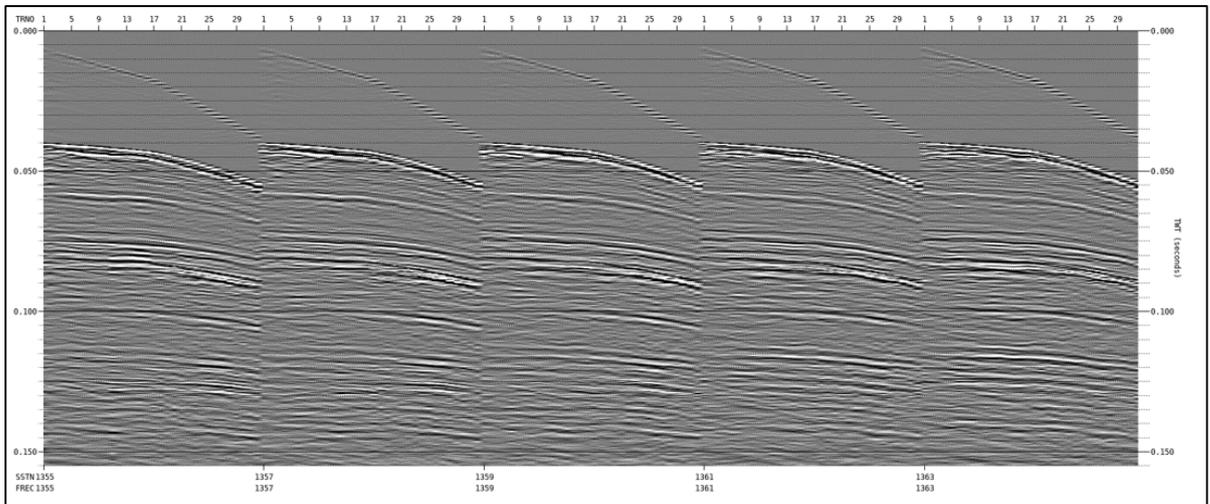
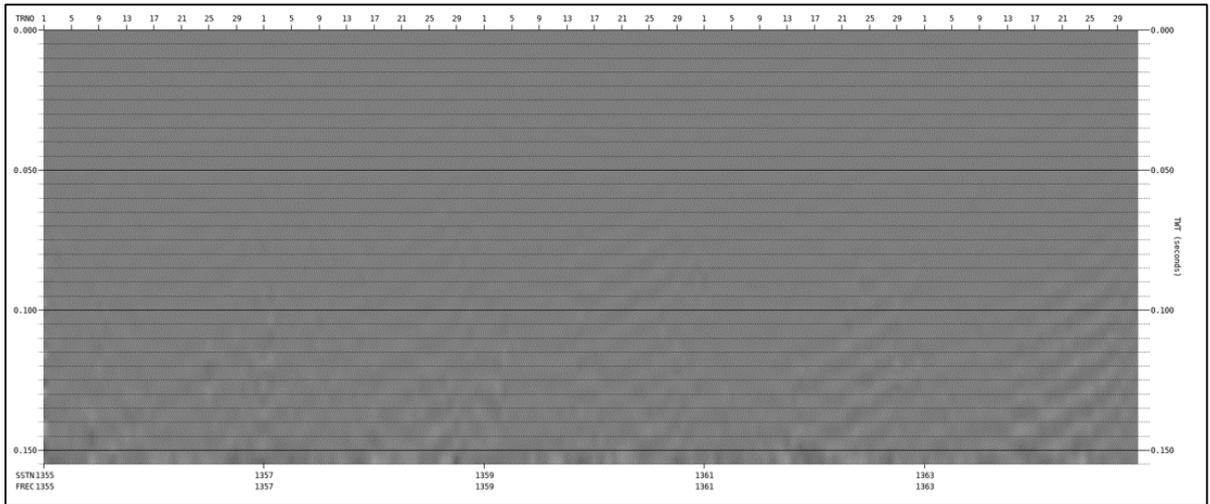
Figure 4.14: Pre-denoise shot record data examples from IJ3IA112P1 Source 1 Streamer 2.

Figure 4.15: Post-denoise shot record data examples from IJ3IA112P1 Source 1 Streamer 2.

Figure 4.16: Residual plot of denoise routine from IJ3IA112P1 Source 1 Streamer 2.

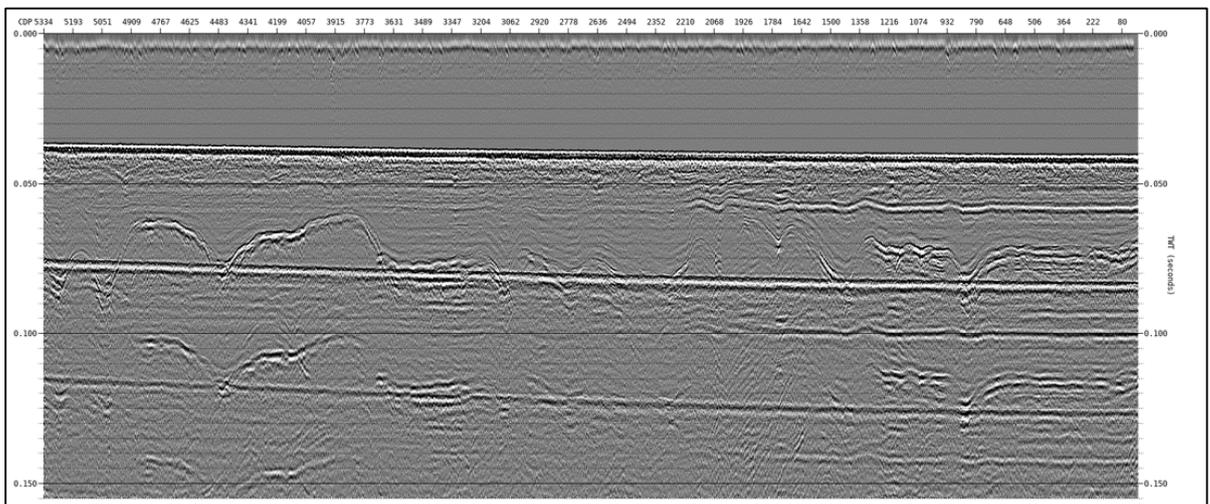
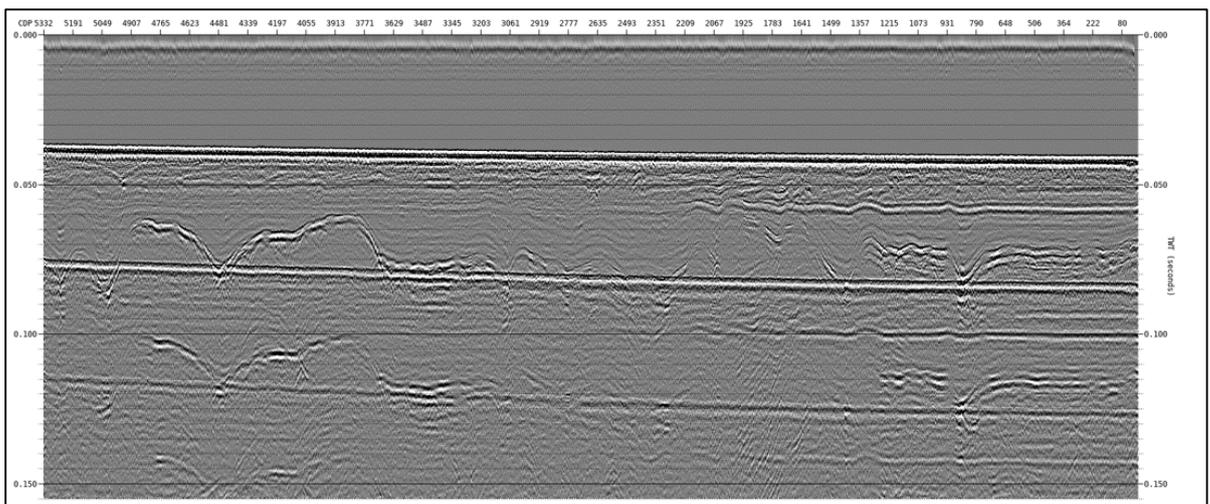
Data examples presenting the results of the denoise routine, one for each source, are presented in Figure 4.17 and Figure 4.18.

Figure 4.17: Denoise stack data example of IJ3IA117P1 Source 1 Streamer 2.

Figure 4.18: Denoise stack data example of IJ3IA117P1 Source 2 Streamer 3.

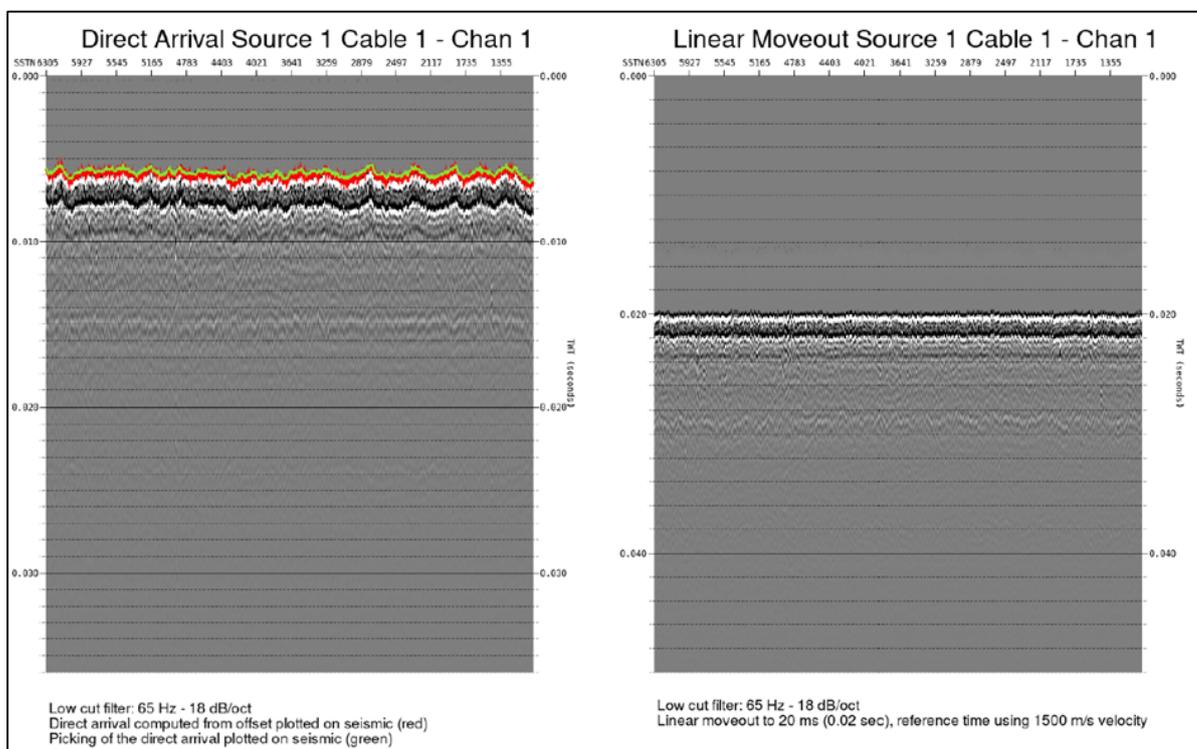
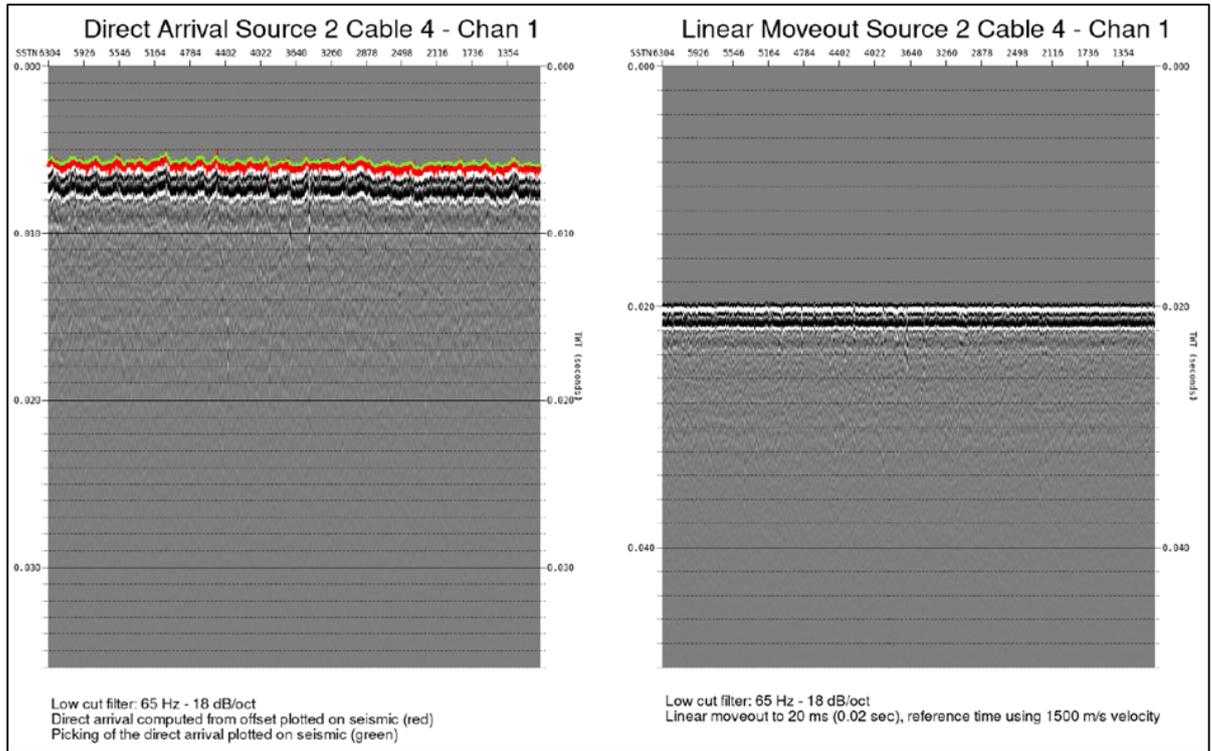
Data examples of direct arrivals, one for each source, are presented below in Figure 4.19 and Figure 4.20.

Figure 4.19: Plot of picked direct arrival (green) and P190 computed direct arrival (red) from Source 1 Streamer 1.

Figure 4.20: Plot of picked direct arrival (green) and P190 computed direct arrival (red) from Source 2 Streamer 4.

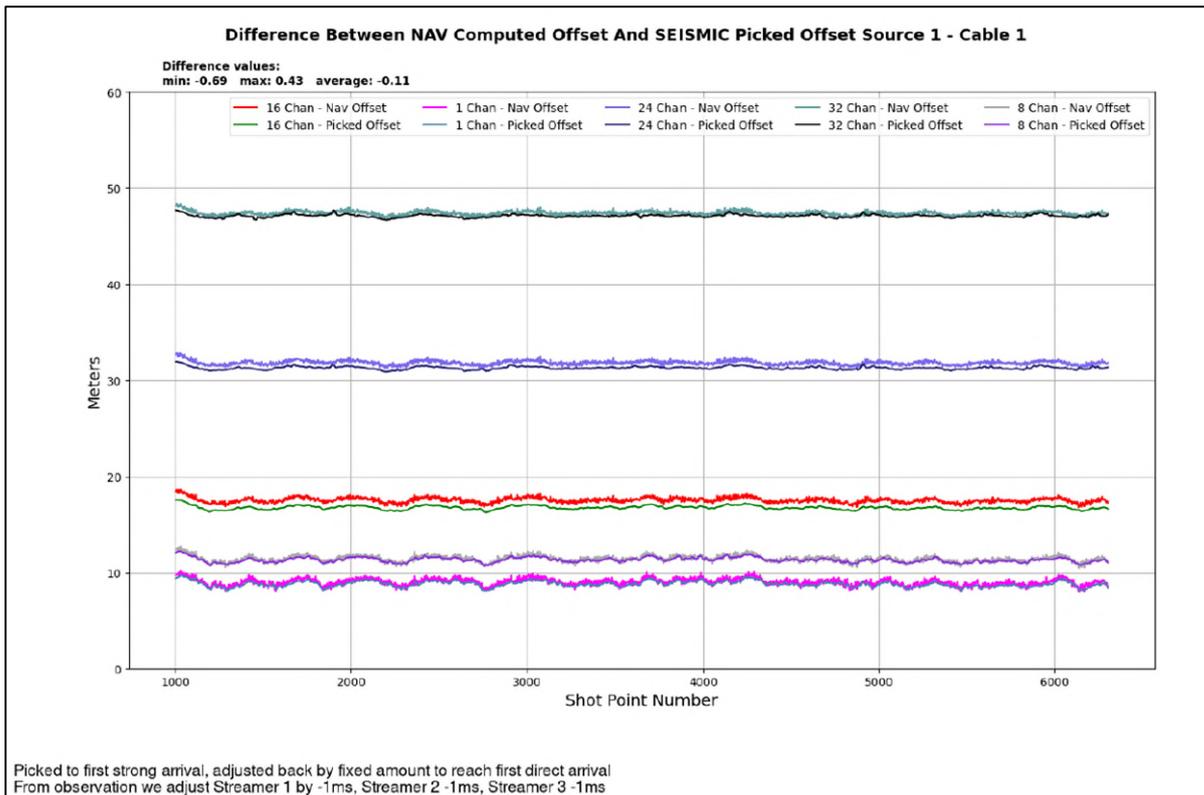
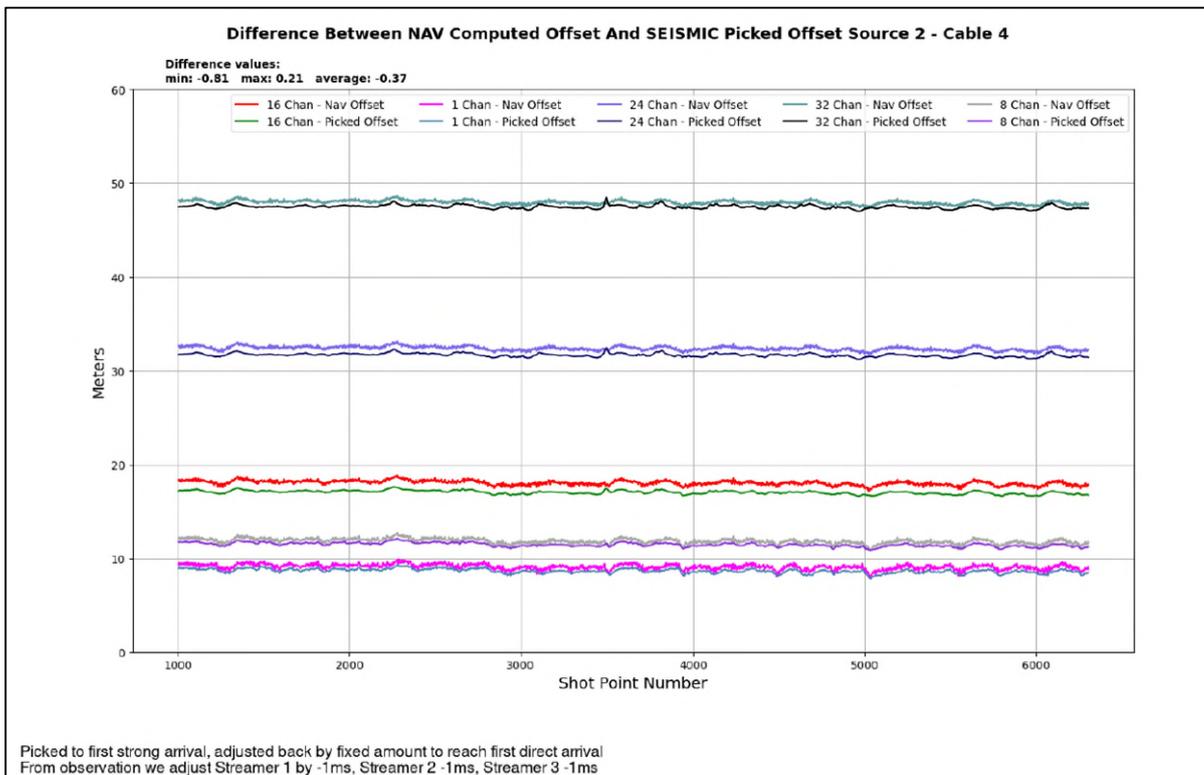
Data examples of the direct offset comparison, one for each source, are presented below in in Figure 4.21 and Figure 4.22.

Figure 4.21: Computed vs. picked direct arrival for channels 1, 8, 16, 24 and 32 for Source 1 Streamer 1.

Figure 4.22: Computed vs. picked direct arrival for channels 1, 8, 16, 24 and 32 for Source 2 Streamer 4.

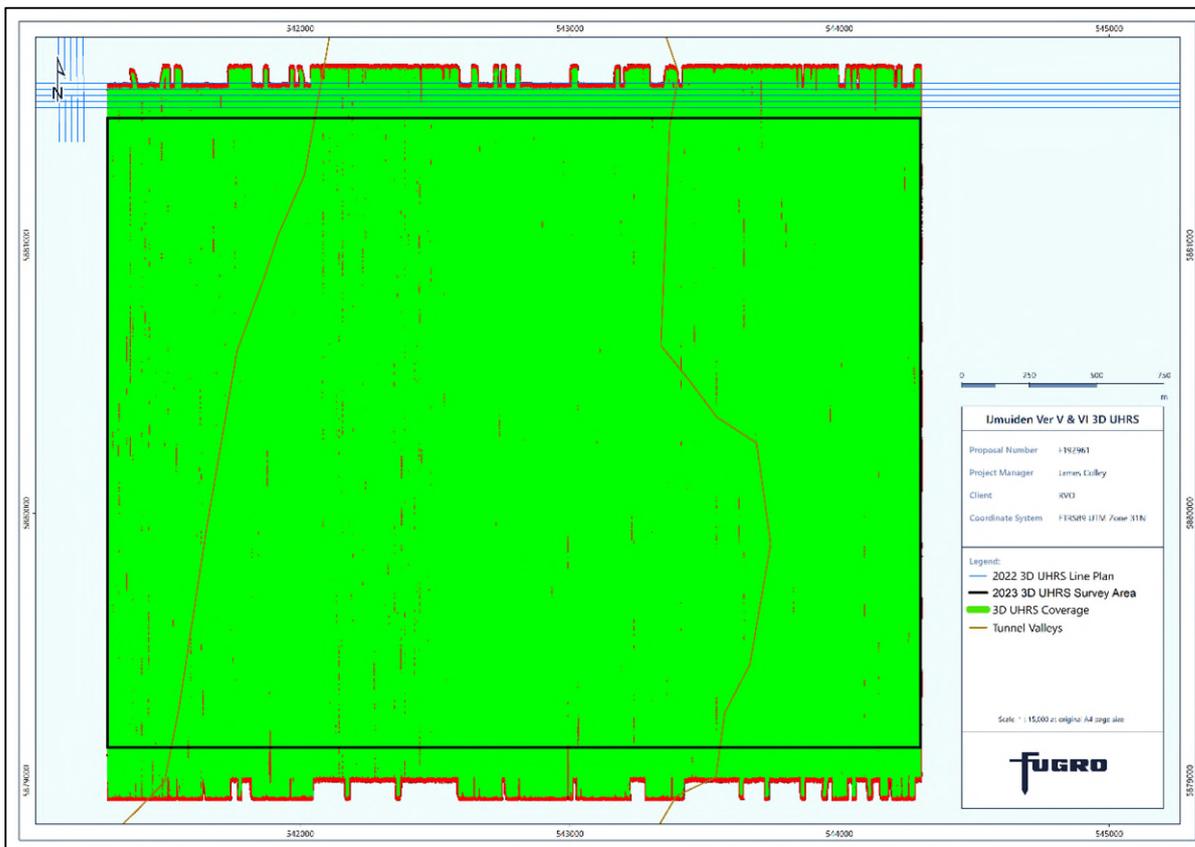
Figure 4.23 below presents an example of the final seismic coverage visualisation created by CoverPoint.

Figure 4.23: Overview of final 3D UHRS coverage from CoverPoint software.

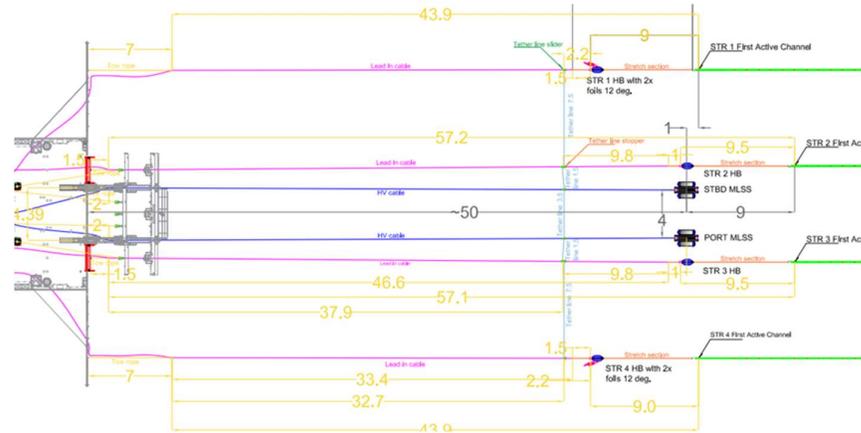
A 2 source 4 streamer 3D UUHR system was deployed (see Table 1.1 & Figure 1.4), comprising 4 hybrid-group streamers. Two Multi-Level Stacked Sparker (MLSS) sources were deployed centrally, approximately 10 m inline from each streamer (channel 1). RTK pods were mounted on 4 head buoys and 4 tail buoys. RTK positioning was also present on each source.
