# Geophysical Survey - Operations and Processing Report - 3D UHRS Block in Site VI

IJmuiden Ver Wind Farm Zone – Site Gamma (Sites V-VI)

# Operations and Processing Report – Fugro Pioneer 3D Seismic

Phase 4 3D UHRS Survey at the IJmuiden Ver Wind Farm Sites V and VI (IJ56) |  
Dutch Sector, The Netherlands

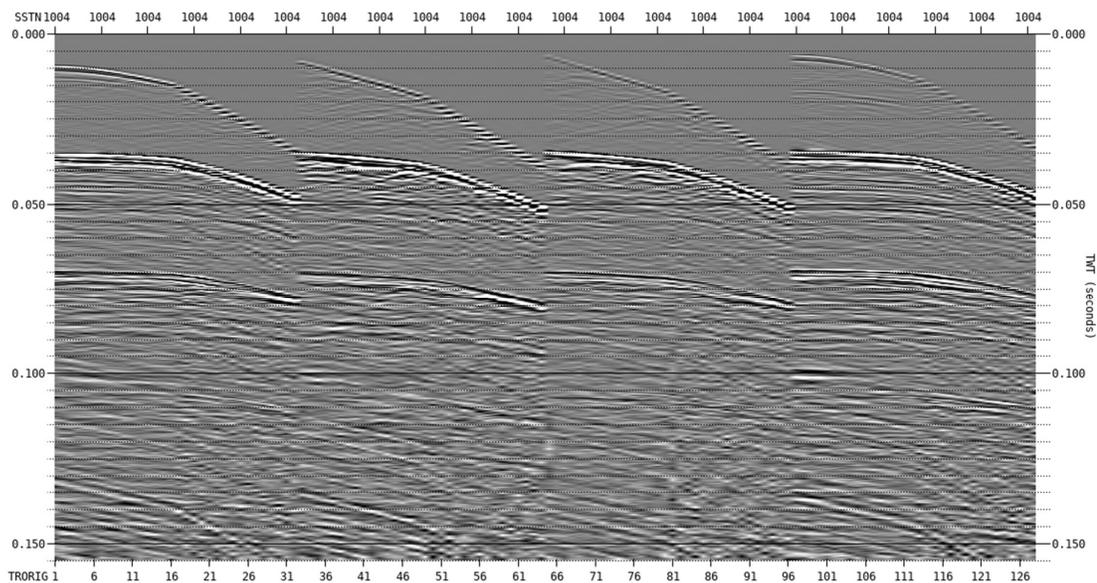
Figure 2.1: Raw shot gathers showing streamers 1 to 4, left to right

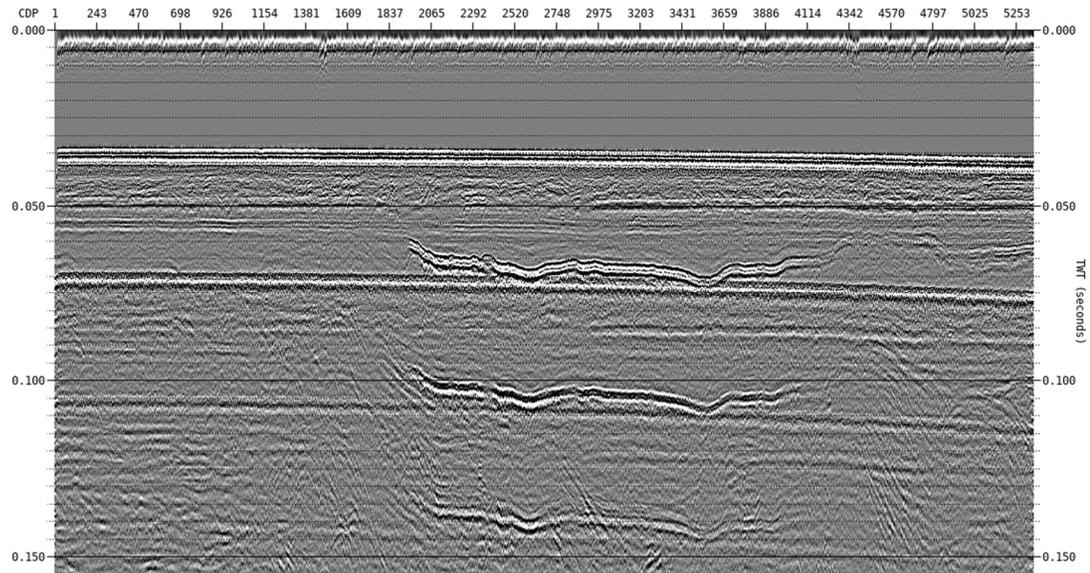
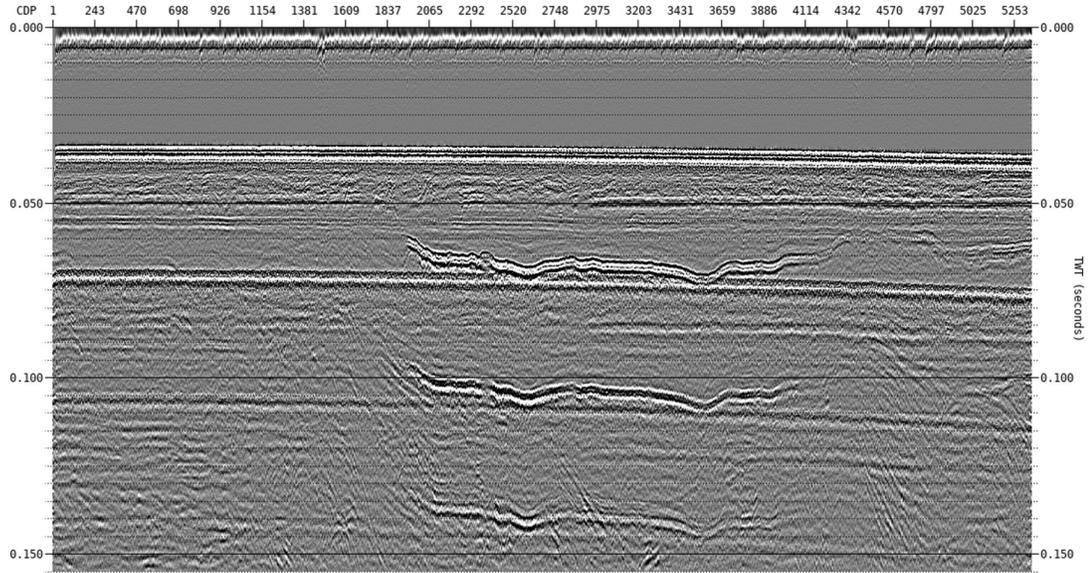
The same processes were applied again in the channel domain, except the spatial window for TFDN was increased to include 101 traces and frequency up to 250 Hz were targeted. Higher values than 250 Hz was tested, but these did not show any improvement in swell noise attenuation, as it is predominantly a lot lower frequency than this.

Figure 2.2: Source 2, streamer 1. Brute 2D stack

Figure 2.3: Source 2, streamer 1. Common channel denoise 2D stack

Figure 2.4: Difference stack showing attenuated noise

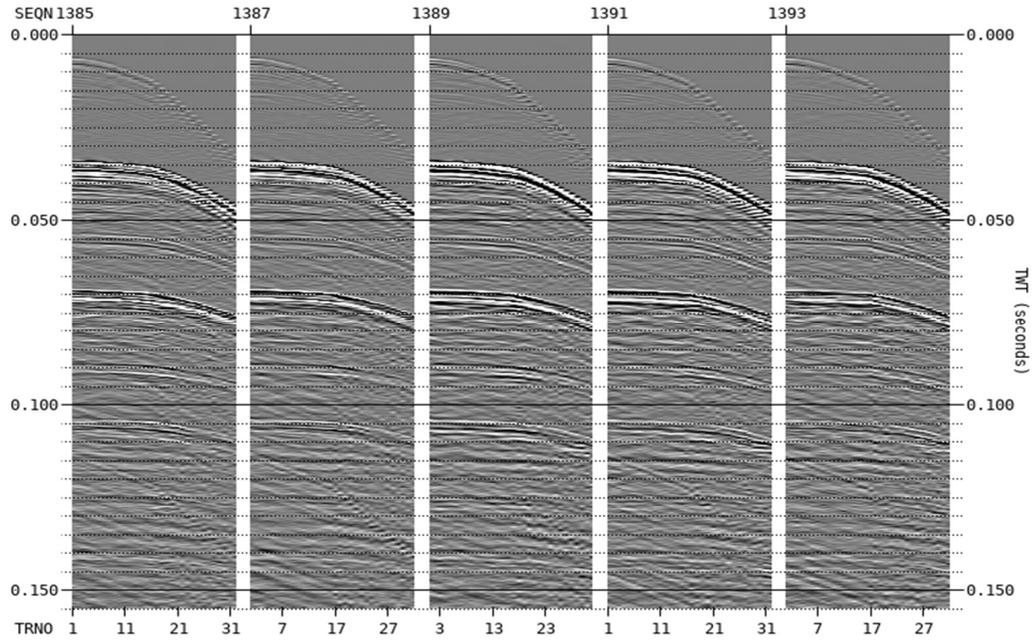
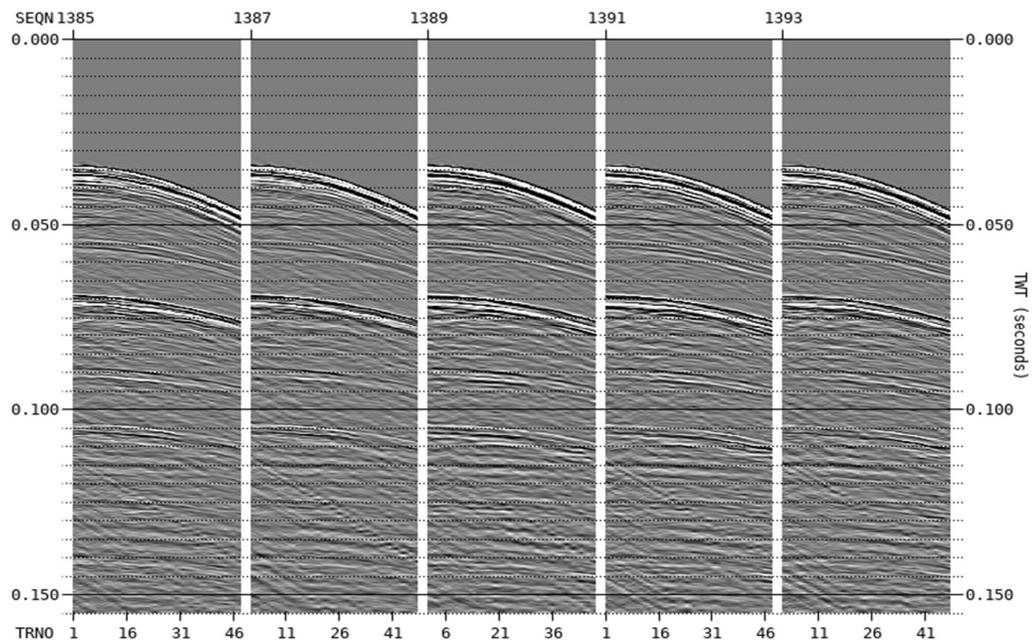
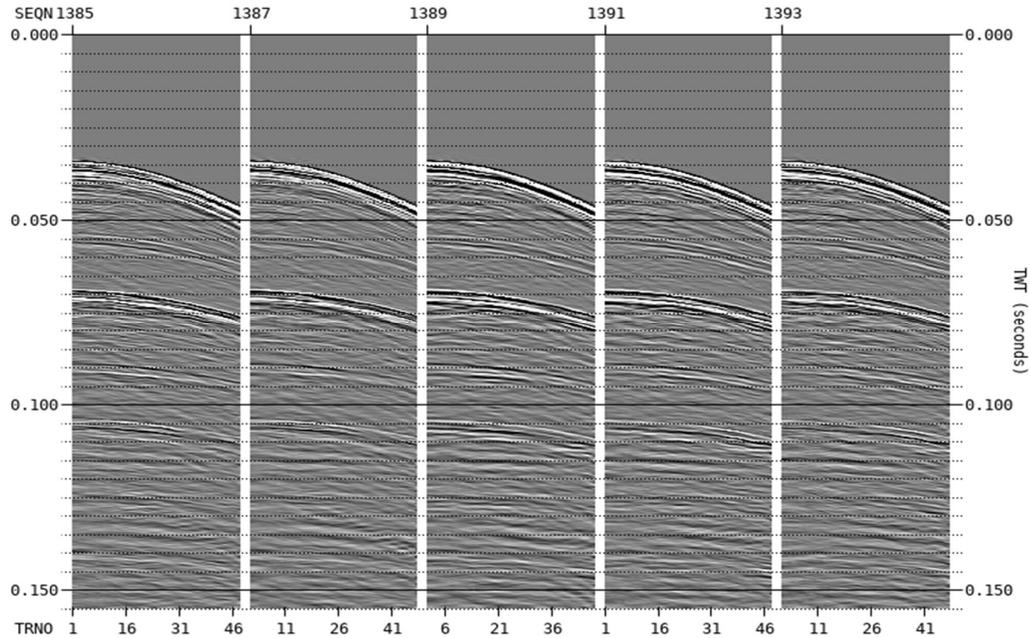
full Tau-P transform. Values of  $\pm 65$  ms transform range began to show hints of primary removal, and  $\pm 25$  ms was less effective at linear noise attenuation.

Figure 2.5: Source 1, streamer 1. Pre-interpolation shot gathers

Figure 2.6: Source 1, streamer 1. Post-interpolation

Figure 2.7: Source 1, streamer 1. Post linear noise attenuation

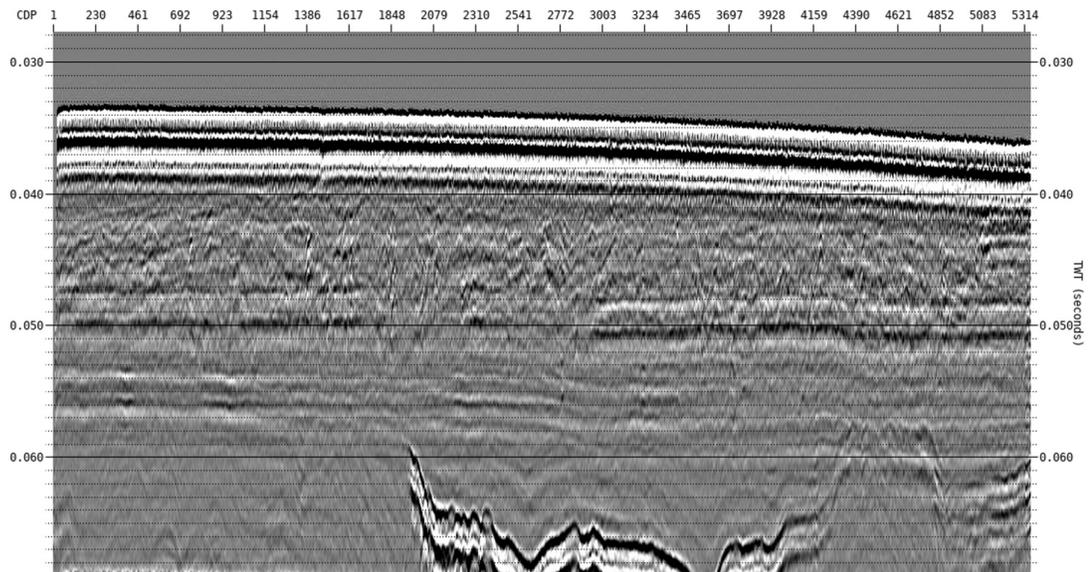
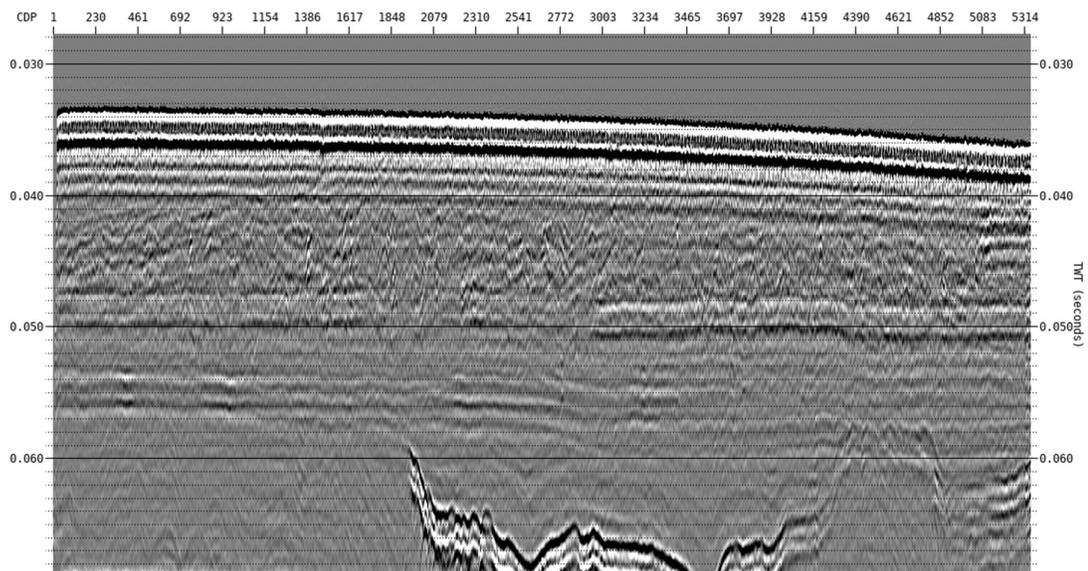
Figure 2.8: Source 1, streamer1. Pre-designature 2D stack (zoom 25 – 70 ms TWT)

Figure 2.9: Source 1, streamer1. Post source Deghost and Debubble

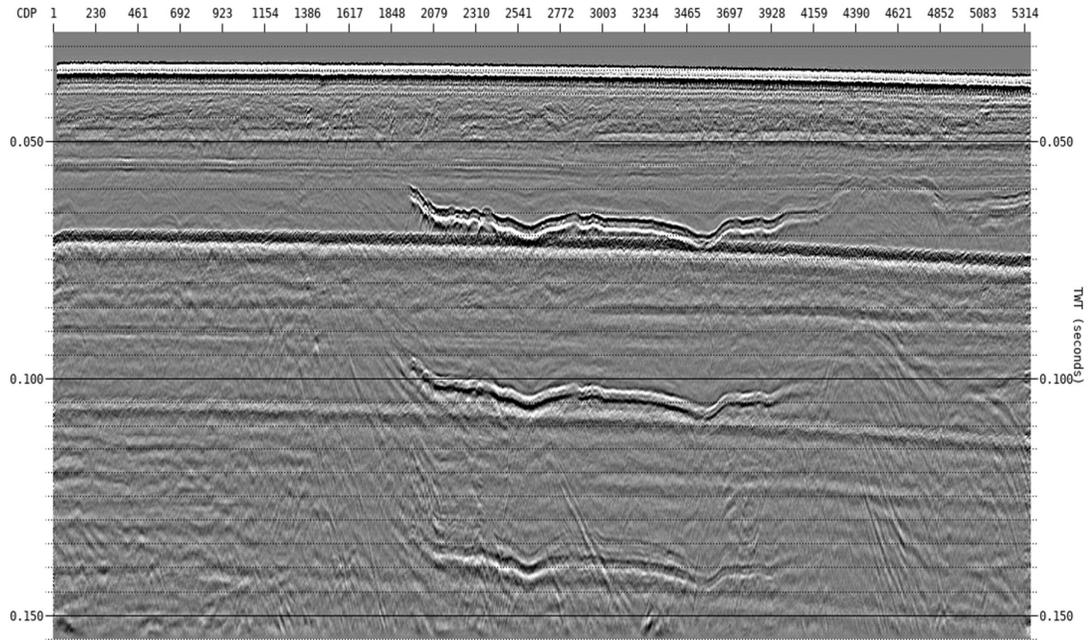
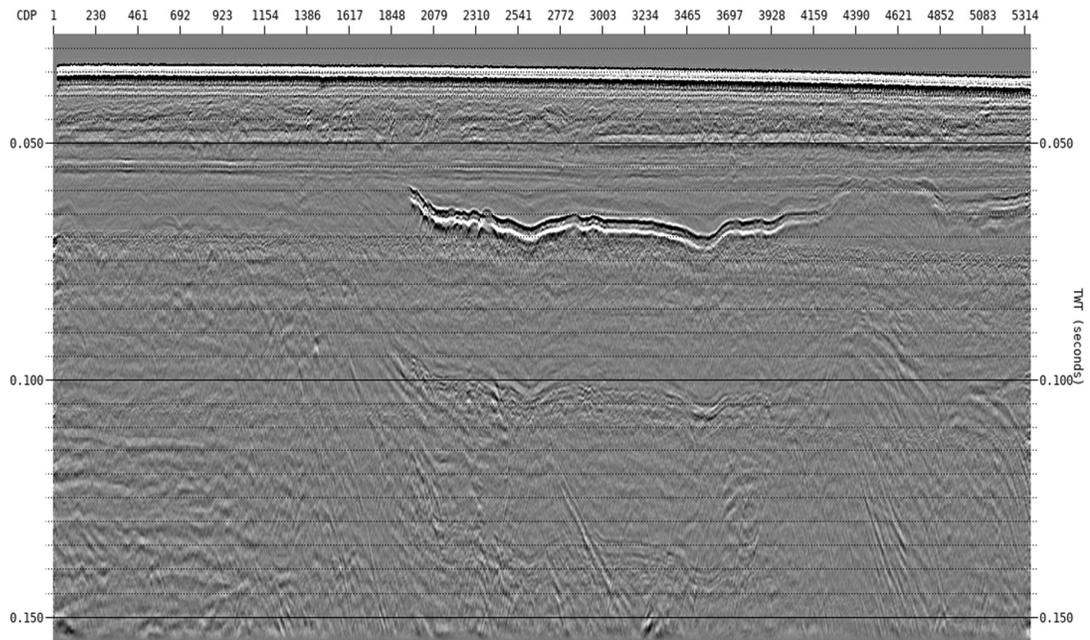
However, residual diffracted (high frequency) multiple remained and is tackled in the next step.

Figure 2.10: Source 1, streamer 1. Pre-2D SRME 2D stack

Figure 2.11: Source 1, streamer 1. 2D SRME stack. Note the residual diffracted multiple on the first bounce

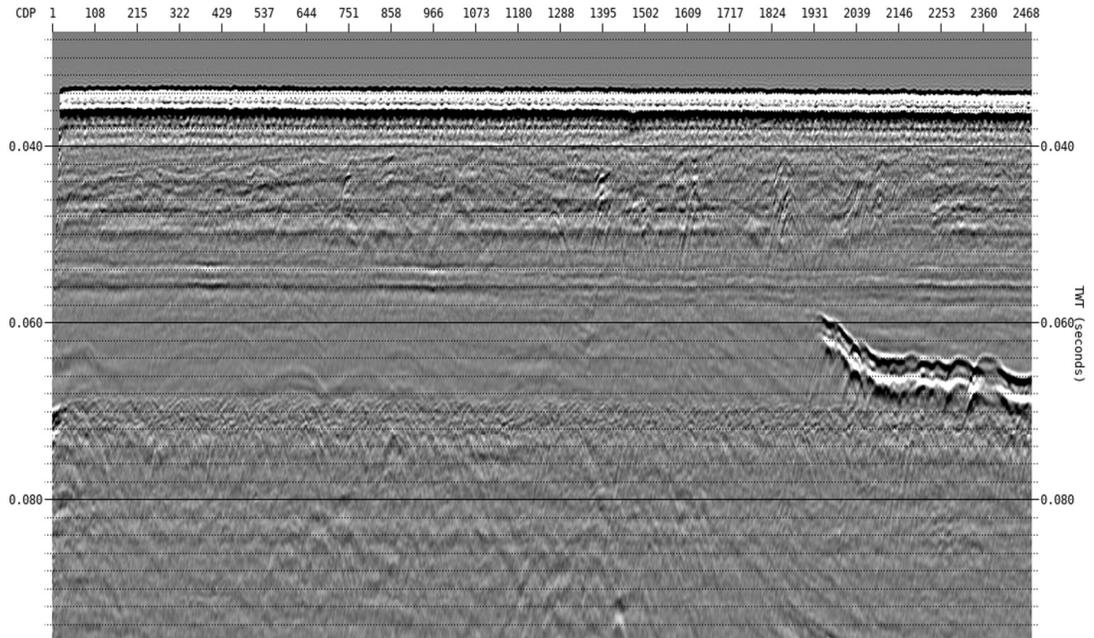
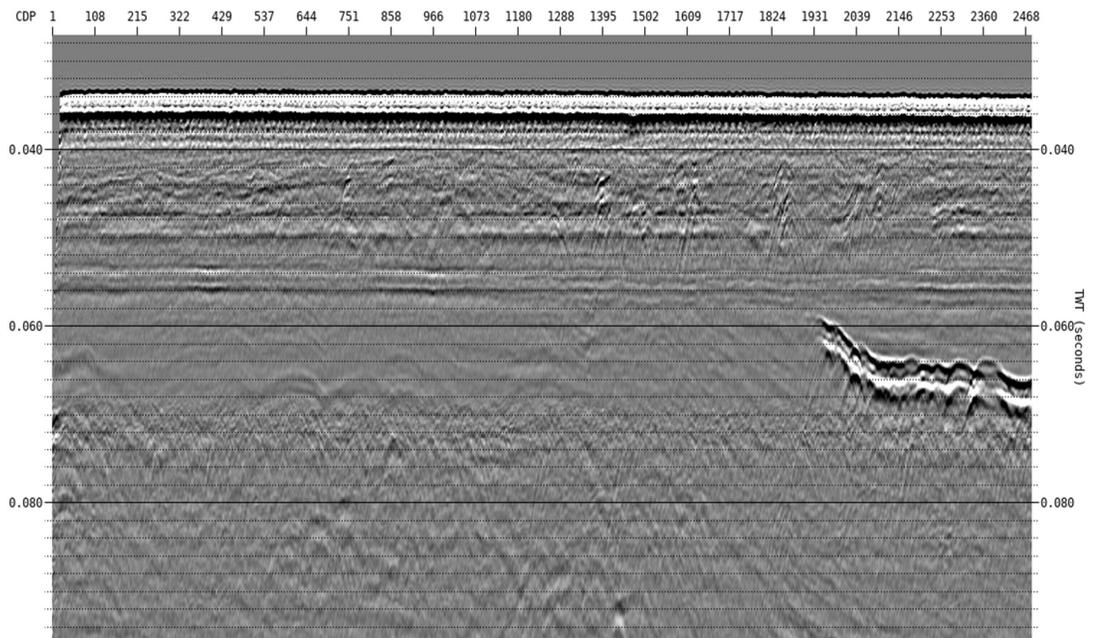
MEMUL uses moveout equations to generate a multiple model. The model is derived by extrapolating observed shot records through an additional round trip to the sea floor, equaling the multiple period. The water bottom time was picked from the nearest channel on each gun streamer combination. MEMUL adaptive matching in the channel domain was computed over 551 adjacent traces, with a filter length of 6 ms and a window length of 6 ms. The model generated by MEMUL was then adaptively subtracted from the input data, using a multi-channel matching filter that incorporated summed auto and cross correlations and a wiener filter to achieve a safe and effective multiple removal. The filter had a filter length of 0.75 ms and a window length of 100 ms

Figure 2.12: Source 1, streamer1. Pre-demultiple 2D stack (zoom window 35 – 100 ms TWT)

Figure 2.13: Source 1, streamer 1. Post demultiple (including diffracted multiple attenuation)

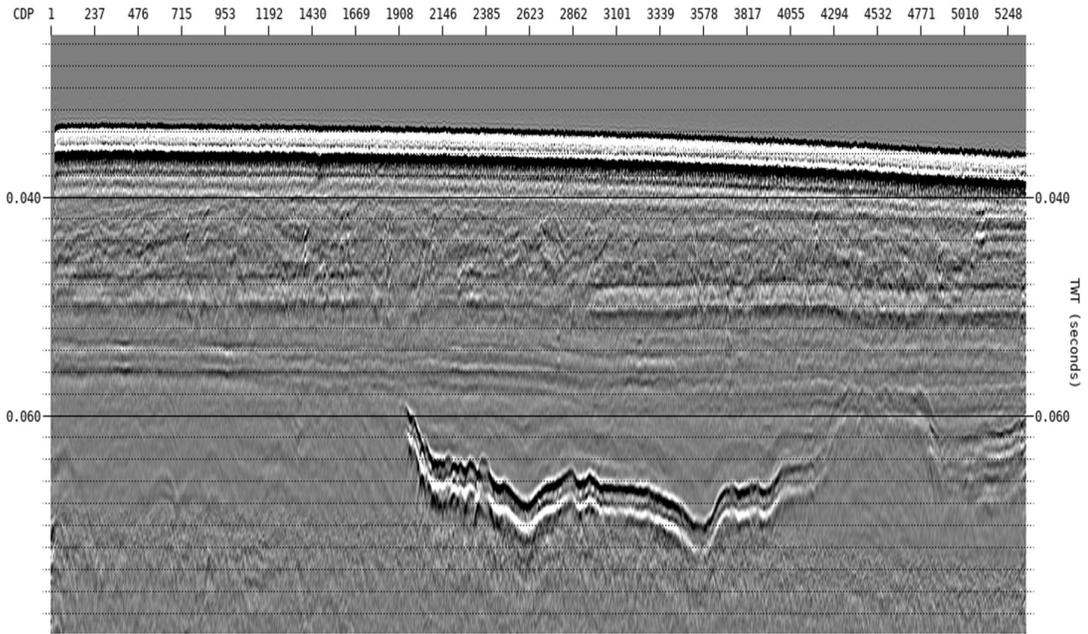
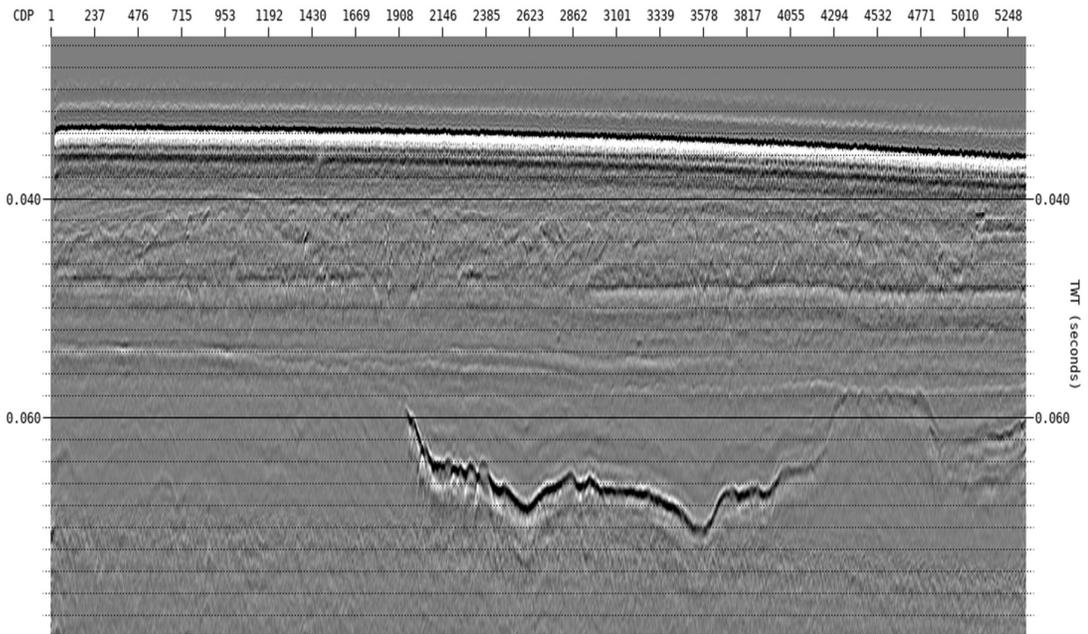
Again a wave height allowance of 0 m was used to disable the frequency dependent scattering and an iterative (40 – 10 %) search window for the receiver ghost (1.4 m seed depth) was applied.

Figure 2.14: Source 1, streamer 1. Pre-deghost 2D stack (zoom window 35 – 80 ms TWT)

Figure 2.15: Source 1, streamer 1. Receiver Deghosted stack

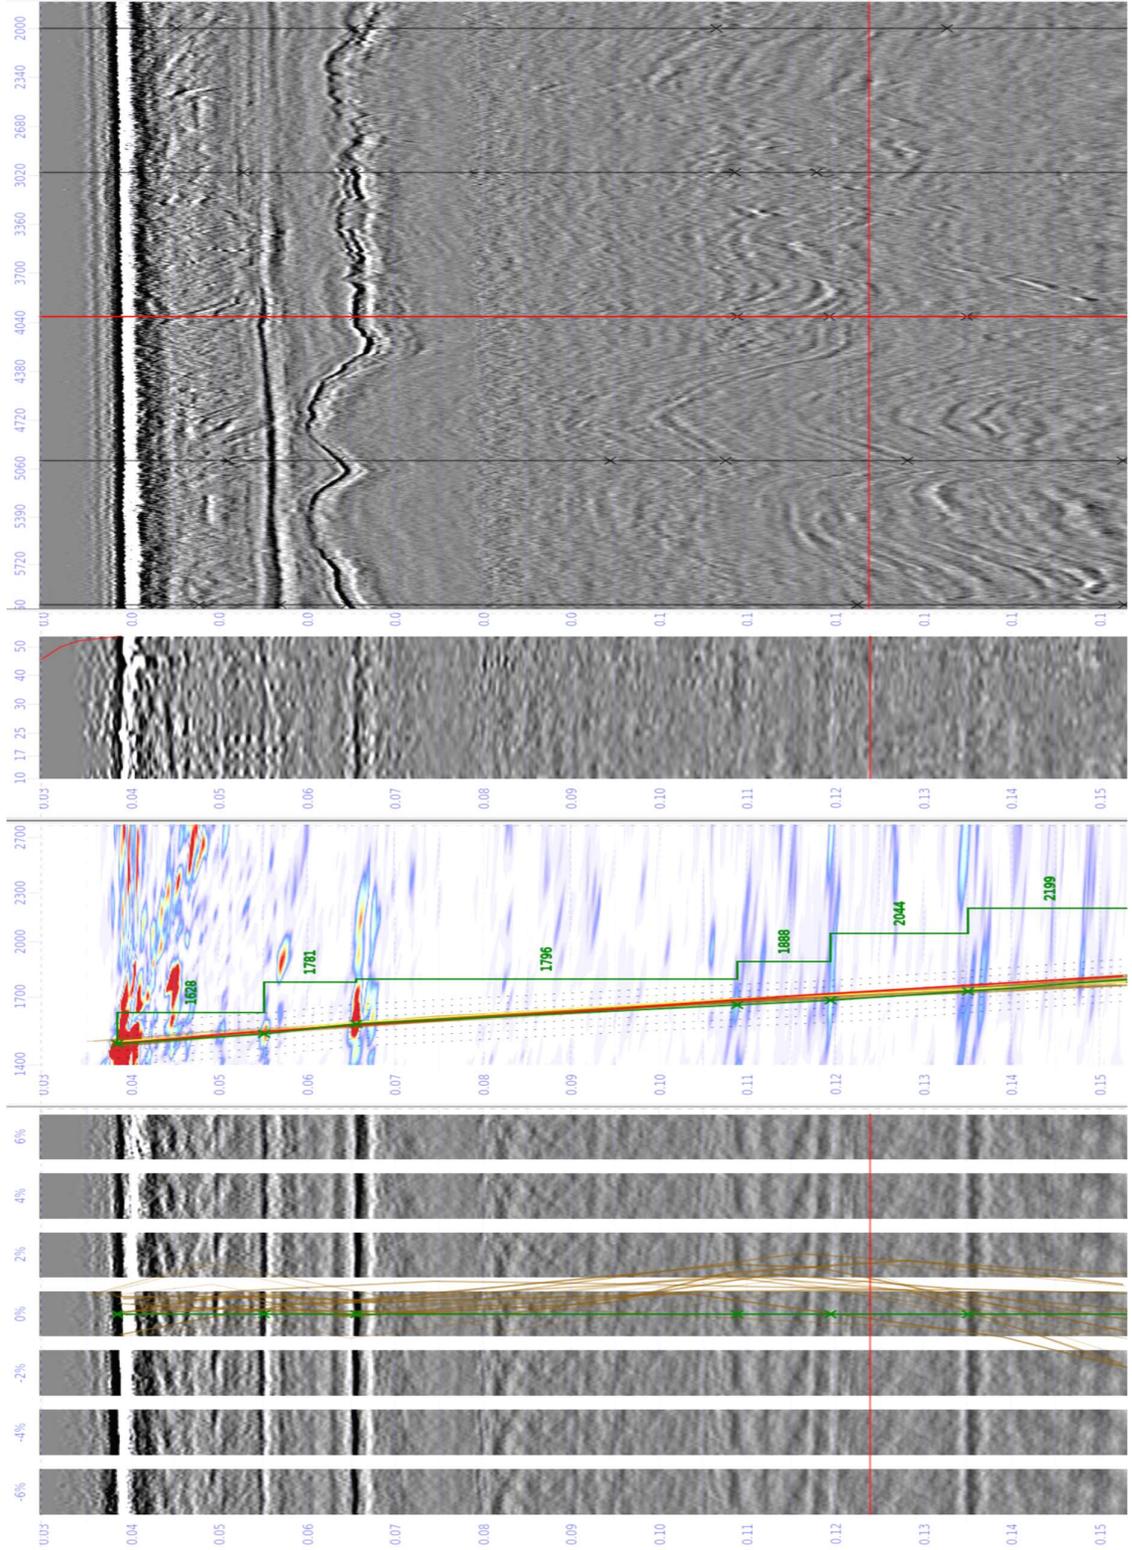
The RMS velocity field is converted to interval velocity via the DIX equation and interpolated to match every bin location on the final stack volumes.

Figure 2.16: Example velocity location in PEGASUS software. Multi-velocity stacks, dynamic gathers, semblance, and real-time stack (left to right)

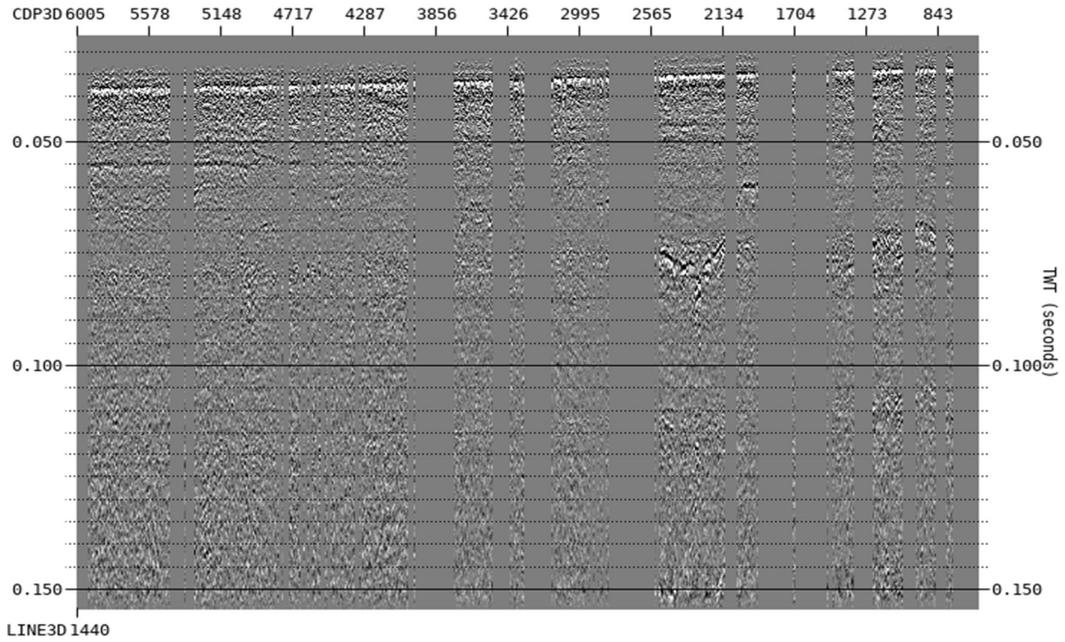
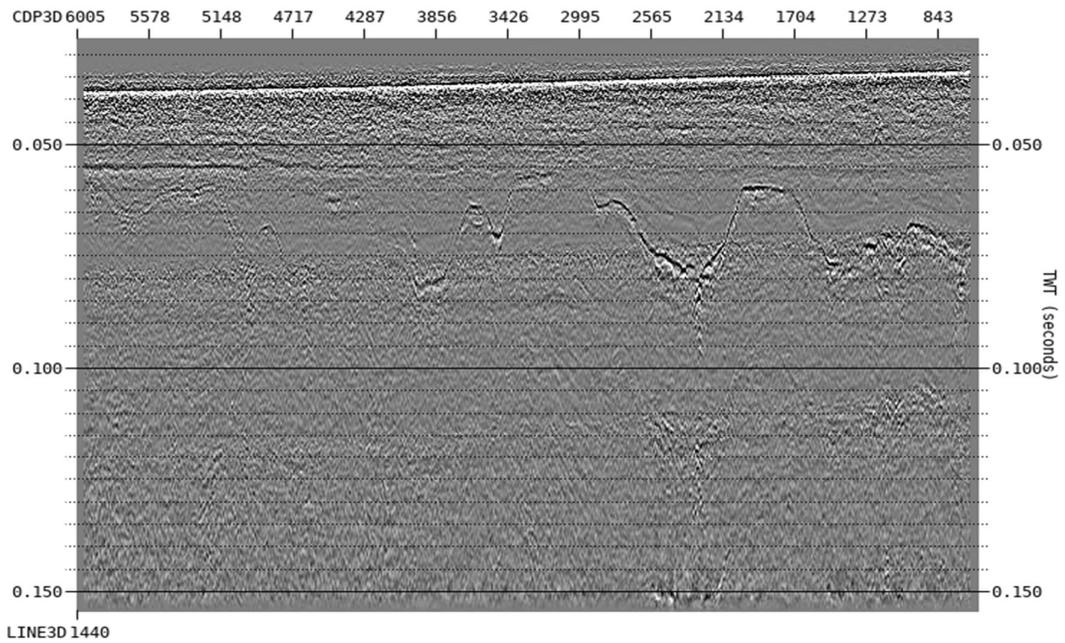
The Uniseis tool FRECON was used on each of the 24 offset volumes. The module works in 3D, selectively transforming data using an anti-leakage Fourier transform. This allows the module to effectively interpolate dipping reflectors while transform method inherently prioritises signal over noise.

Figure 2.17: Phase 4. Offset volume 2 before interpolation and regularisation

Figure 2.18: Phase 4. Offset volume 2 after FRECON

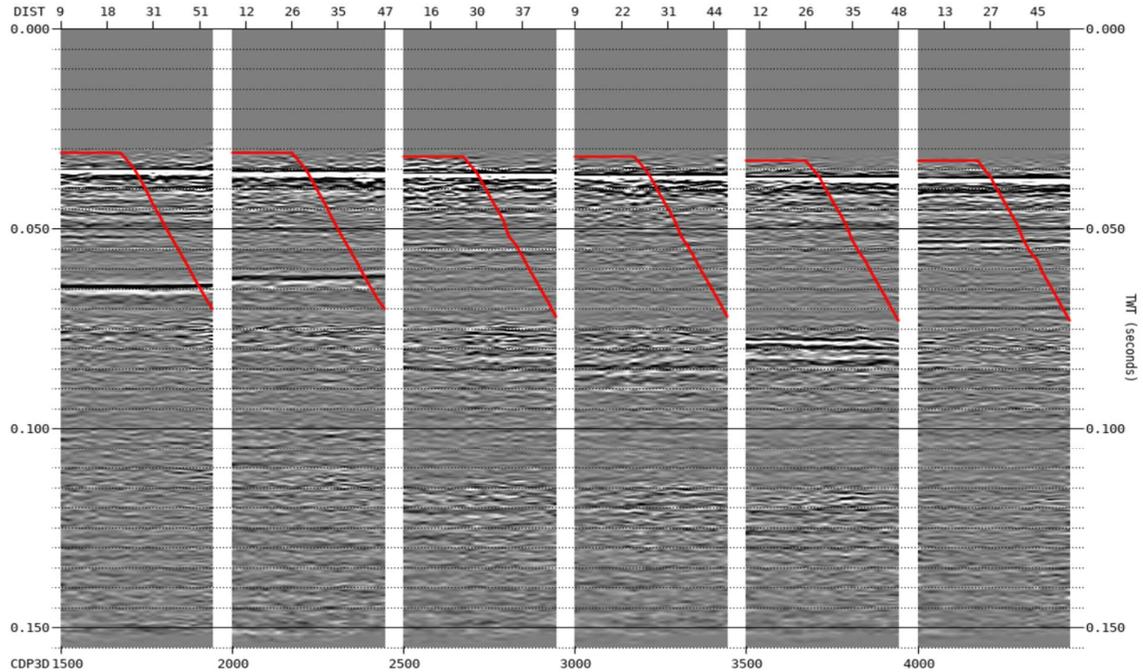
The data were then ready to be stacked. An outer trace mute was applied to remove NMO stretch on far offsets. A more open mute would introduce stretch in the shallow regions, a consequence of the shallow water conditions. Trace normalization of 1/N was used when stacking. See below for an example of the gathers with the final mute overlaid.

Figure 2.19: Mute overlaid (red) on 3D CDP gathers

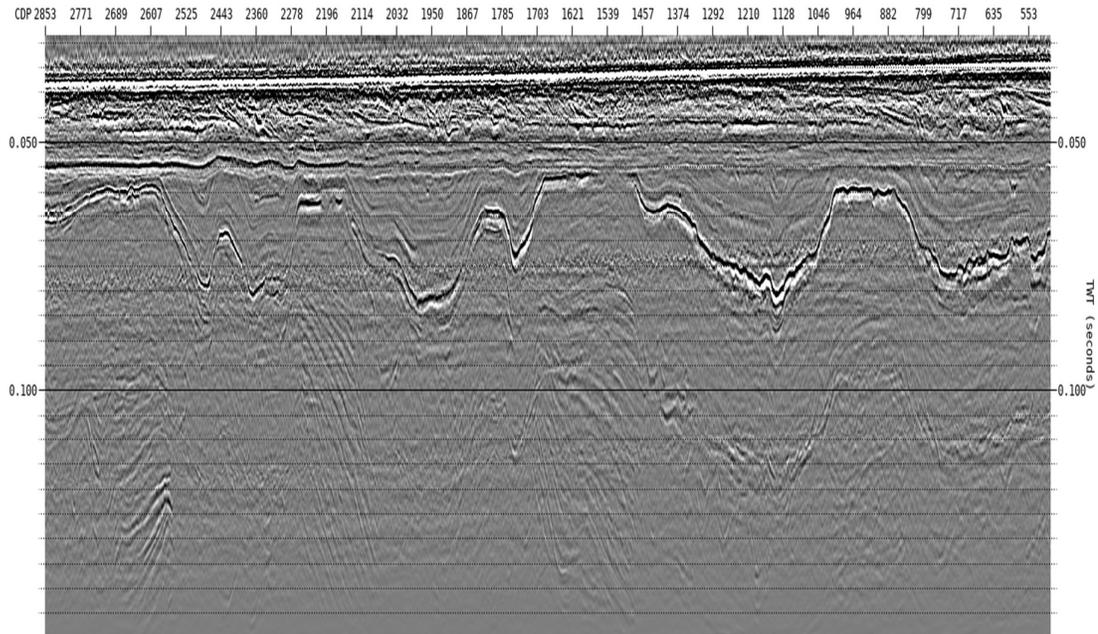
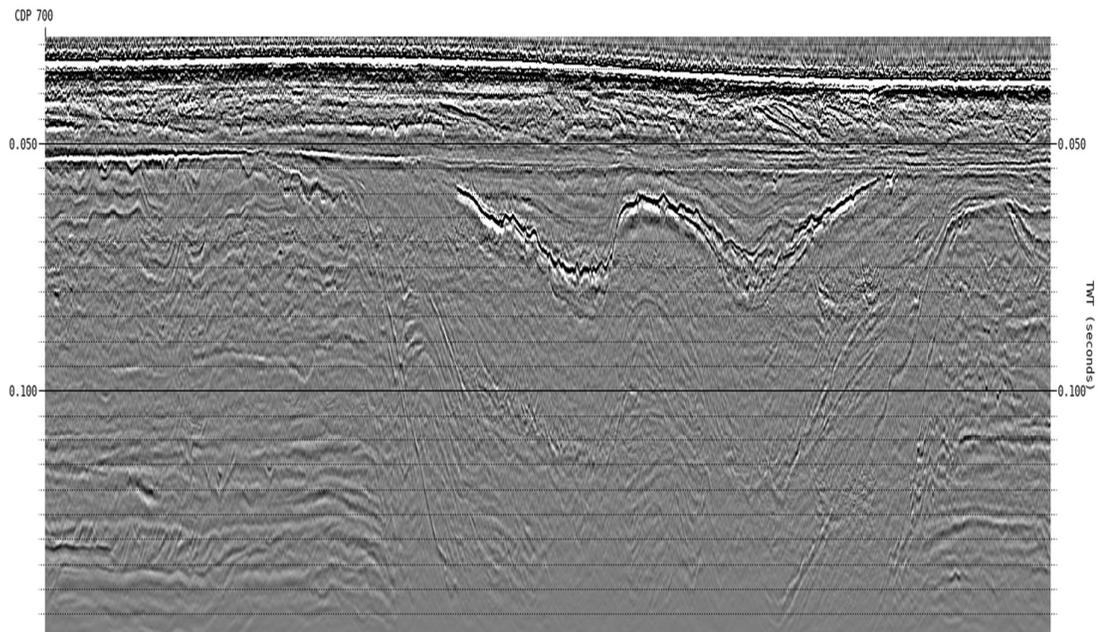
3D Post-Stack Kirchhoff Time Migration was performed using the picked velocities. A migration aperture of radius 80 m was used with a 60% stretch mute to minimise dipping artefacts. Anti-aliasing was applied by pre-filtering the data within the migration scan depending upon the local migration operator dip. Anti-aliasing protection prevents any undesirable data being included.

Figure 2.20: 3D inline 1440. 3D migrated IL stack

Figure 2.21: 3D xline 700. 3D migrated XL stack

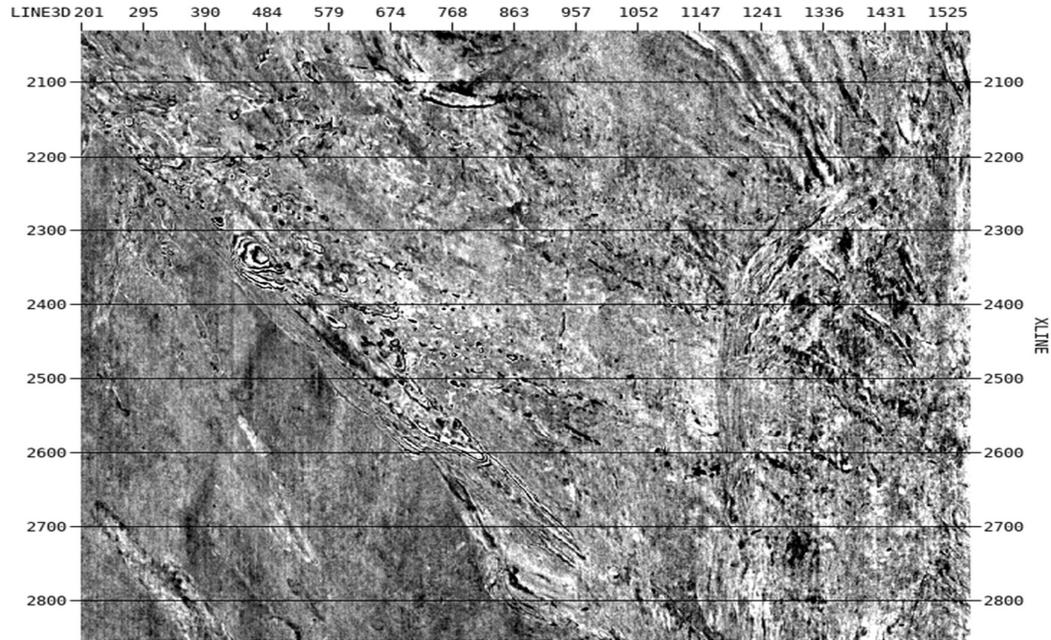
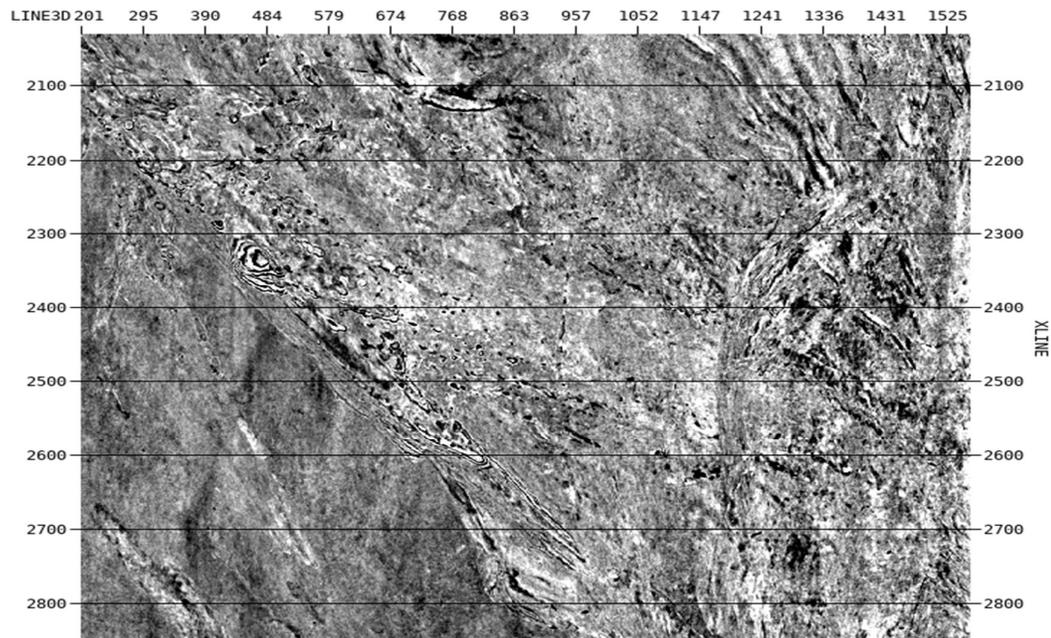
Spatially periodic noise can be viewed on timeslices as regular amplitude modulations or striping. In marine seismic data this is usually related to the streamer/gun configuration where it is commonly known as an acquisition footprint. Stripes in the spatial domain appear as discrete spots of energy in the  $K_x$ - $K_y$  domain. Filtering was performed on one transformed time-slice at a time with an example of a timeslice below.

Figure 2.22: Pre-KxKy timeslices (timeslice at 43 ms TWT)

Figure 2.23: KxKy timeslices (footprint attenuation)

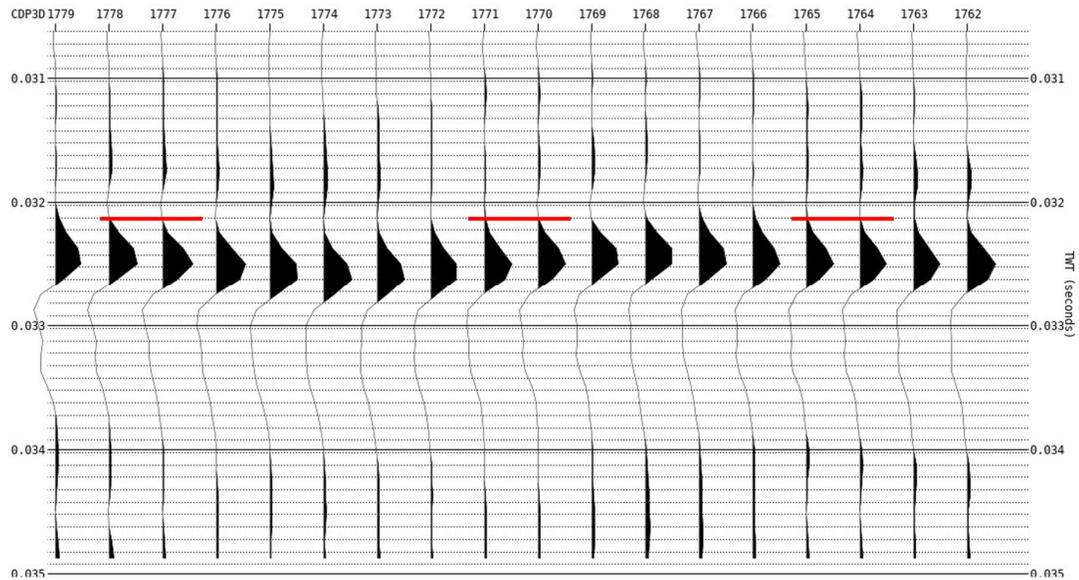
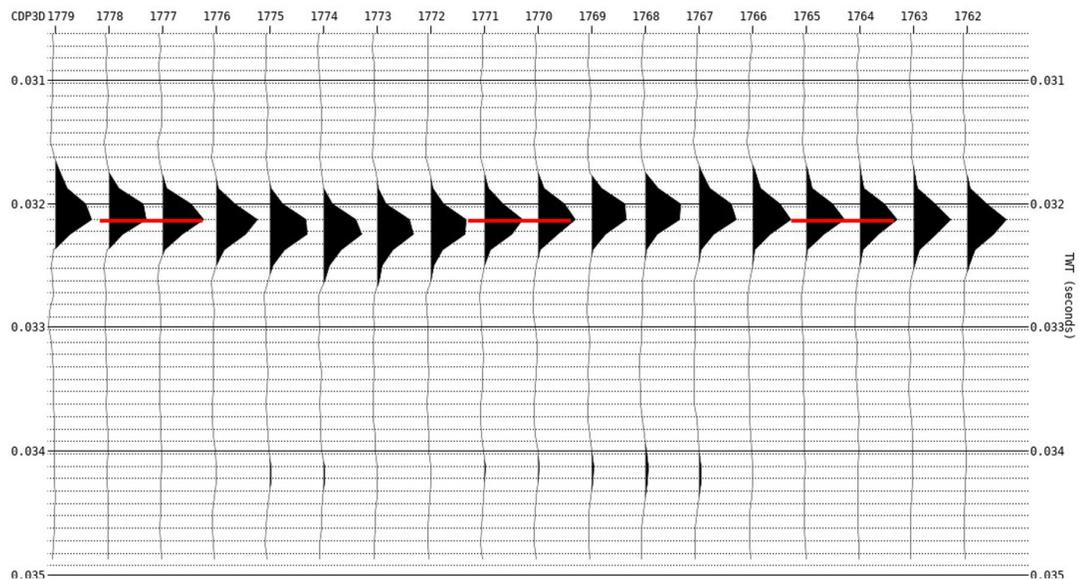
A zero-phase filter was designed using an extracted wavelet. This was created by flattening the seabed and stacking all the data. The onset of the super stacked wavelet was then shifted to 0 ms and the zero-phase filter calculated. See below for an example of the zero-phase filter applied to the stack.

Figure 2.24: Example seabed wavelet before zero-phase

Figure 2.25: Example wavelet after zero-phase

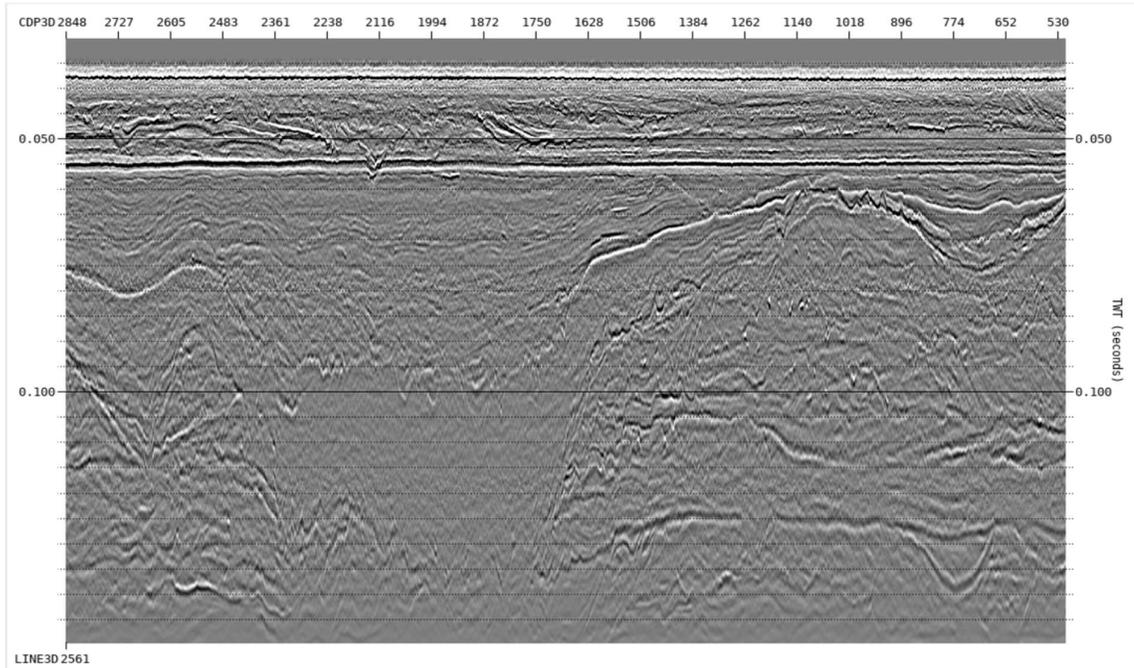
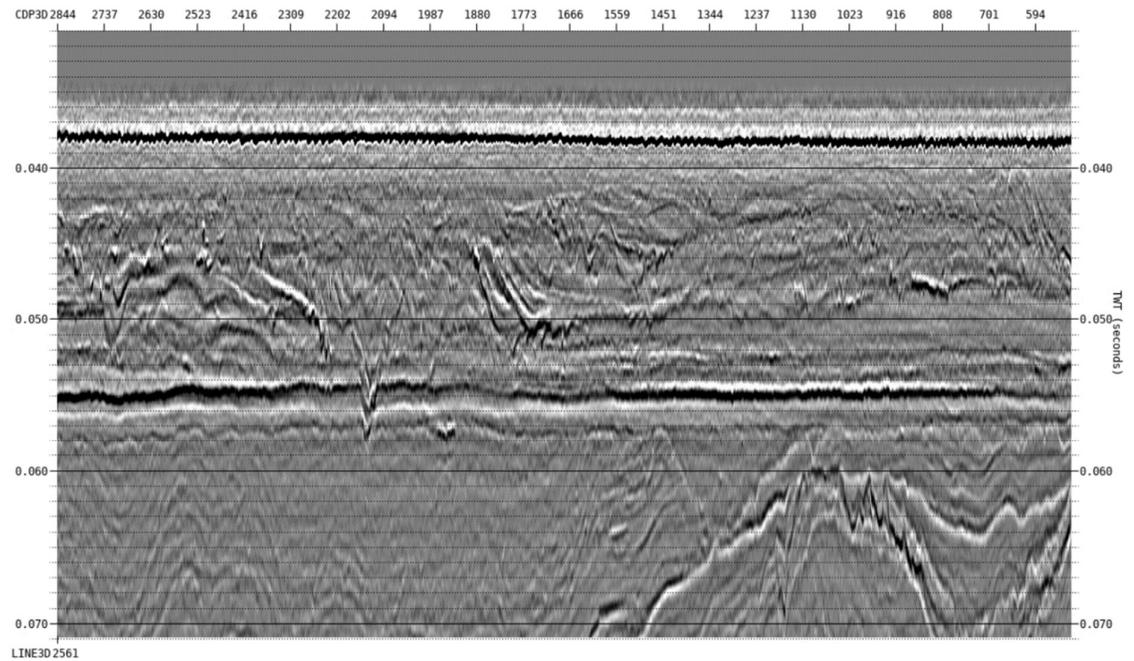
Amplitude-only Q (Q = 100) was applied for one set of deliverables.

Figure 2.26: Inline 2561. Final image (including amplitude-only Q)

Figure 2.27: Inline 2561. Final image (zoom window 30 – 70 ms TWT)

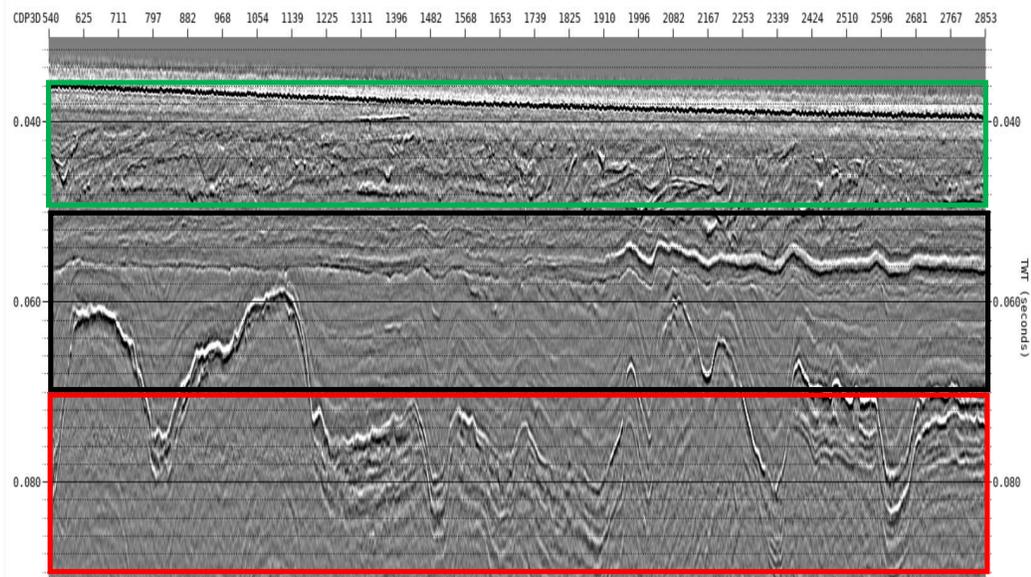
Figure 2.29 Phase 4 inline 1600 - boxes represent analysis windows for the below.

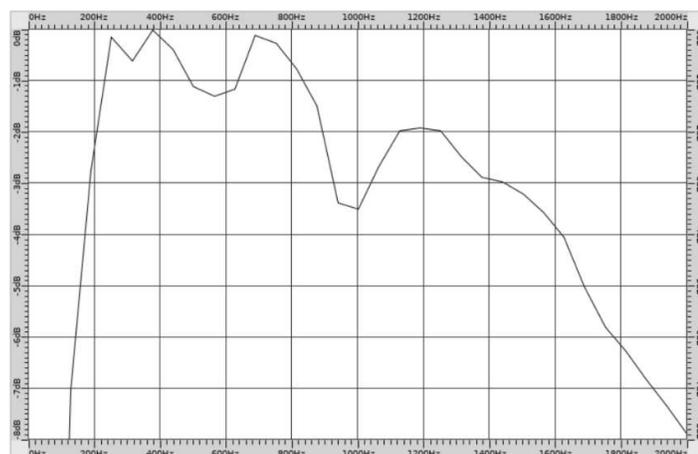
- Within the depth range 0-20 m bsb (referring to Figure 2.30), a dominant frequency of 375 Hz corresponds to a vertical resolution of 1.07 m. Additionally, the spectrum shows a relatively broad bandwidth to 687.5 Hz estimating a vertical resolution of 0.58 m. A dominant bandwidth of 190-1400 Hz predicts a resolution range of 0.29-2.11 m.
- Within the depth range 20-40 m bsb (referring to Figure 2.31), a dominant frequency of 437.5 Hz corresponds to a vertical resolution of 0.91 m. A dominant bandwidth of 250-750 Hz predicts a resolution range of 0.53-1.60 m.
- Within the depth range 40-60 m bsb (referring to Figure 2.32), a dominant frequency of 437.5 Hz corresponds to a vertical resolution of 0.91 m. A dominant bandwidth of 250-725 Hz predicts a resolution range of 0.55-1.60 m.

Figure 2.30 Amplitude spectra over 0-20 m bsb. Dominant frequency is 375 Hz, and the dominant bandwidth is approximately 190-1400 Hz

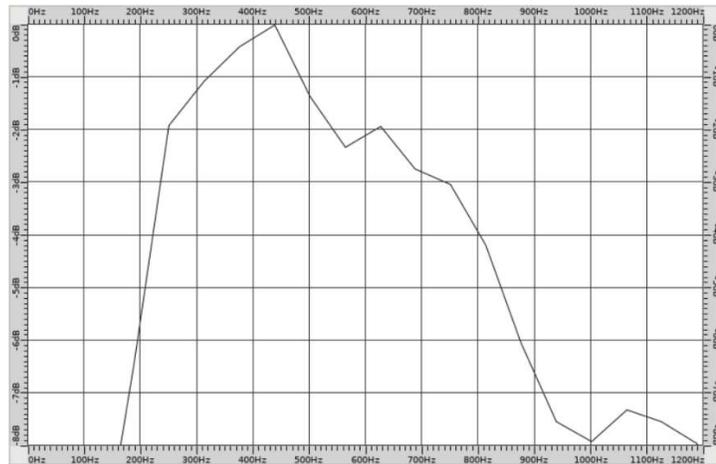
Figure 2.31 Amplitude spectra over 20-40 m bsb. Dominant frequency is 437.5 Hz, and the dominant bandwidth is approximately 250-750 Hz

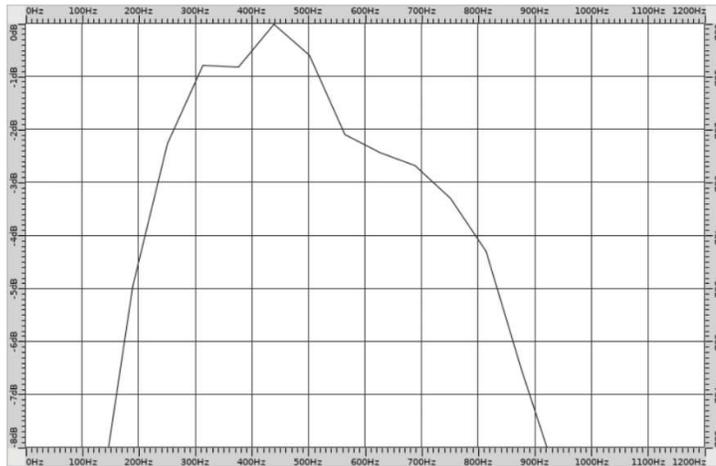
Figure 2.32 Amplitude spectra over 40-60 m bsb. Dominant frequency is 437.5 Hz, and the dominant bandwidth is approximately 250-725 Hz
