# UXO – Report

## Nederwiek Wind Farm Zone

# Desk Top Study

Label : 74787 / RO-220325 version 2.0

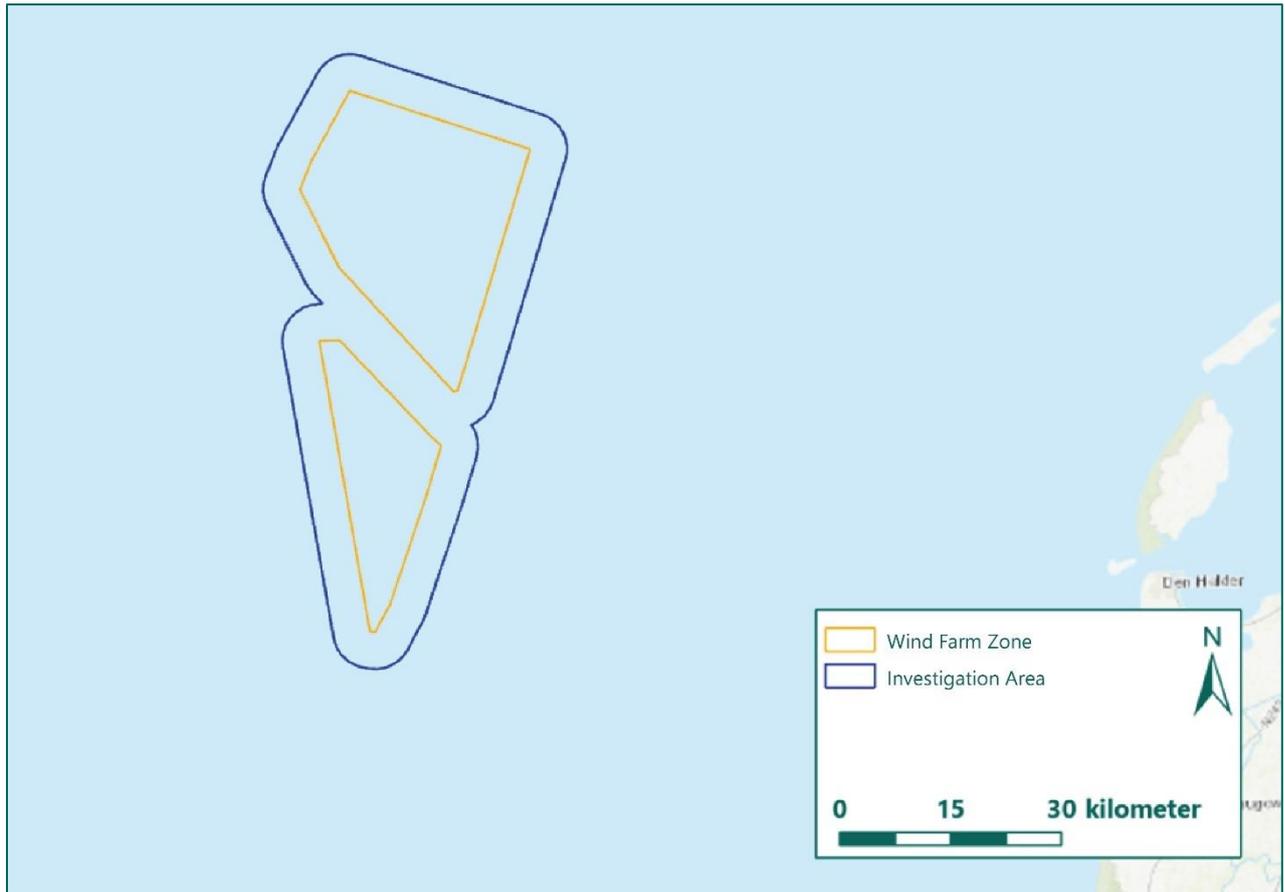
Figure 1: WFZ and Investigation Area (Source of base map: Esri).

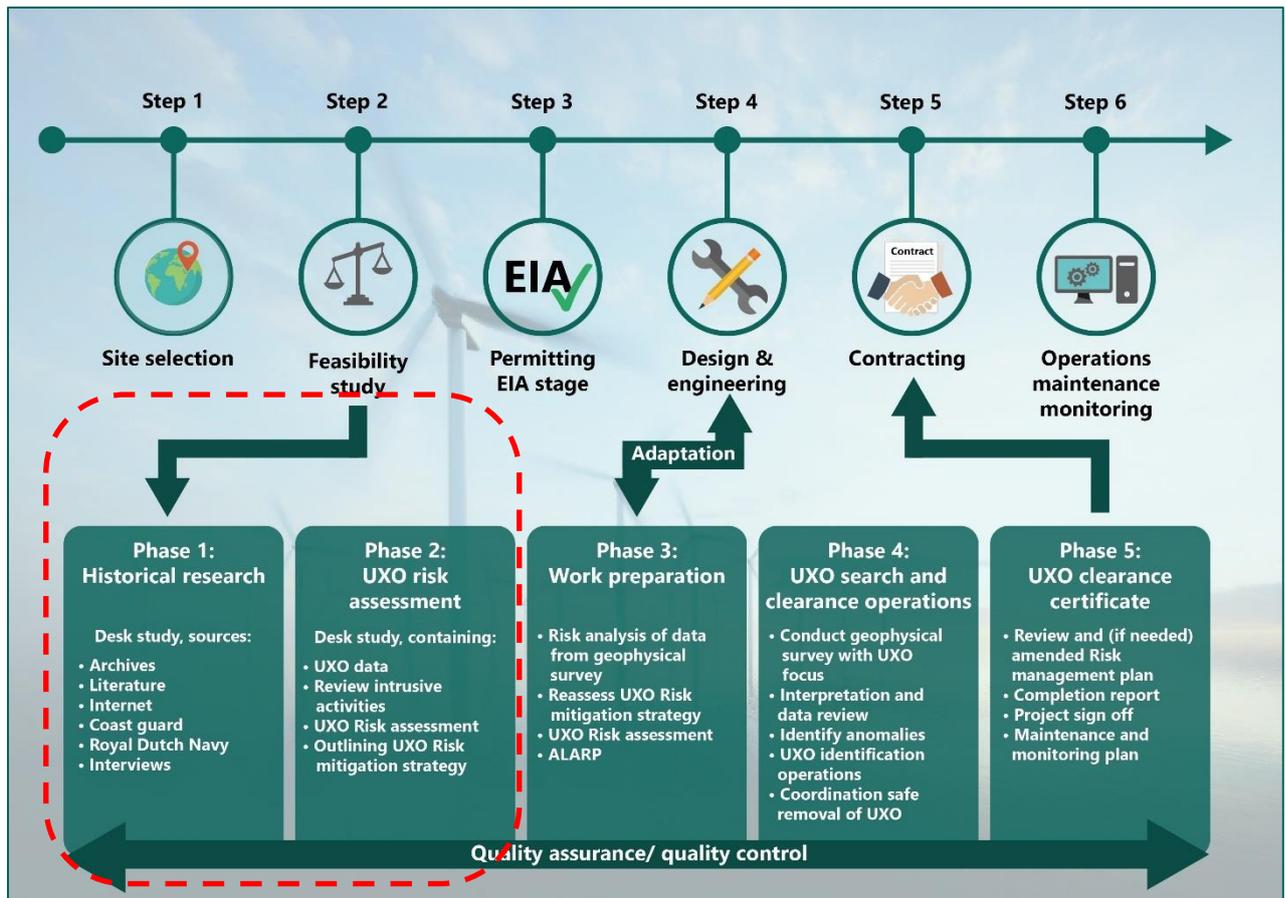
This report describes phase I (historical research) and phase II (UXO risk assessment) of the UXO risk management process. These phases are rendered within the red highlighted area within Figure 2: UXO risk management phases. The full UXO risk management process is also described in Figure 2 (see Annex 1 for a larger image). The execution of the following phases of the UXO risk management process is the responsibility of the future developer.

Figure 2: UXO risk management phases.

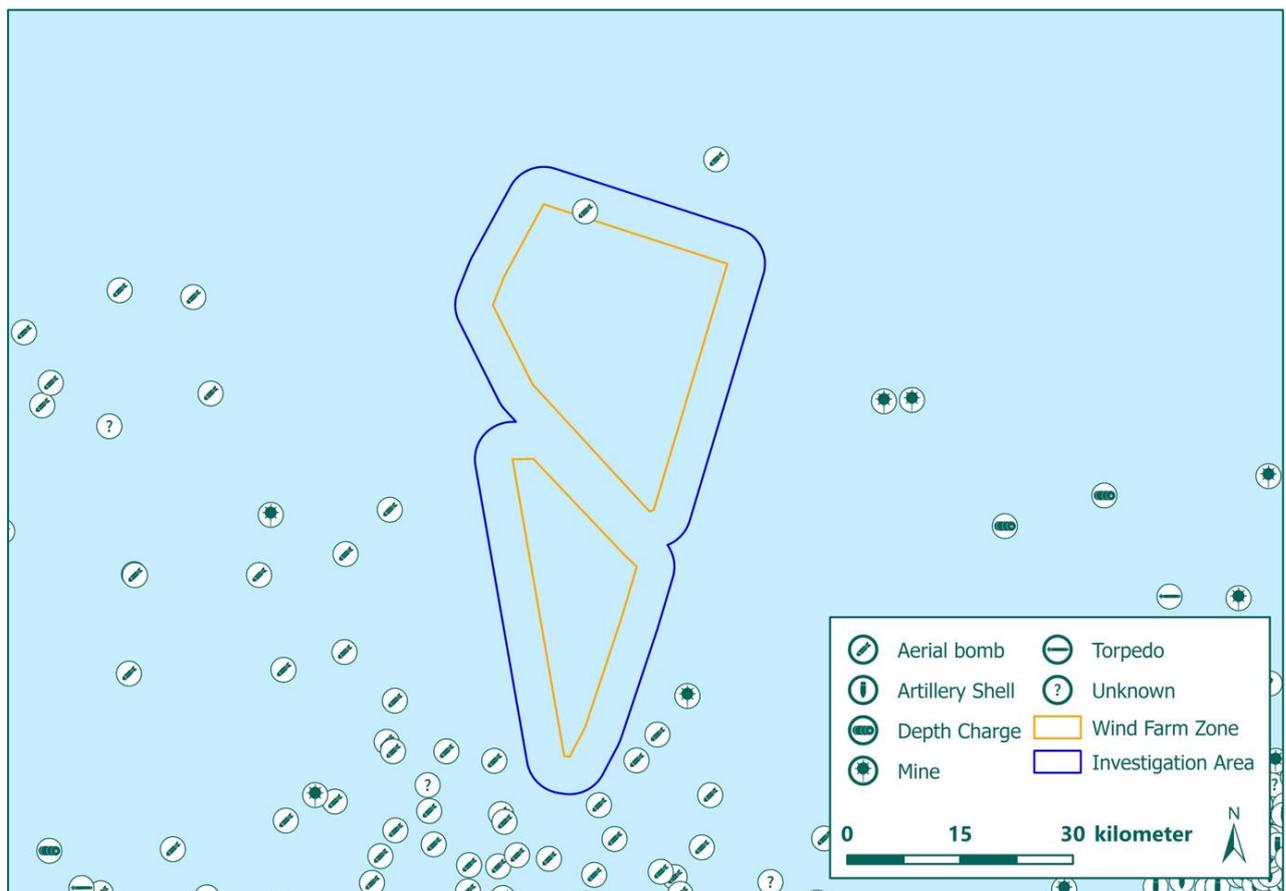
The bombs cleared by the Dutch Coast Guard could originate from air strikes and/or jettisons. Next to aerial bombs, some unknown UXO have been cleared, which might be a result of anti-aircraft gunfire. In the figure below encountered UXO are shown. The encountered UXO closest to the Investigation Area are shown in blue.

Figure 15: Overview of UXO encounters within and near the Investigation Area (Source: Dutch Coast Guard).

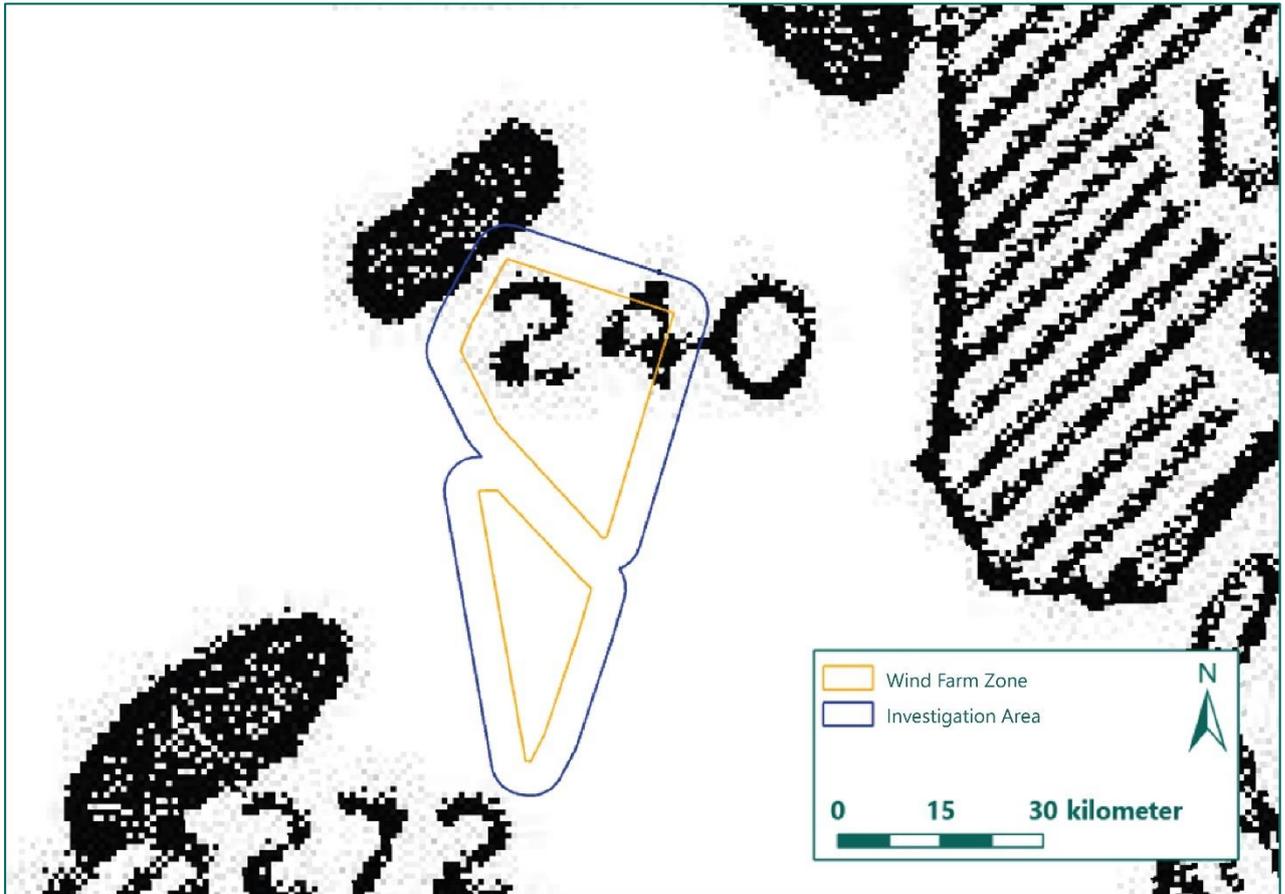
Figure 16: German WWI-minefield with 240 mines within the Investigation Area (Source: CRO 62).

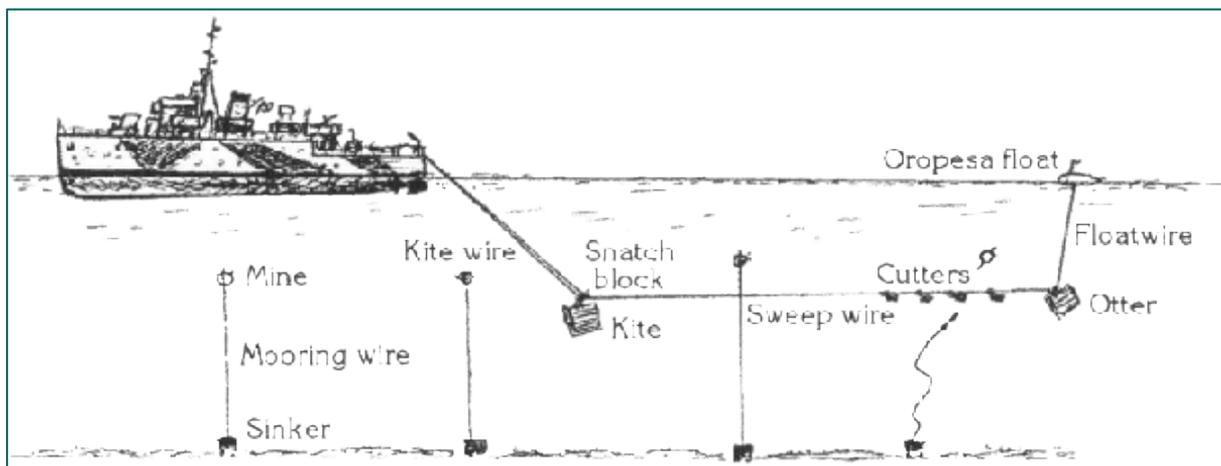
Mines also continued to pose a danger to shipping after the Second World War. To combat this threat, a large-scale minesweeping campaign was set up. The Investigation Area was situated in the Dutch sweeping zone. Details about minesweeping within the Investigation Area have not been found in the consulted sources. Minesweeping was conducted with a variety of methods. Moored mines were usually swept with Oropesa sweeping gear<sup>12</sup>.

Figure 29: Oropesa sweeping (source: 'The 'Art' of Minesweeping', 27 May 2013, <http://www.minesweepers.org.uk/sweeping.htm>, consulted 2 August 2019).

The moorings of the mines were cut with cutters dragged on a wire behind a ship. Cutting the mooring wires/cables caused the mines to float to the surface, where the mines could easily be shot with cannon or rifle fire. Shooting the mines caused them to sink or to detonate. Ground mines were swept with acoustic hammer boxes, triggering the acoustic mines, or by magnetic sweeping gear to trigger magnetic mines.

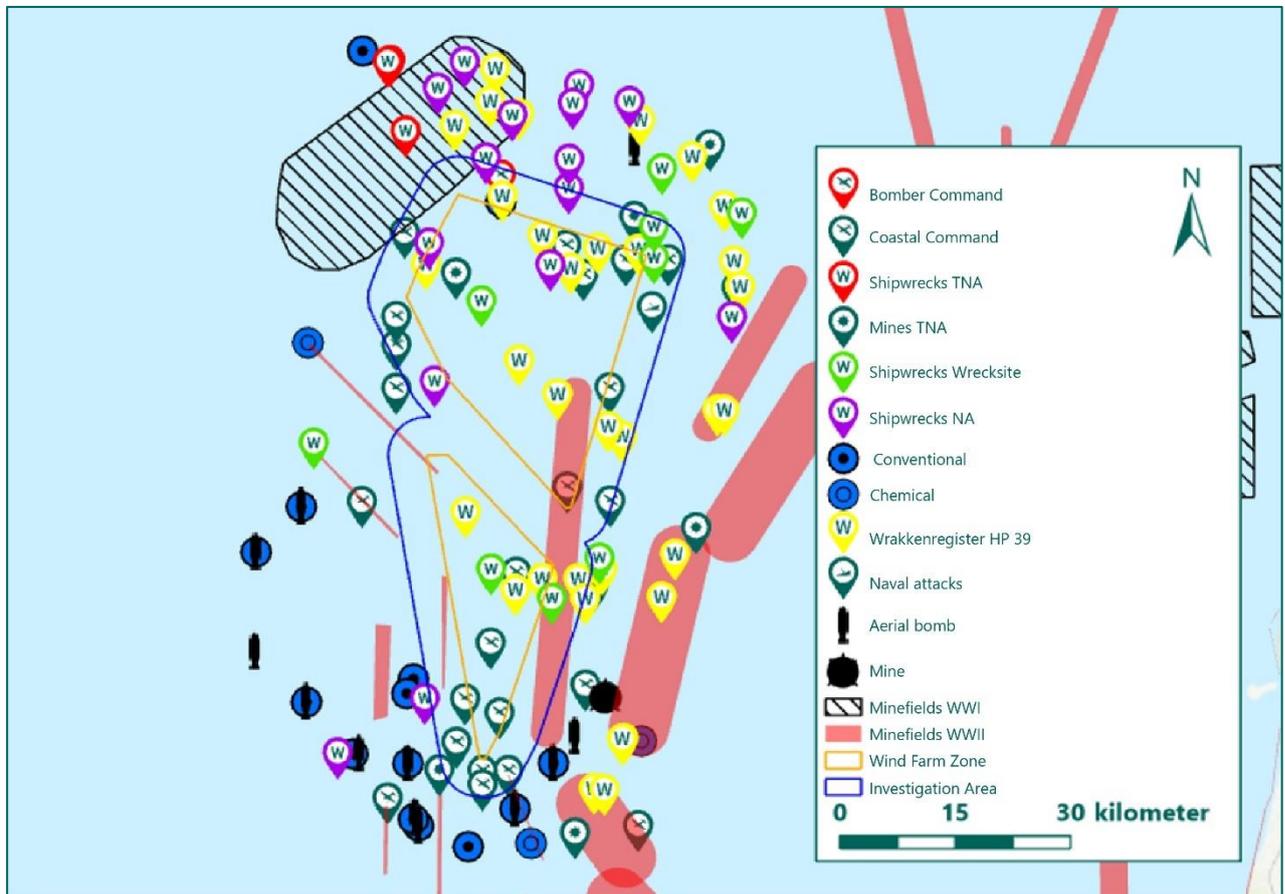
Figure 33: Overview of war related events (Source basemap: Esri).

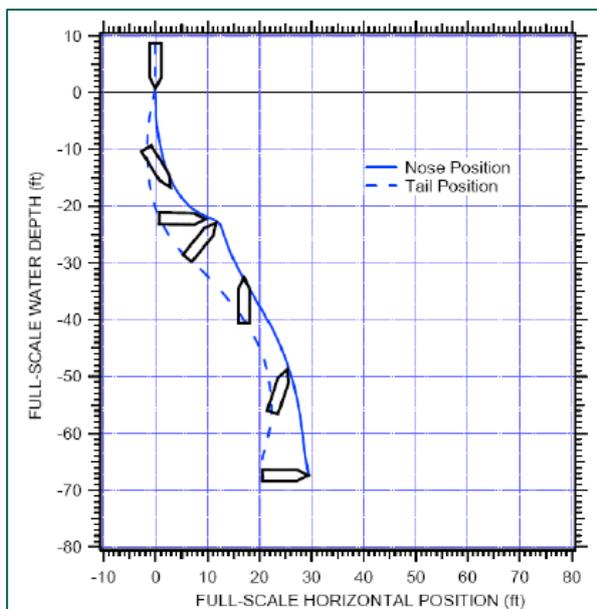
Figure 34: Trajectory of Mk 84 with no tail section and water-entry velocity of 296 m/s. Note that unit of measurements are in feet (ft).

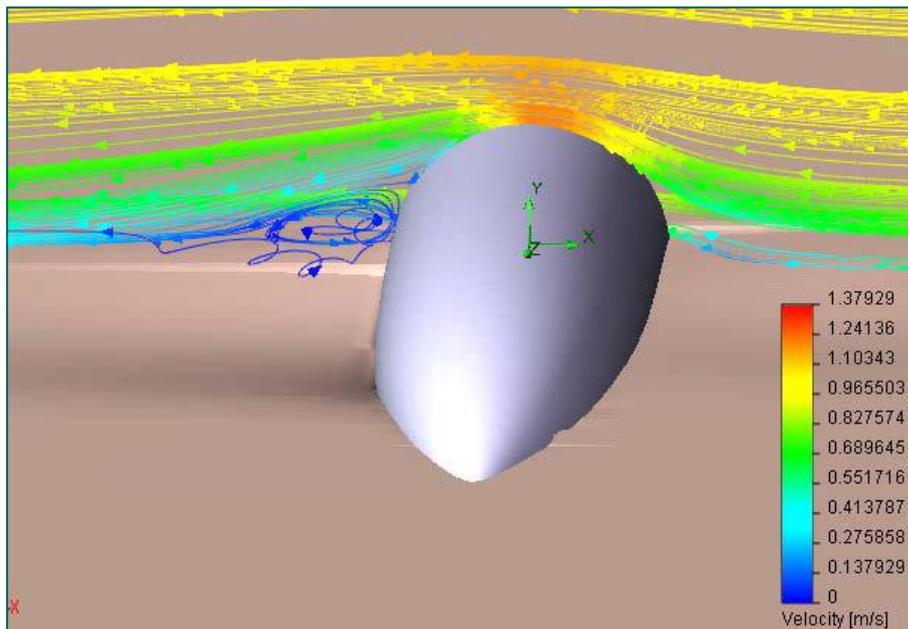
Figure 35. Example of flow stresses and subsequent vortices around a surrogate UXO.

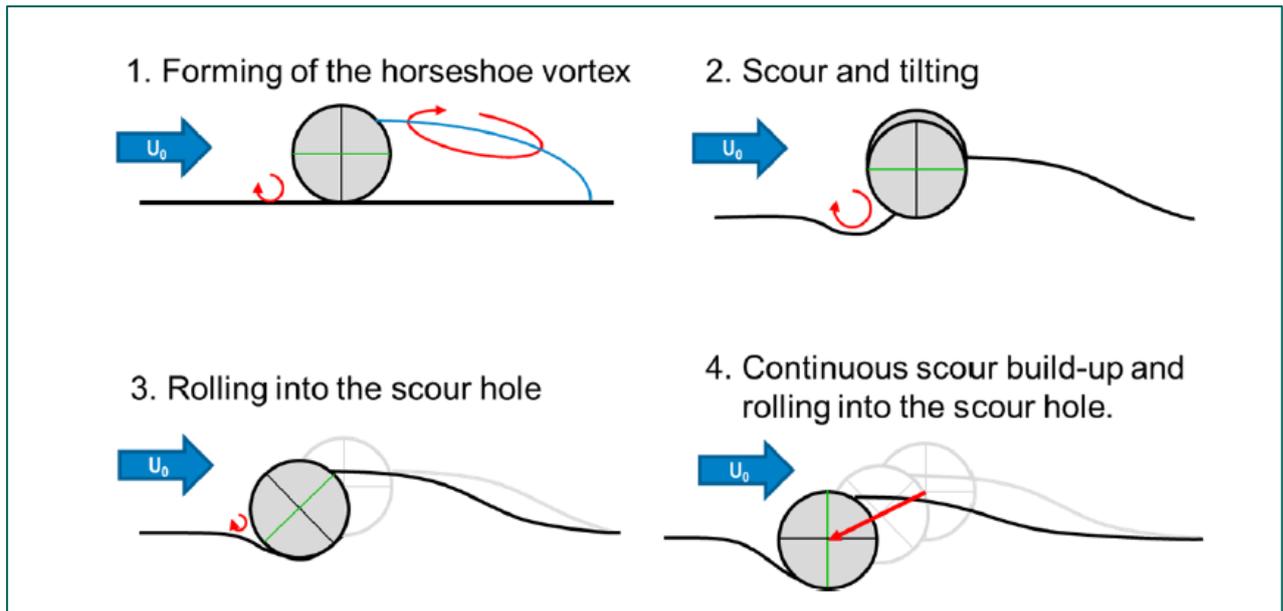
Figure 36. Example of scour mechanism and self-burial in constant inflow conditions.<sup>18</sup>

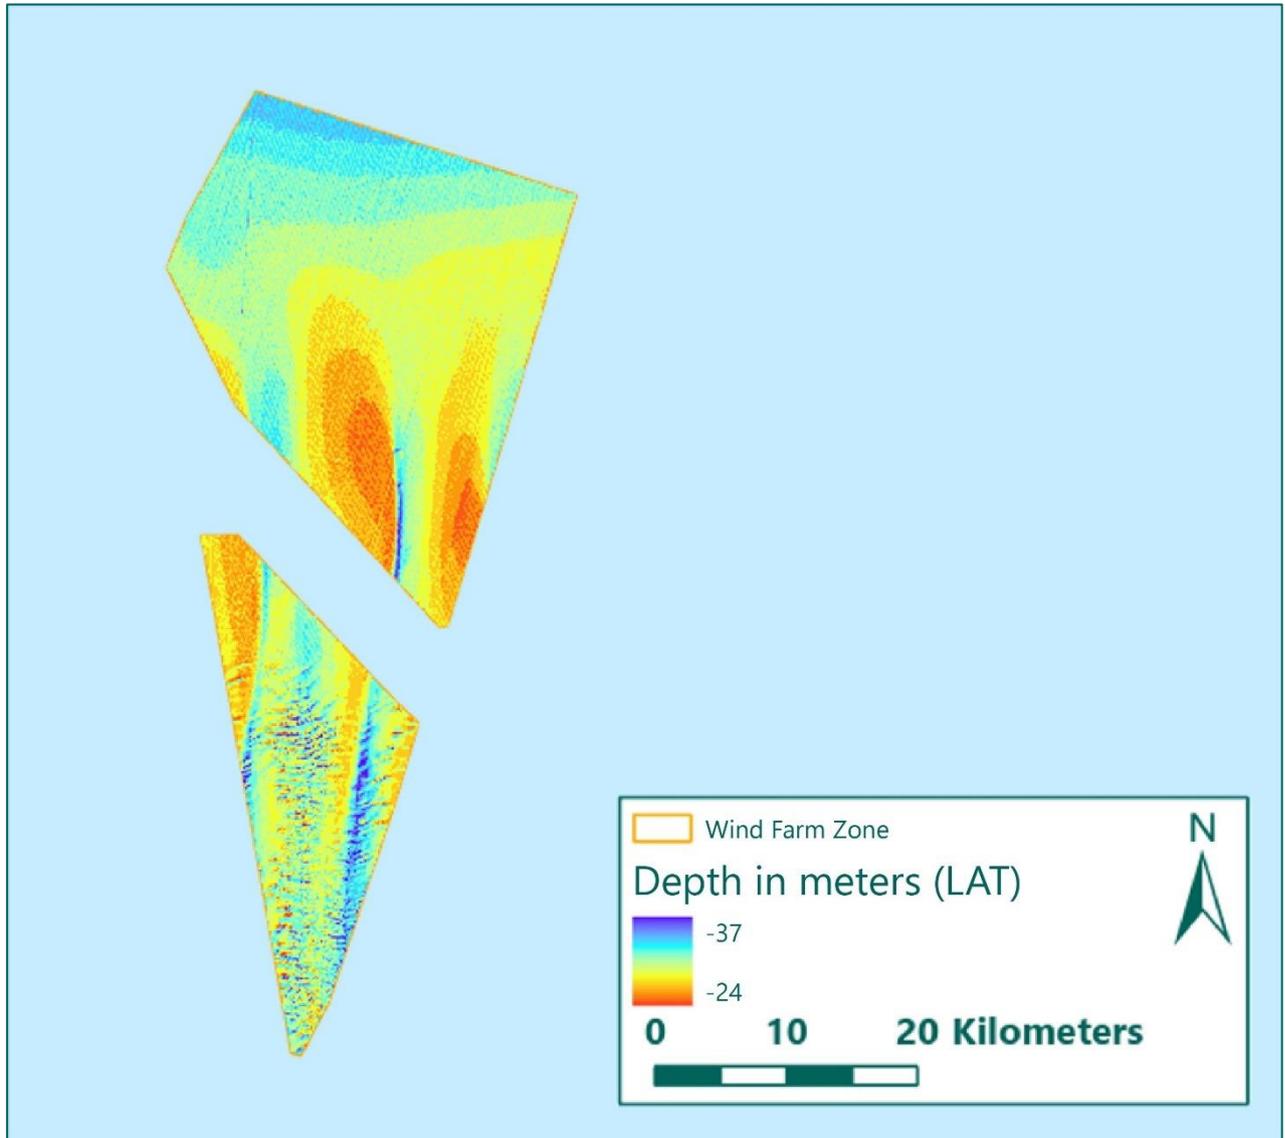
Figure 38: Available bathymetry of the investigation area.<sup>21</sup>

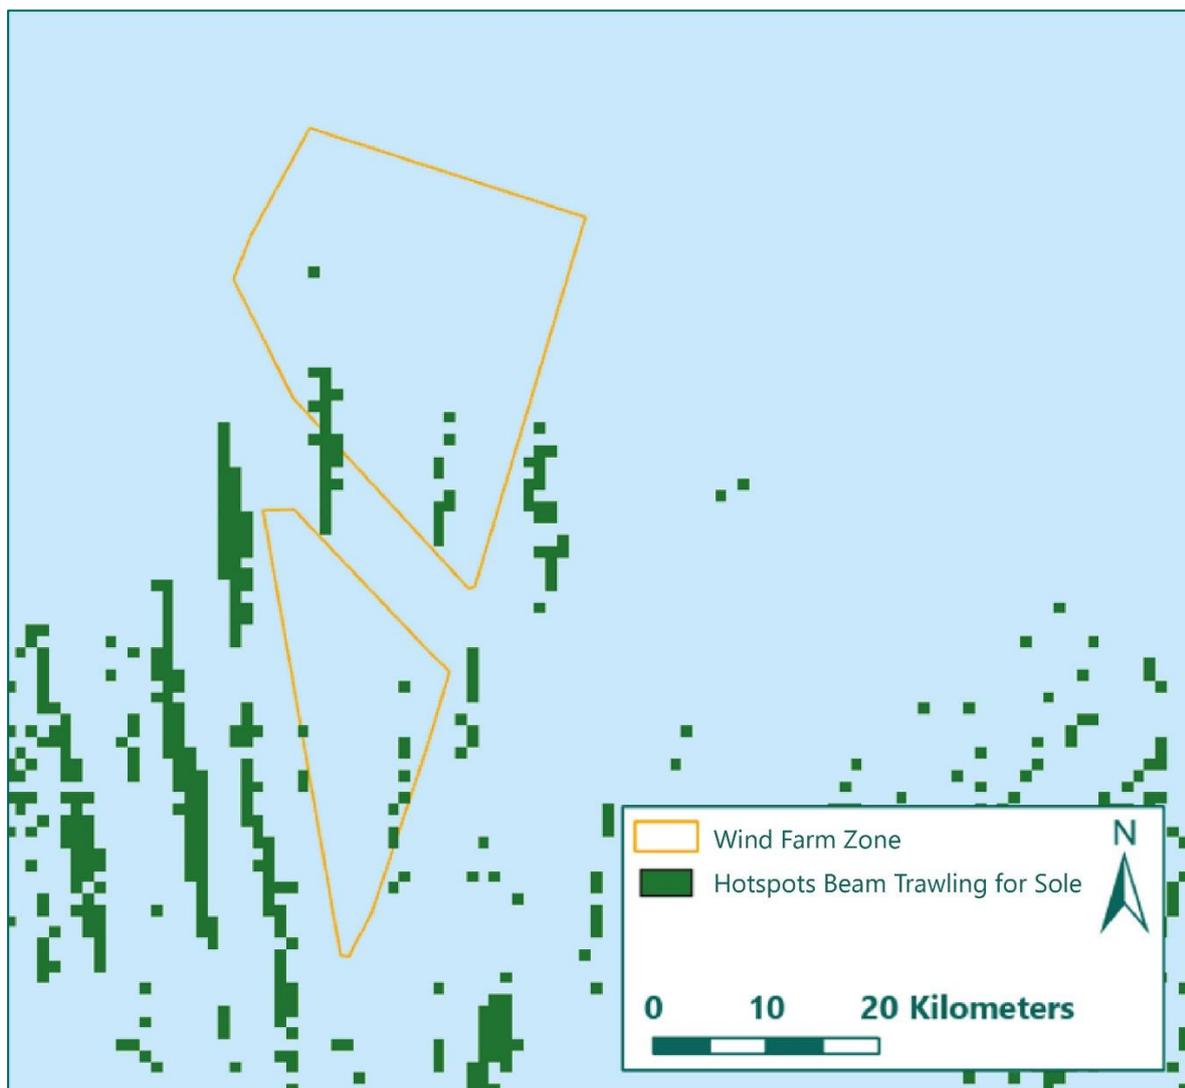
Figure 39. Hotspots for beam trawling for sole.

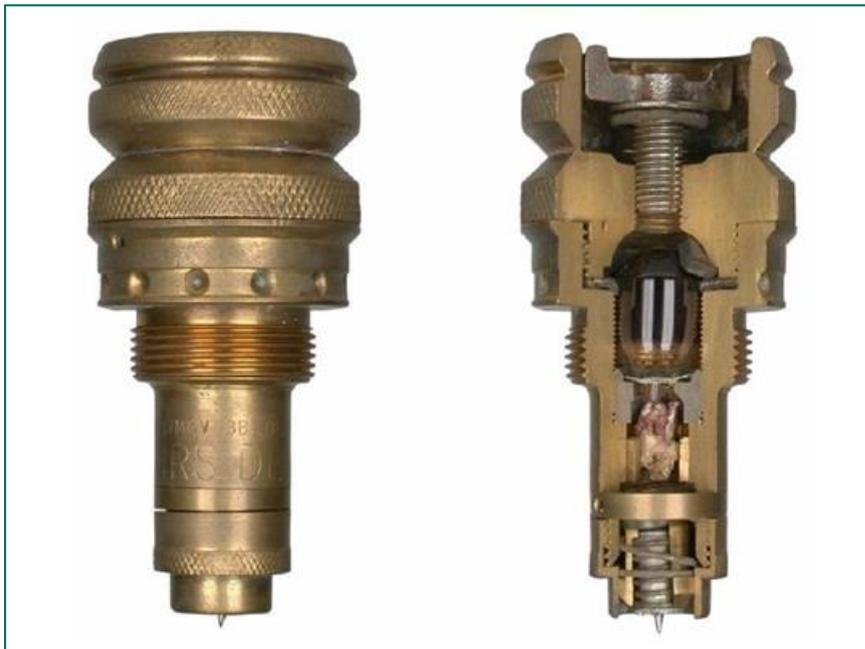
Figure 40. Tail fuze No. 37 Mk.I.

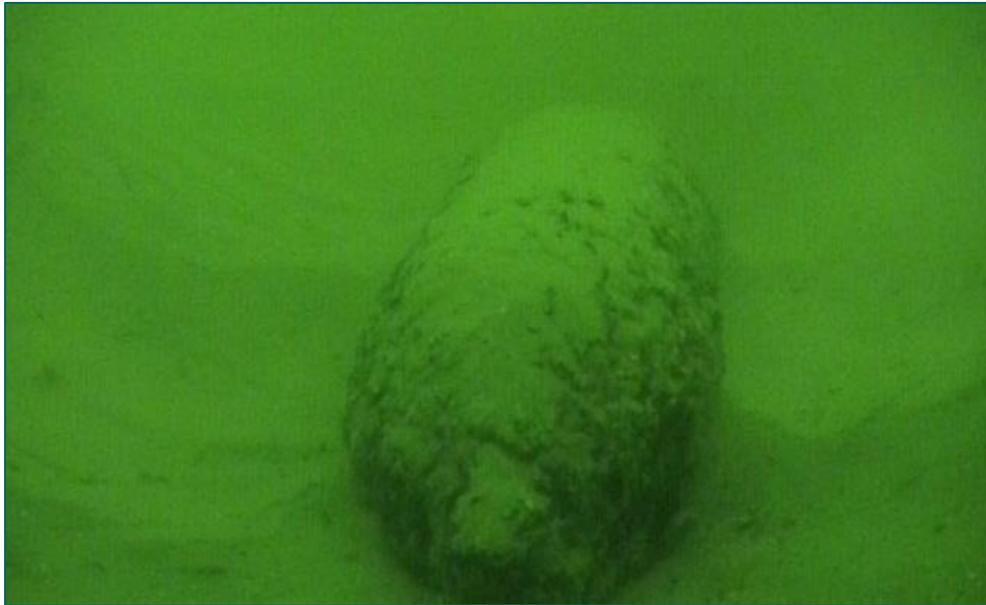
Figure 41. One of several aerial bombs encountered during clearance operations in the Hollandse Kust Zuid (HKZ) wind farm zone in 2020.<sup>25</sup>

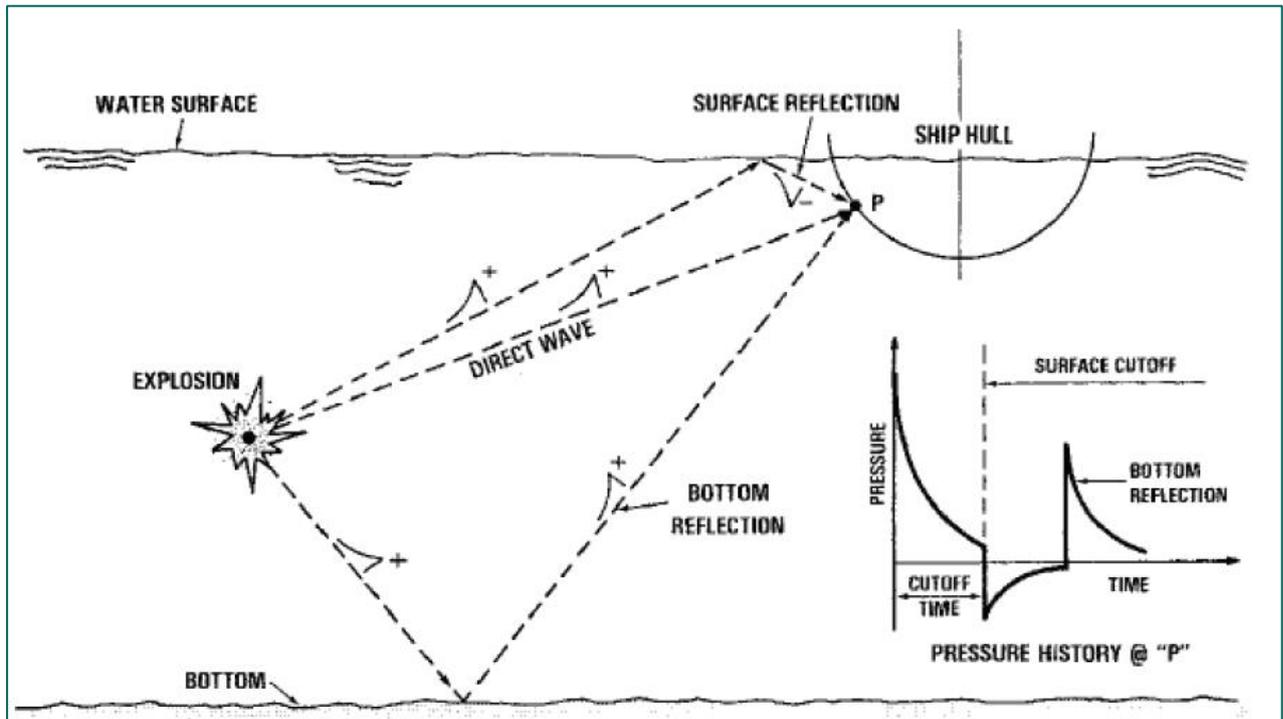
Figure 45. Multiple shock wave strikes caused by a single explosion.<sup>31</sup>

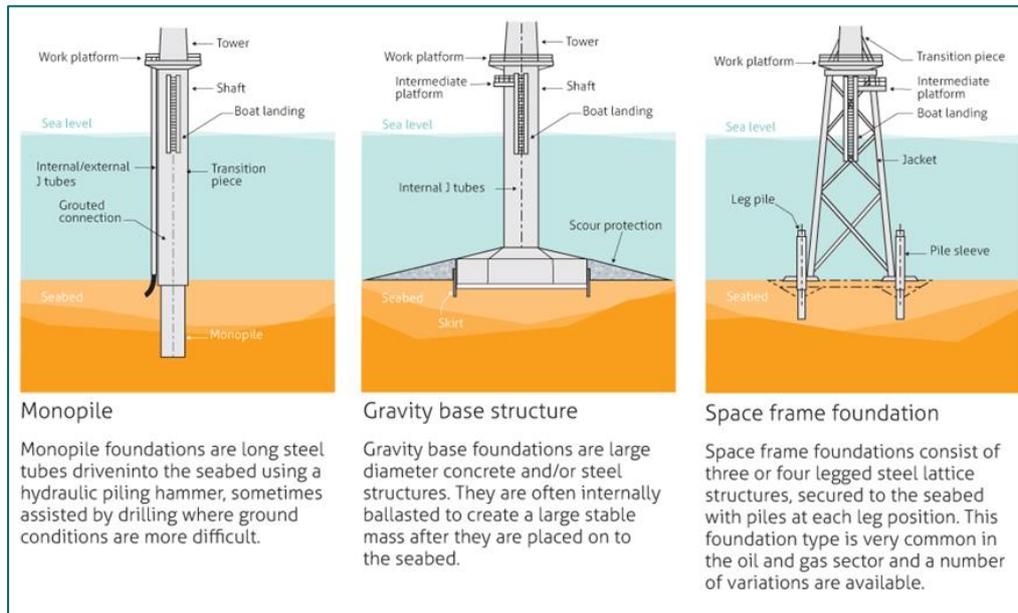
Figure 46: Example of suitable foundation types.<sup>34</sup>

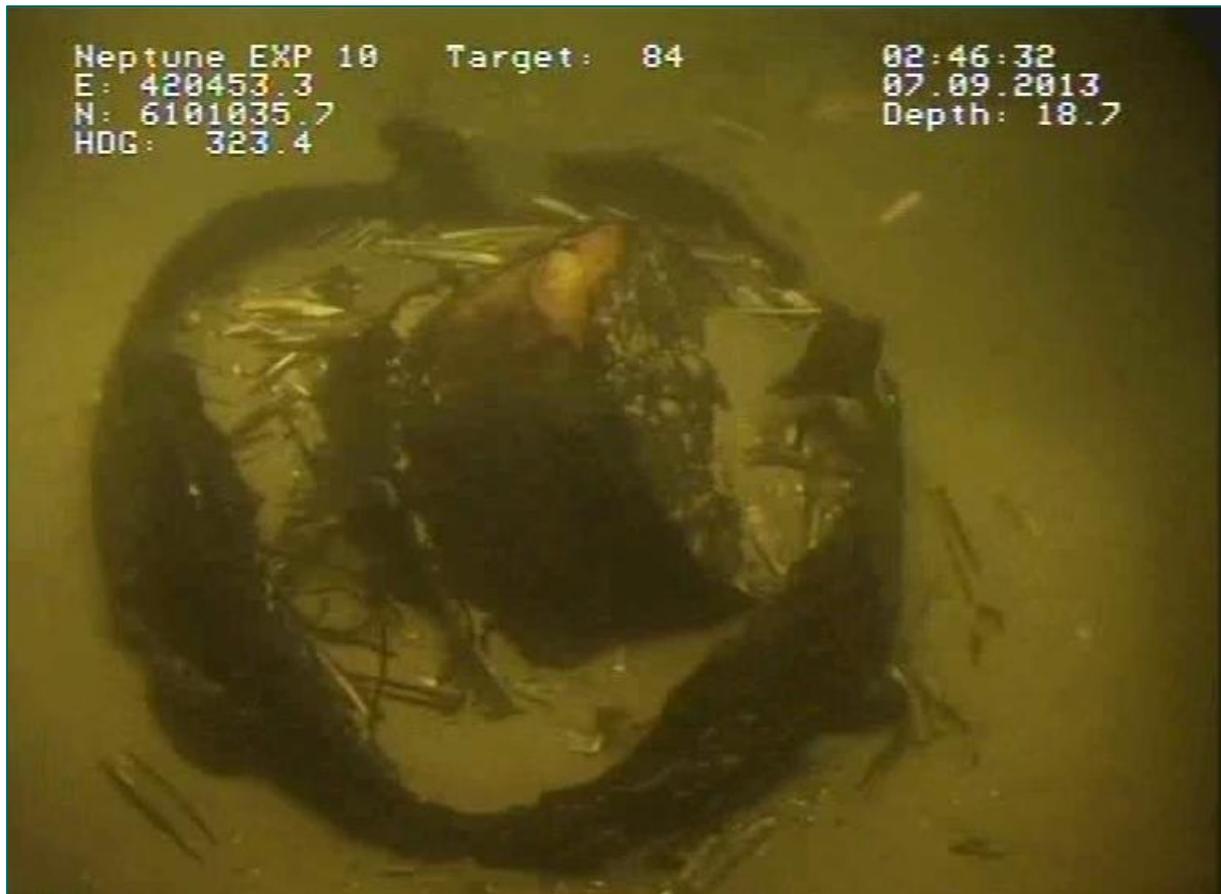
Figure 47. Example of a naval mine found in the North Sea in poor condition where its ferrous mass has been significantly reduced by erosion. The main charge chamber is exposed.

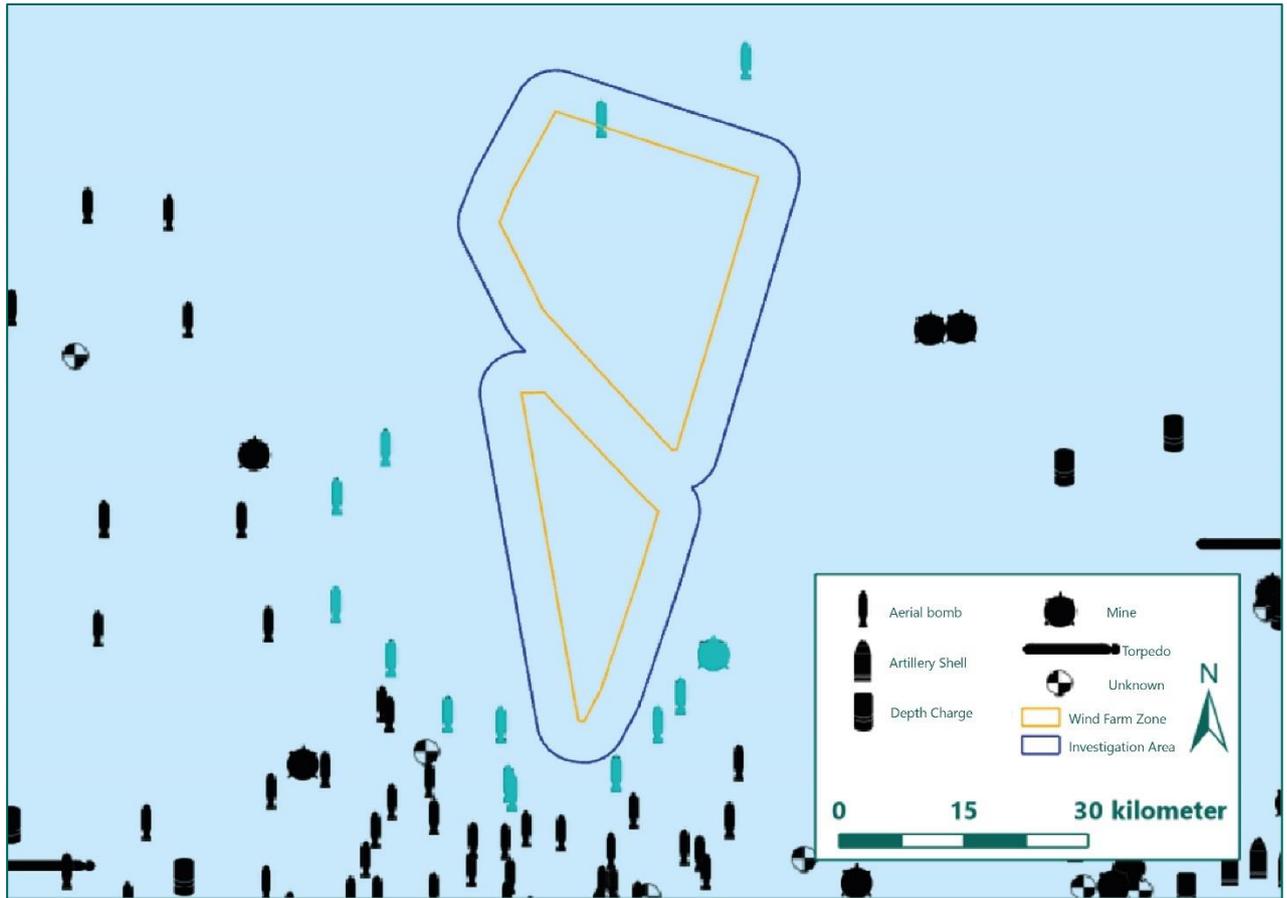
Figure 52: Overview of UXO encounters in and near the Investigation Area (indicated in blue) (Source: Dutch Coast Guard).

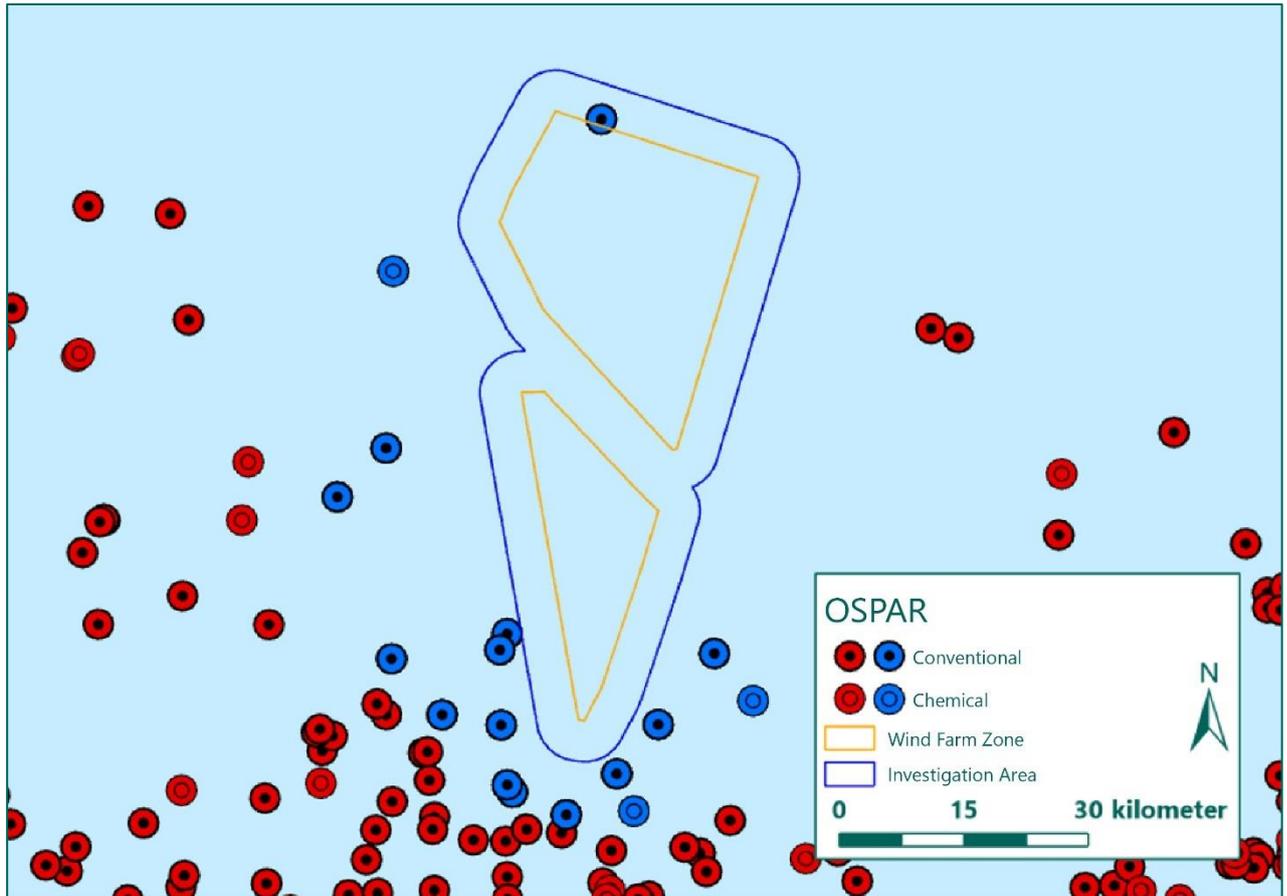
Figure 54: Overview OSPAR ammunition encounters within the Investigation Area (Source: OSPAR).
