Subject Supply of Meteorological and Oceanographic data for Borssele Wind Farm Zone Period 22 October – 22 November 2016 (Lot1)

**Supply of Meteorological and Oceanographic data at Borssele Wind Farm Zone (BWFZ)
Monthly Progress Report: 22 October - 22 November 2016**

**Reference No: C75339_MPR13_R1
19 December 2016**

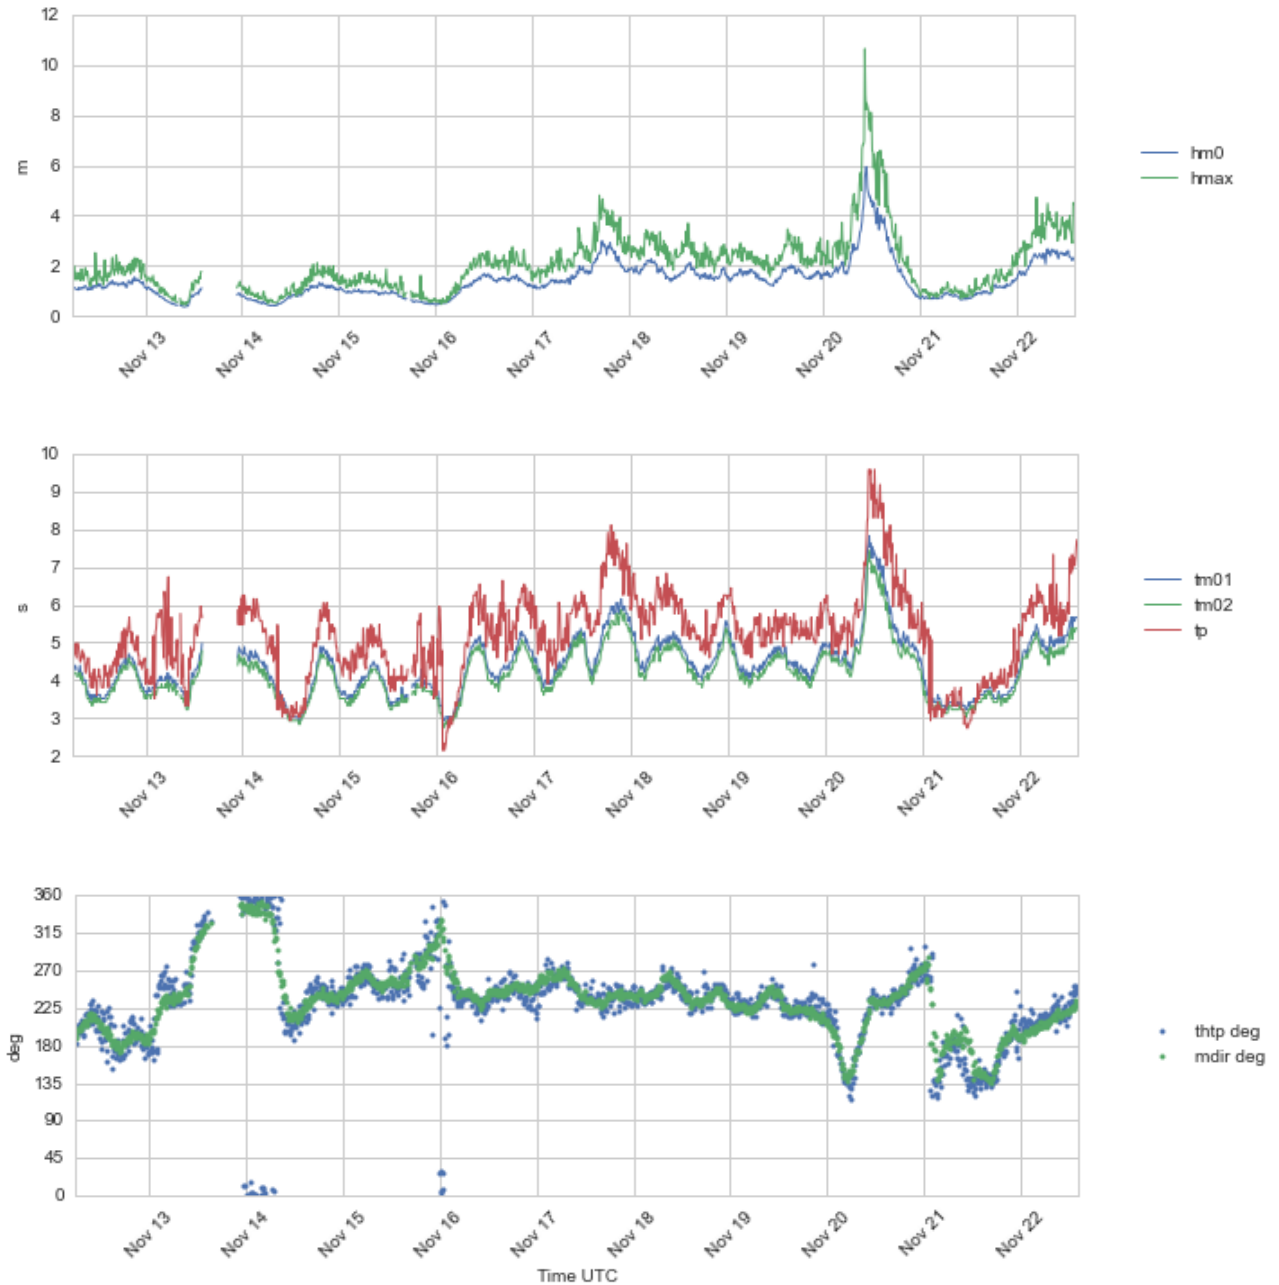
The highest significant wave height (H_{m0}) measured in this period was 5.94 m from a south-westerly direction ($\sim 225^\circ$) at midday 20th of November. Wind speeds of around 30 m/s from south-west ($\sim 225^\circ$) were observed in the profile prior to the highest sea states. The highest single wave with a height of 10.6 m was also observed on 20th of November.

The variations in wave height agree well with the wind speeds in general. The average wave period parameters T_{m01} and T_{m02} show semidiurnal variations which can be explained by the shift in frequency when the waves are travelling along with or opposing the current direction, since the tidal current direction varies in a semi-diurnal pattern.

Figure 4.4 Time series plots of wave height (Hm0 and Hmax) (upper panel), wave period (Tm01, Tm02 and Tp) (second panel), and wave direction (ThTp and Mdir) (lower panel), 22 Oct - 1 Nov 2016.

Figure 4.5 Time series plots of wave height (H_{m0} and H_{max}) (upper panel), wave period (T_{m01} , T_{m02} and T_p) (second panel), and wave direction ($ThTp$ and $Mdir$) (lower panel), 2 - 12 Nov 2016.

Figure 4.6 Time series plots of wave height (Hm0 and Hmax) (upper panel), wave period (Tm01, Tm02 and Tp) (second panel), and wave direction (ThTp and Mdir) (lower panel), 12 - 22 Nov 2016.

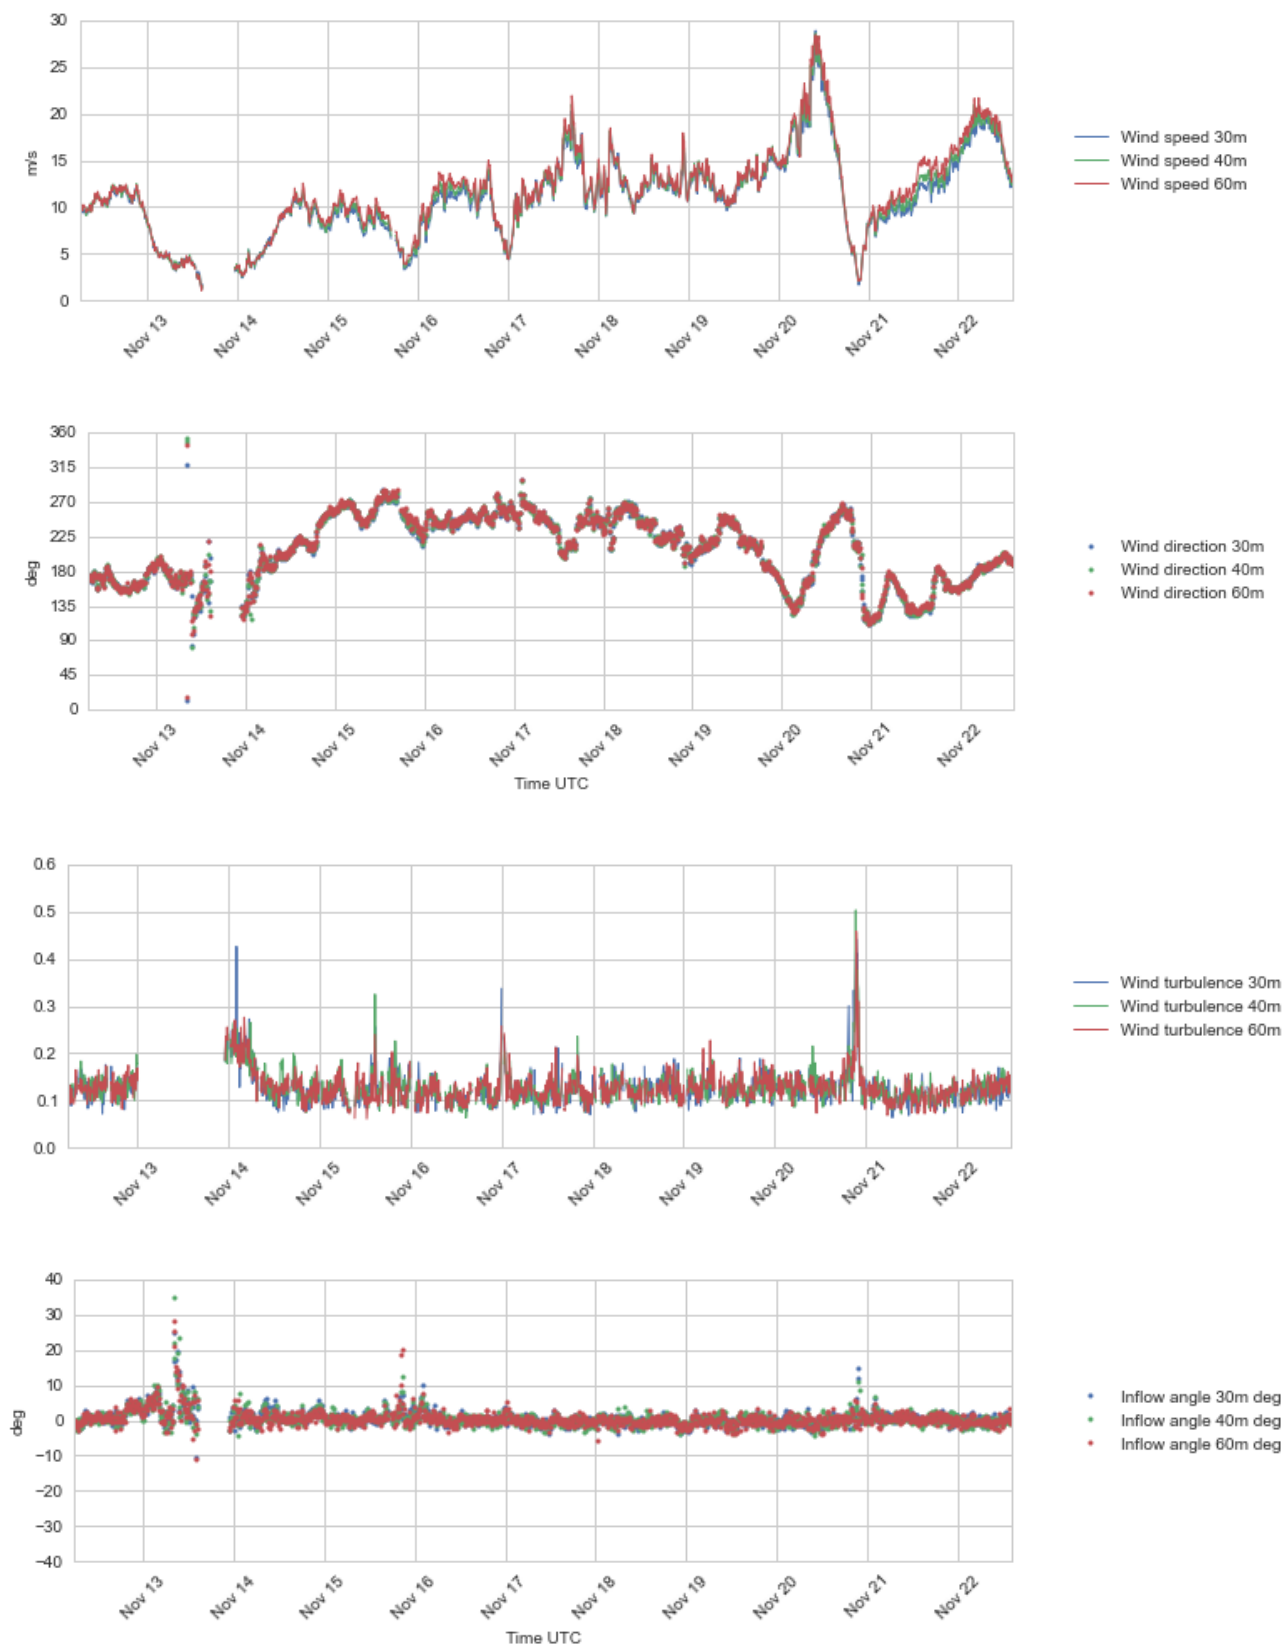
Figure 4.16 Plots of wind profile data, 30 – 60 m a.s.l., 12 - 22 Nov 2016.

Figure 4.17 Plots of wind profile data, 80 – 120 m a.s.l., 12 - 22 Nov 2016.

Figure 4.18 Plots of wind profile data, 140 – 200 m a.s.l., 12 - 22 Nov 2016.

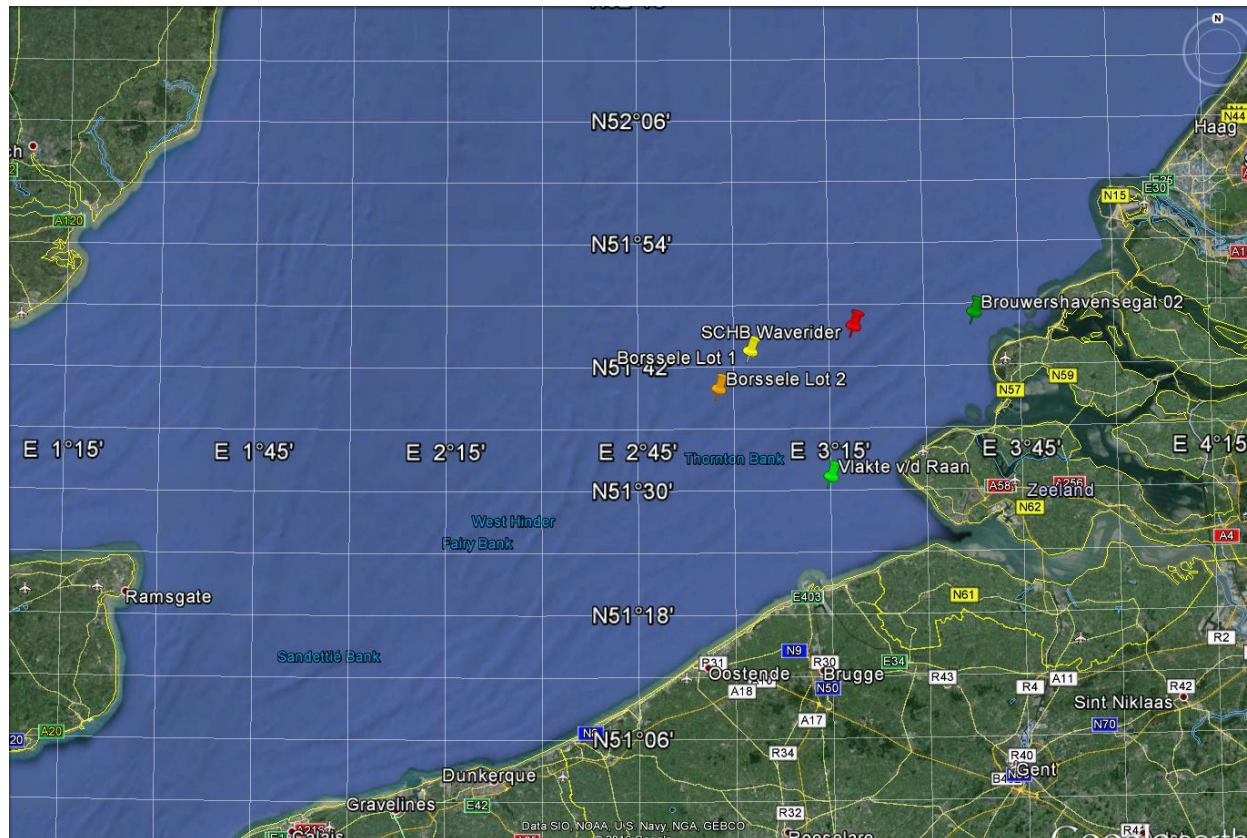
Figure 3.1 Google Earth image indicating Lidar buoy Lot 1 and 2 positions and reference stations. (The Borssele Lot 1 Lidar buoy which is validated in this report is marked by the bright yellow pin.)

The SCHB station should be expected to have lower heights of wind sea than the Borssele Lidar buoy location in southerly to north-easterly winds due to the more limited fetch distance in those directions. In situations with wind sea from north-east to north-west, and situations dominated by northerly swells the two buoy should be exposed to approximately the same wave heights.

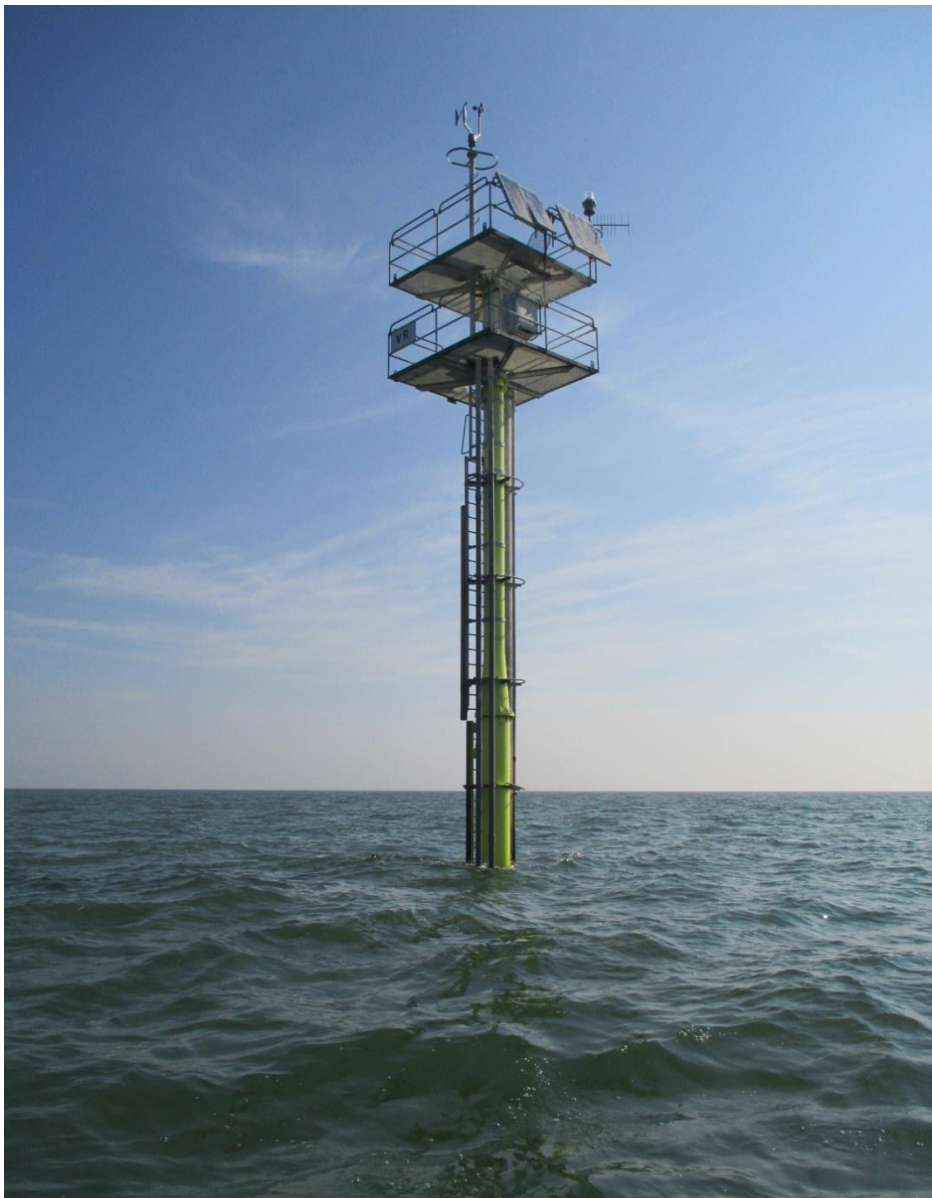
The Vlakte van de Raan (VR) station is measuring wind speed and wind direction. Figure 3.2 shows a photo of the wind mast. Wind speed is measured with the KNMI cup-anemometer. Cup diameter is 105 mm and the distance between the centre of the cups to the rotation axis is 100 mm. Wind direction is measured with the KNMI wind vane. Distance between axis and the outer side of the vane is 535 mm. The anemometer and wind vane are located 13.9 m above the mean sea level. The azimuth of the wind vane plugs at the tip of the booms are determined with a camera relative to distant objects at close to the horizon. The instruments are logged with the KNMI wind SIAM. Wind gusts are determined from a running 3 sec mean value.

Figure 3.2 The wind measuring station at Vlakte van de Raan.

Calibration of the cup anemometers is done in the wind tunnel of KNMI. Wind vanes are balanced and the direction of the vane is tested. Sensors are replaced after 26 month. The cup anemometer contains a photo-chopper with 32 slits. The accuracy is 0.5 m/s. The threshold velocity is 0.5 m/s. The resolution is 0.1 m/s. The response length is 2.5 m. The wind vane contains a code disk. Accuracy is 3°. Resolution is
